PROPERTY CONDITION ASSESSMENT

CITRUS GROVE OF RIALTO
1432 Willow Avenue,
Rialto, California 92376

September 01, 2023

Project No. COR-120

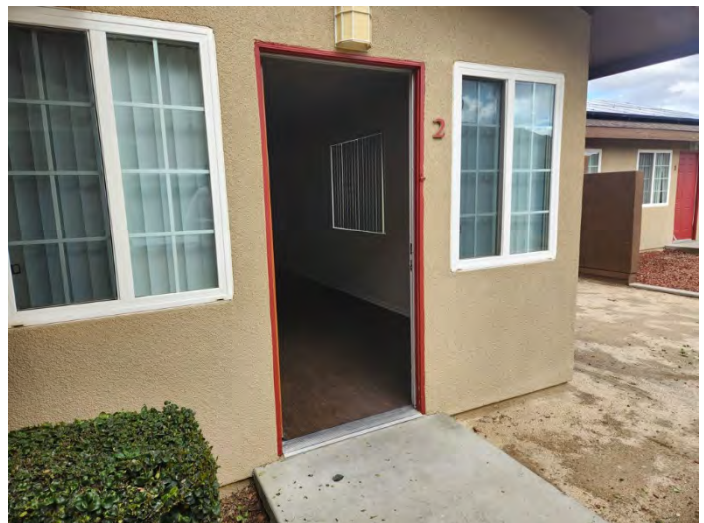
5. The entrance to Apartment 2-1442M. The windows on either side of the entrance door are replacement units that have concealed nailing flanges.

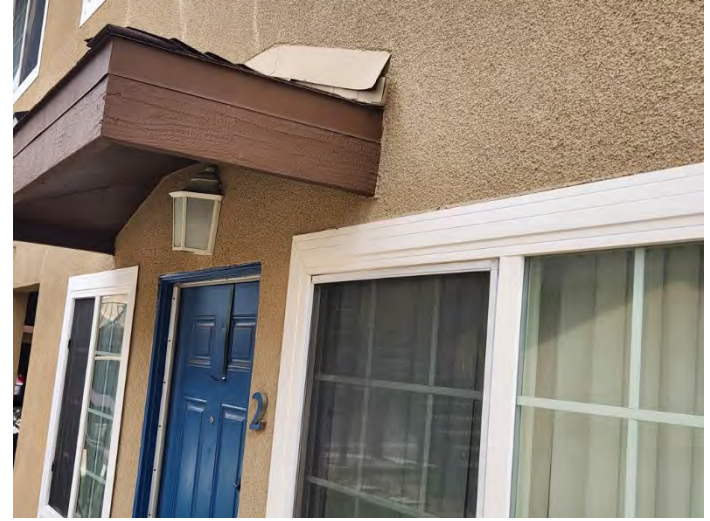
6. A window below the entrance canopy of Apartment 2-1341M. This is a retrofit window that has an exposed cover flange. Management has reported that this window leaks when the caulking between the frame and the stucco wall fails.

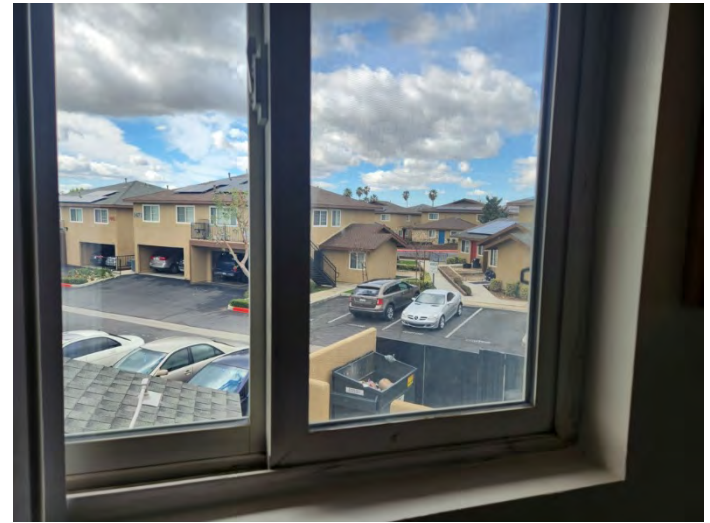
7. The condition of the interior trim in the kitchen window in Apartment 4-1482C.

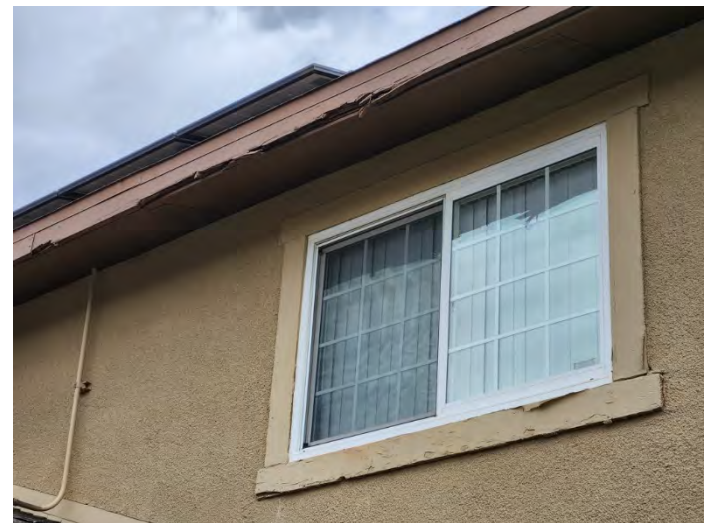
8. Deteriorated wood fascia and window trim at Building 1451C.

- Selective dry rot framing replacement on soffits, fascia, window trim
 - Carport beam and landing
 - New unit exterior doors and associated stucco/waterproofing repairs
 - New vinyl windows in all units
 - New waterproofing at landings
 - New heat pump domestic water heaters
 - New light fixtures
 - New gutters and downspouts on all residential buildings
 - New fire extinguisher cabinets
-

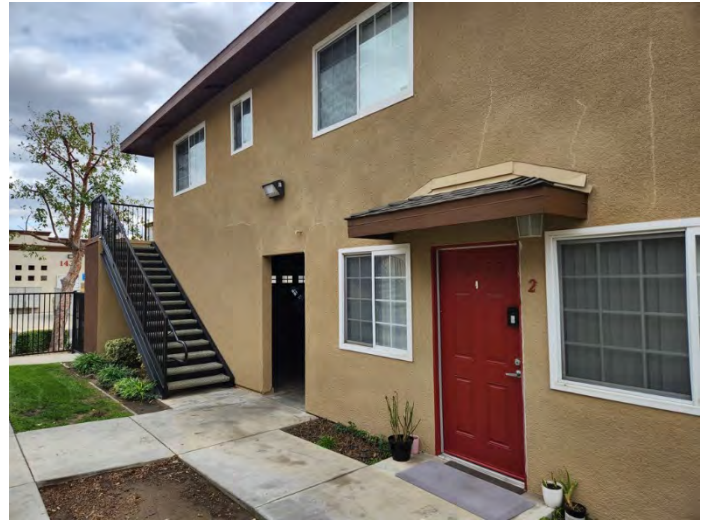
9. The side of Building 1431C indicating the typical apartment entrance and the wall-mounted light fixture at the stair. There are vertical cracks on the stucco wall, which have been repaired.

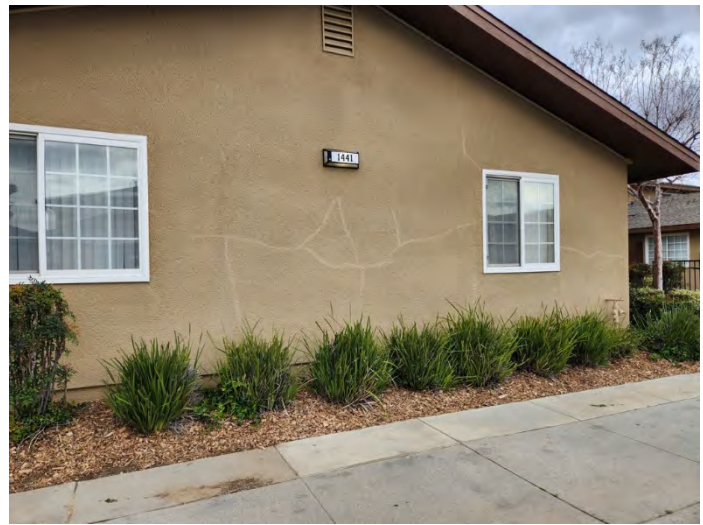
10. The Building-1441C wall on Clifford Street, indicating linear cracking that has been repaired and the typical attic gable vent.

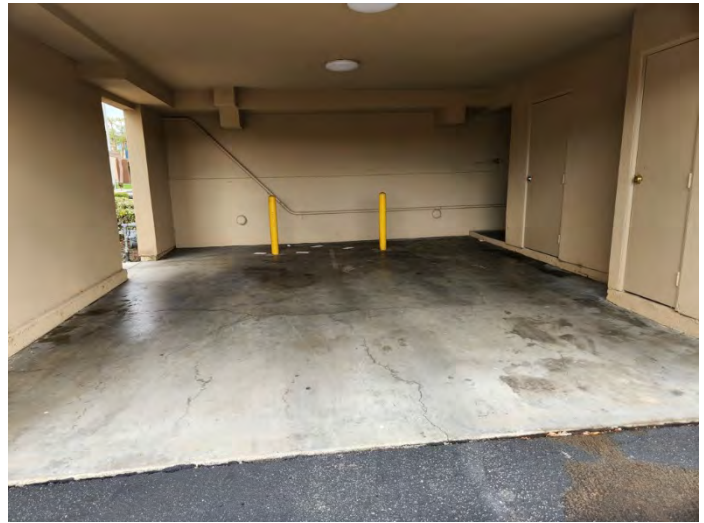
Condition:	No issues evident except for cracking and spalling of the concrete slabs on grade
------------	---

13. A pair of carports in Building 1351W. There is linear cracking and spalling of the concrete slab-on-grade.

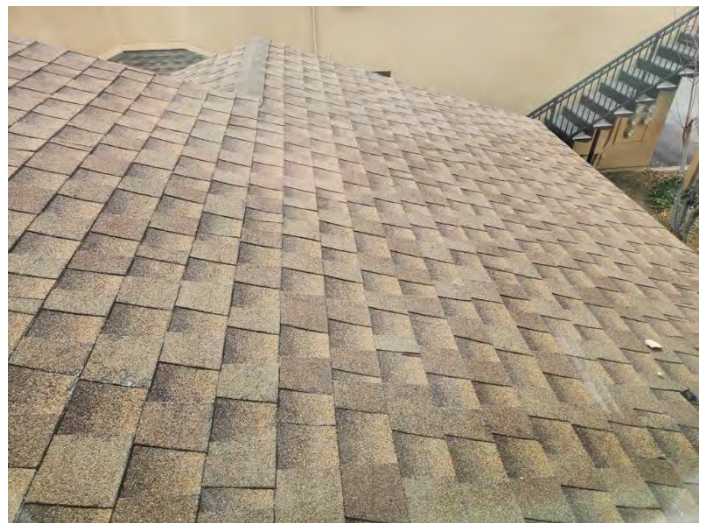
14. The condition of the shingle roof on building 1442M.

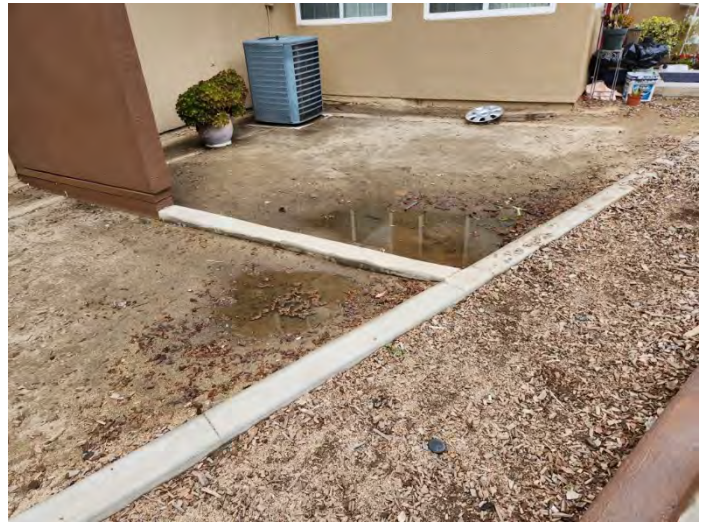
Description:	Roof Run-Off	The roofs drain directly to grade. No gutters and downspouts are provided.
	Surface Run-Off	The paved and landscaped areas are generally graded to catch basins. (Photo Nos. 20, 22).
	Underground System	Catch basins discharge into underground storm sewers.
	Municipal Connection	The underground storm lines extend to curb outlets on the streets. (Photo No. 23).
	Service Provider	No information provided.
Condition:	We noted ponding in the landscaped areas and erosion below the concrete walkways. The catch basins are blocked and/or the storm lines are undersized. (Photo Nos. 20, 21, 22).	
Recommendations:	The storm surface run-off and drainage systems should be modified to facilitate proper site drainage. Where necessary, the open areas should be re-graded. Catch basins that are backing up and associated storm underground piping should be replaced with adequately sized components as necessary.

22. Ponding over the area drain in front of Building 1481M.

Stormwater Drainage: The open areas should be re-graded, and catch basins and storm lines should be replaced with adequately sized components to improve storm drainage. See Item 3.7.

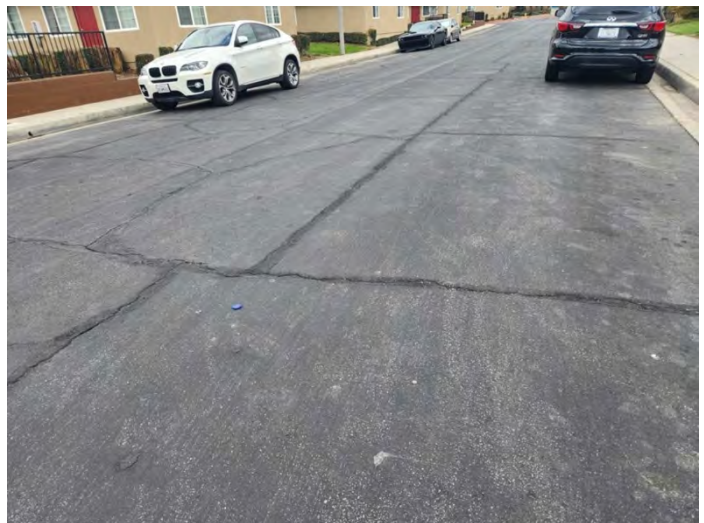
3.5.2 On-Site Roadways and Parking Areas		
Description:	The on-site street and parking spaces are paved with asphaltic concrete.	
Condition:	Cracks in the asphalt pavement, worn seal coat and exposed aggregates were noted. (Photo Nos. 29, 30, 31, 32, 33, 34, 35, 36, 37).	
Recommendations:	We recommend selective repairs, seal coating and re-striping of the asphalt pavement.

29. Linear cracking and failed crack seals on the asphalt pavement over Millard Street.

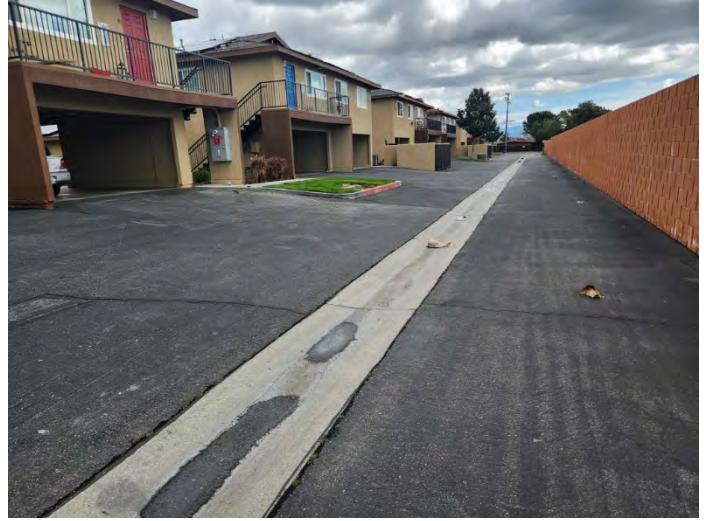
30. Looking east on the alley that runs along the south side of the property parallel to Winchester Drive. There is linear cracking and exposed aggregate over the asphalt pavement. There is cracking and spalling of the concrete v-gutter. To the right is the concrete masonry unit property line wall.

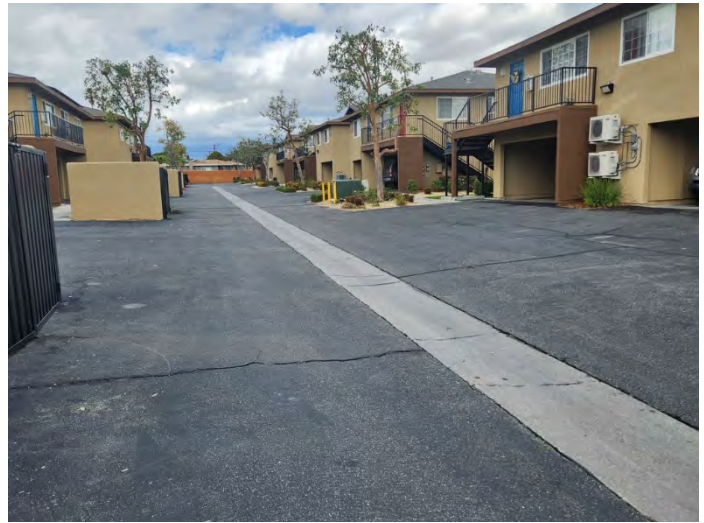
3.5.3 Curb and Gutter		
Description:	Concrete curbs, and combination curb and gutter are provided along perimeter of the asphalt paved areas. Concrete v-gutters are provided along the center of the drive aisles for drainage.	
Condition:	We noted cracking and spalling of the concrete curbs and gutters and v-gutters. (Photo Nos. 30, 31, 34, 36).	
Recommendations:	We recommend selective repairs of the cracked and spalling sections of concrete curb and gutter and v-gutters.

31. Looking south on Clifford Street with Building 1452C on the right. There are wide open linear cracks in the asphalt pavement and the aggregate is exposed. Cracking and spalling along the concrete v-gutter is evident.

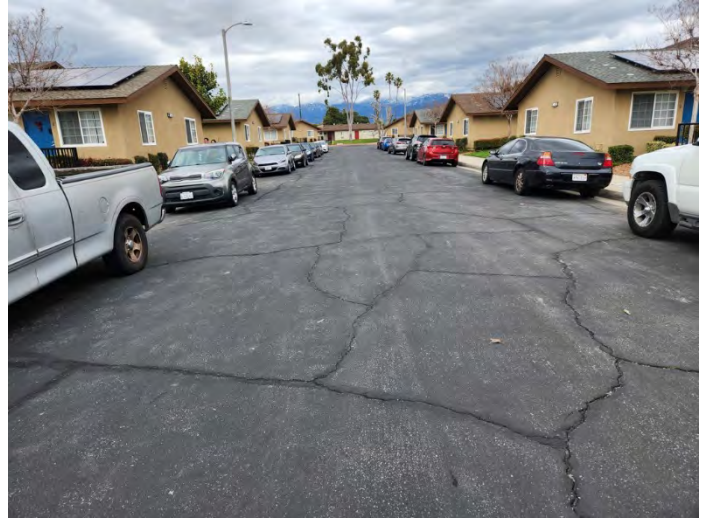
33. Looking north along Clifford Street. There is block-type cracking on the asphalt pavement. Crack seal repairs have failed.

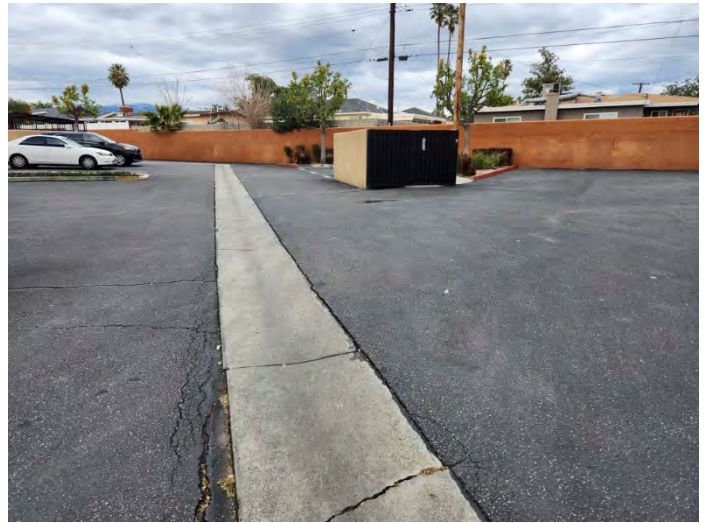
Condition:	The trash enclosures are in fair condition. (Photo Nos.12, 27, 34).
------------	---

34. A trash enclosure and the concrete masonry unit property line wall along the north property line. There cracking of the asphalt pavement and the concrete v-gutter.

Recommendations:	Provide costs for ongoing trash enclosure pad, screen wall, and gate repairs.
------------------	---

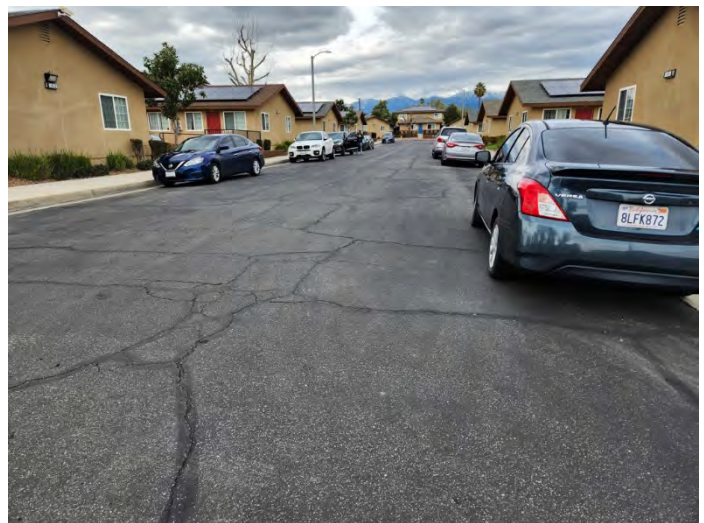
35. Looking north on Millard Street. Block-type cracking of the asphalt pavement is prevalent. Crack seal repairs have failed, and the aggregate is exposed.

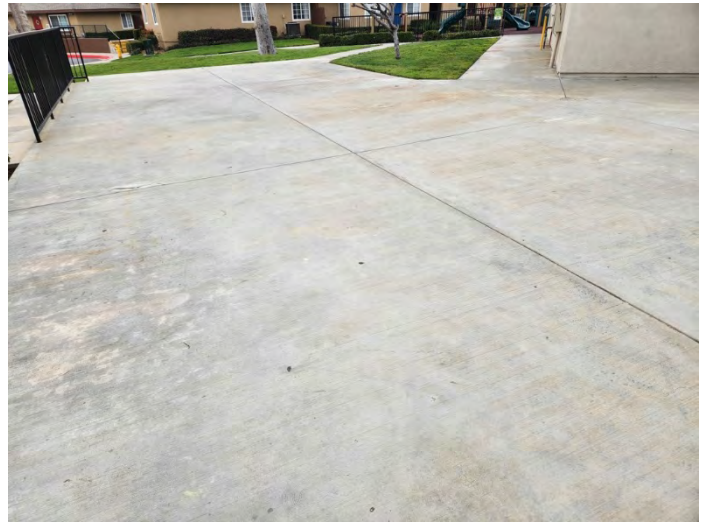
Condition:	The play area and play court are in good condition.
------------	---

43. The concrete play area near the north laundry room. Some cracking and spalling is evident at the joints.

Recommendations:	Provide costs for ongoing repairs to the play area. Costs for repairs to the concrete play court are included under Item 3.5.4.
------------------	--

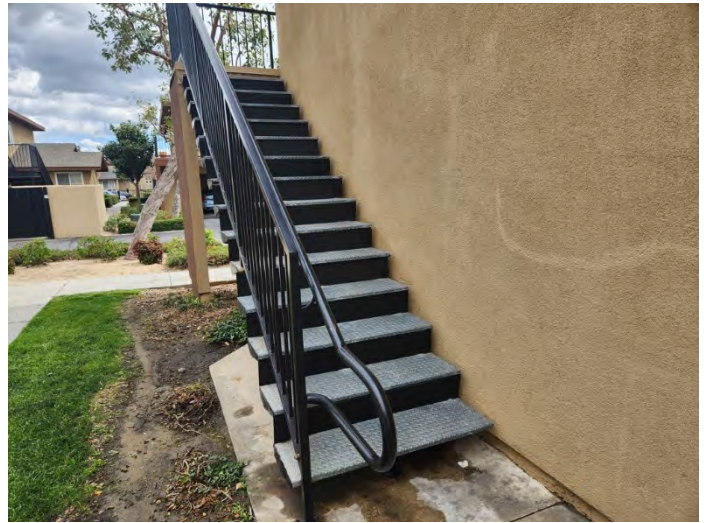
49. The stair that serves Building 1431M. This stair has diamond plate treads that were reported to be slippery when wet.

Exterior Stairs: Metal diamond plate treads should be replaced with precast concrete to reduce potential slips and falls. See Item 4.5.1.

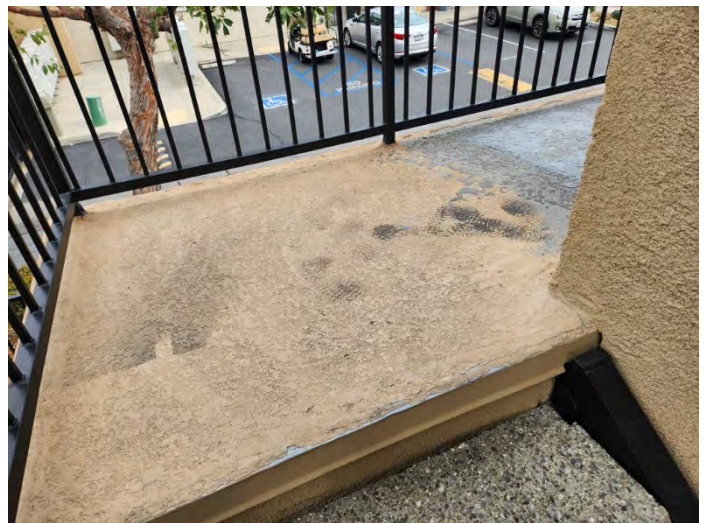
50. The condition of the cementitious topping over the stair landing/porch that serves Apartment 4 in Building 1431C.

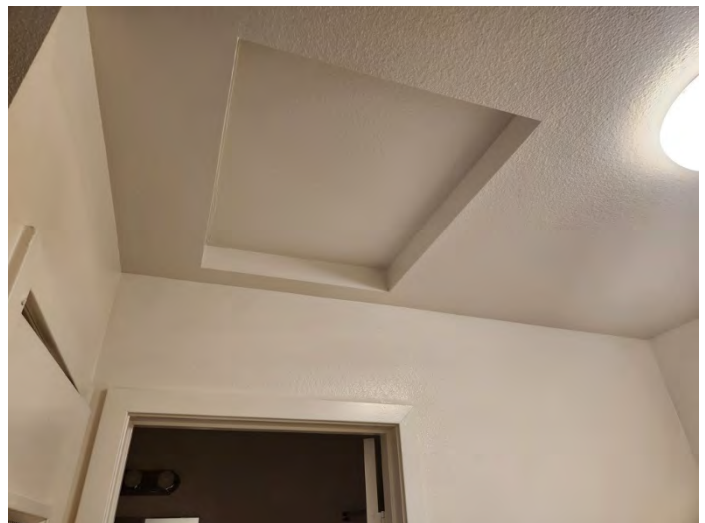
77. The hatch at the stair landing in Apartment 2-1442M. The hatch has been caulked shut.

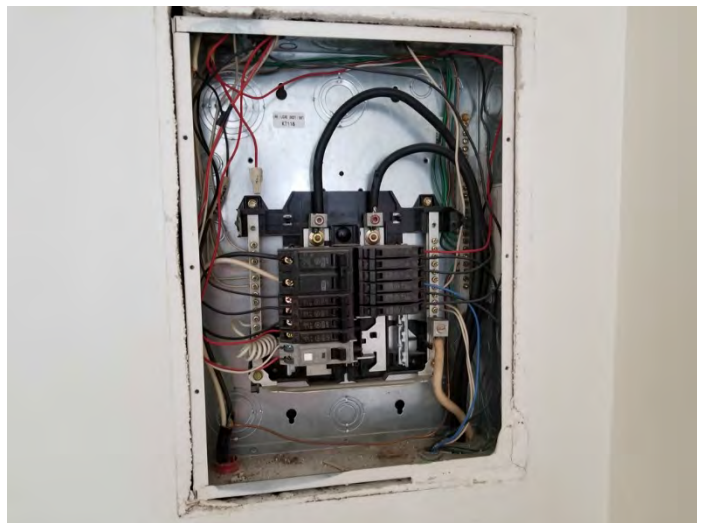
83. The circuit breaker panel in Apartment 4-1482C. Arc-fault interrupters are not provided. The feeders are aluminum and branch wiring is copper.
