## STRUCTURAL ASSESSMENT FOR 335 W. RIALTO AVE

RE: Structural Report for Public Works Building Fire Damage Restoration Project,  
335 West Rialto Avenue

## **GEOPHYSICAL EVALUATION** **CITY OF RIALTO PUBLIC WORKS REBAR SCANNING (GPR)**

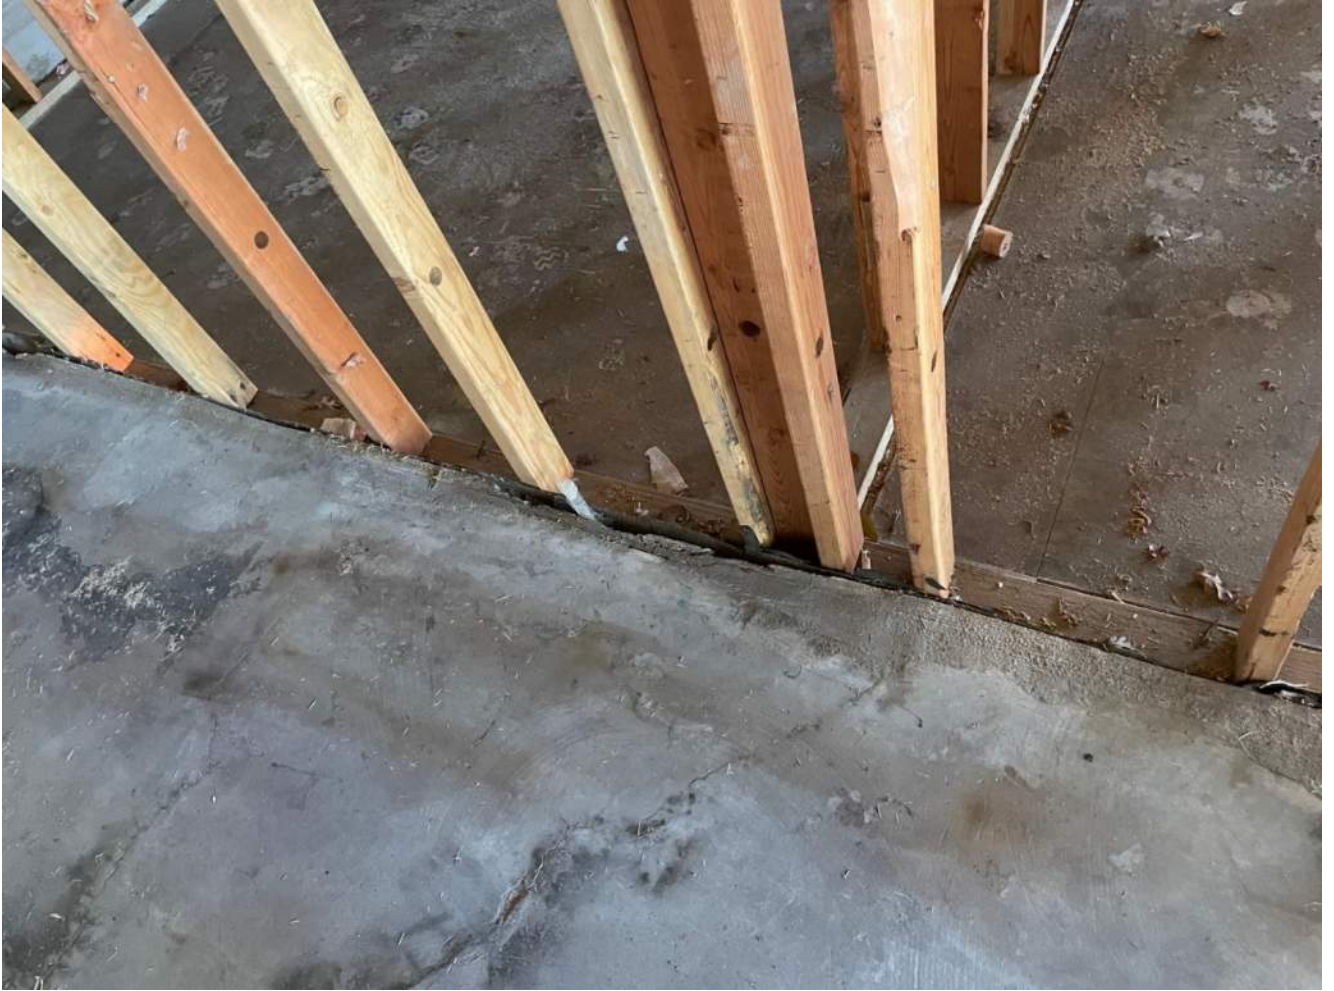
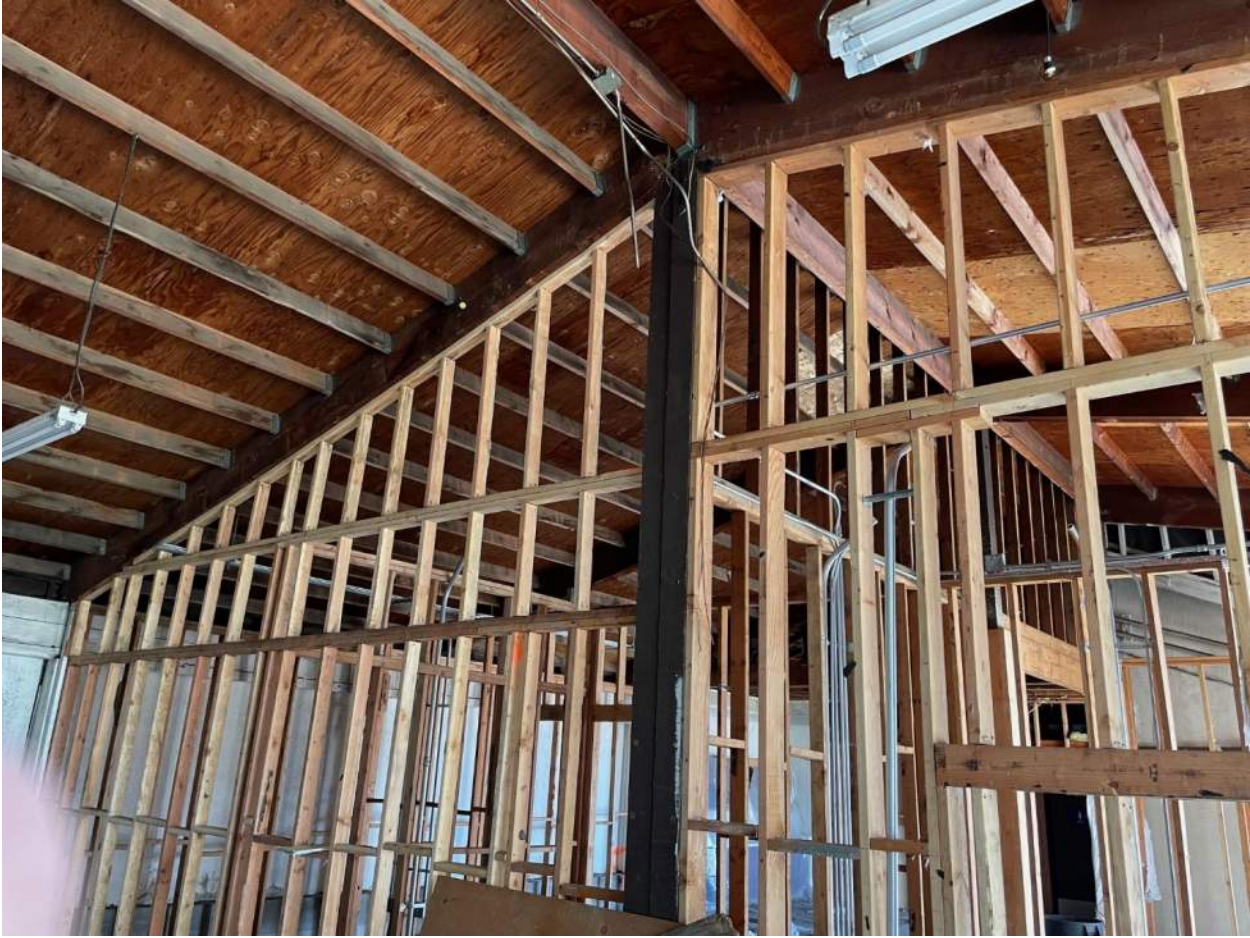
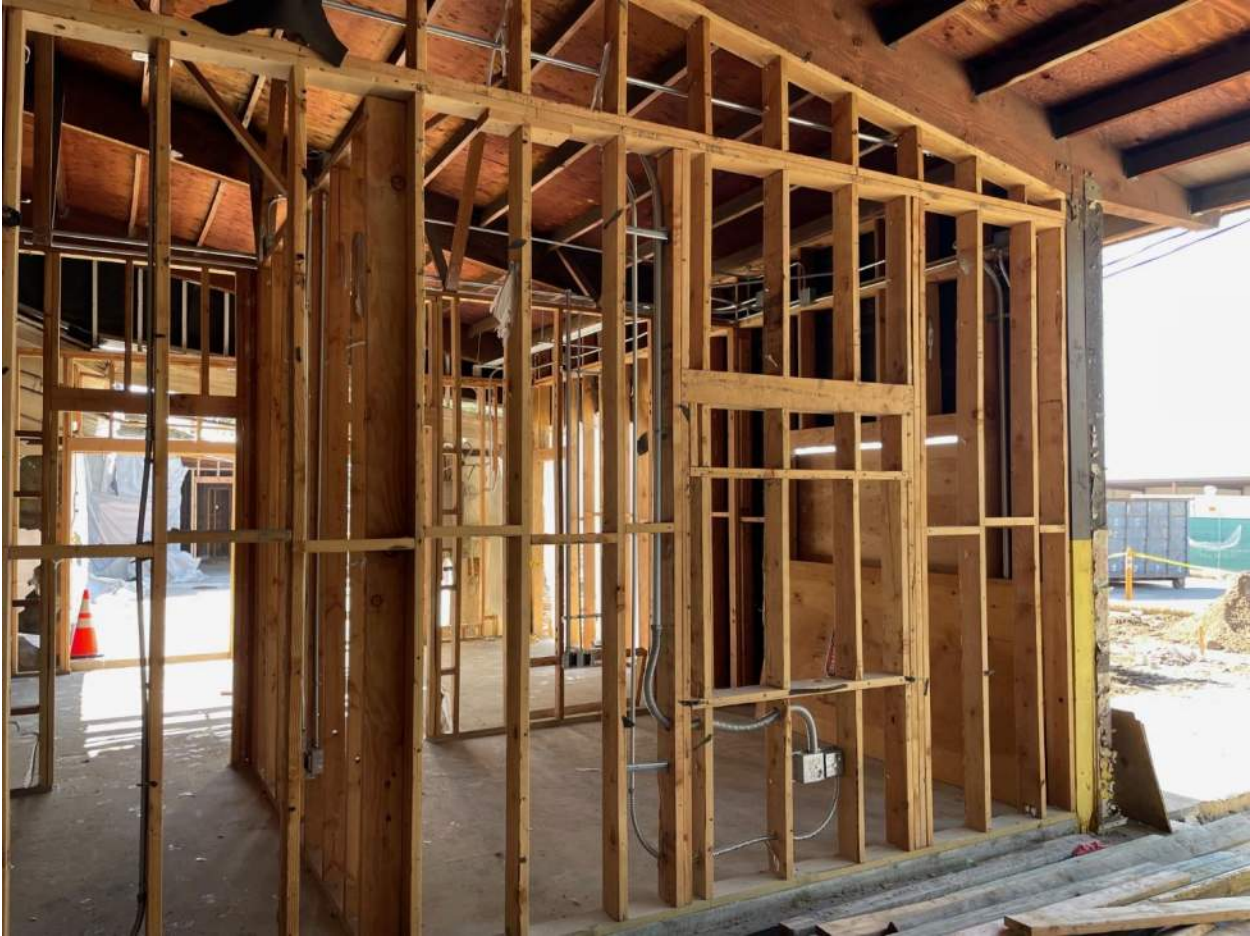
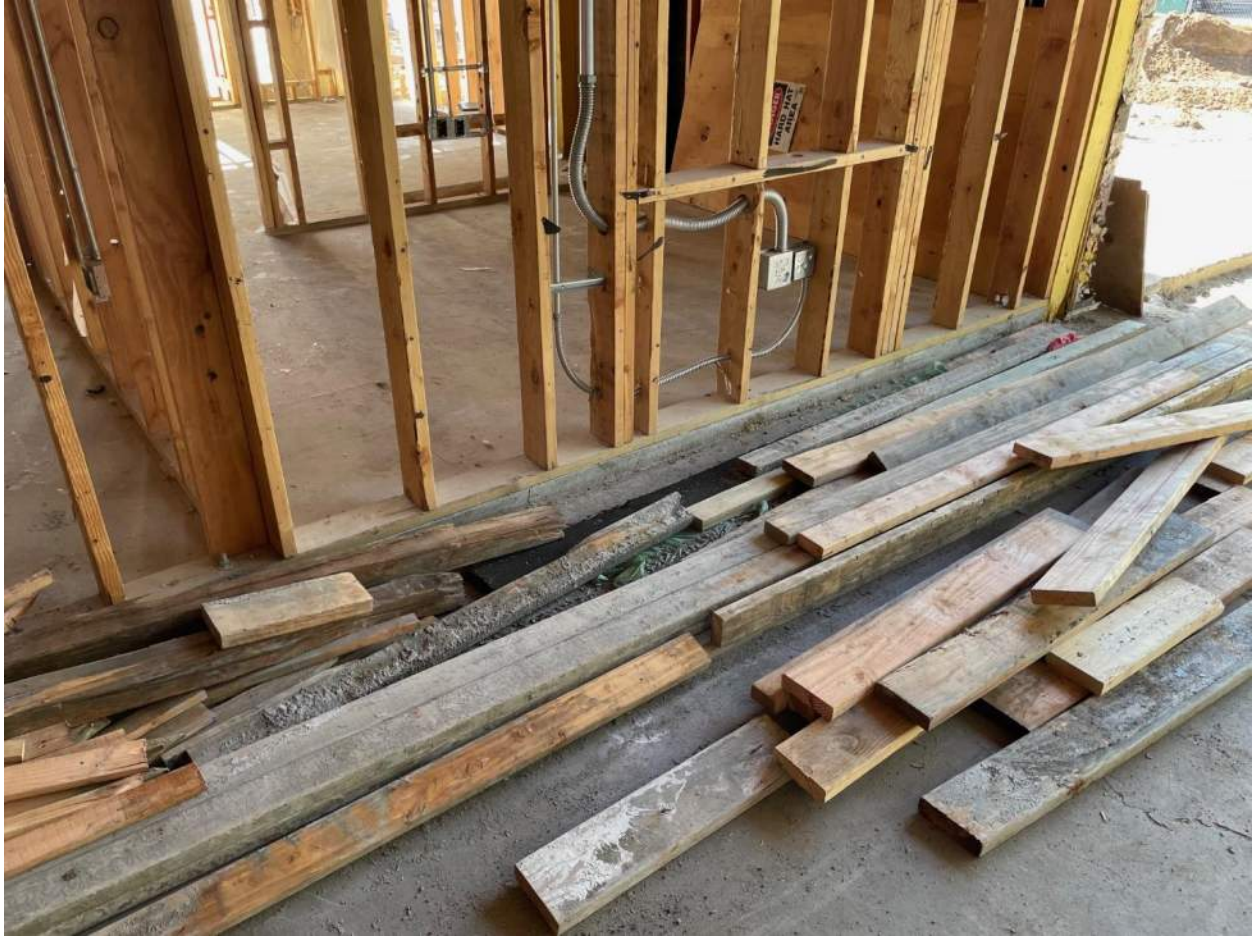
**Line B-B** The north end of the wall has two sets of double plates framed into the wall framing system. One appears to be at roughly the height of a possible framed ceiling. The other double plates are only braced at the posts and one perpendicular wall location, so there is a concern for a possible hinge connection weakness. The southerly portion has one intermediate set of double plates. This would appear to be at the same height as the other double plates which could be at the height of a possible framed ceiling or provide bracing to the roof framing. The southerly portion also has some unconventionally infill framed window openings, which could be corrected. There are some upgrades required by the current construction documents, including sill anchorage. Photos 1 to 4.

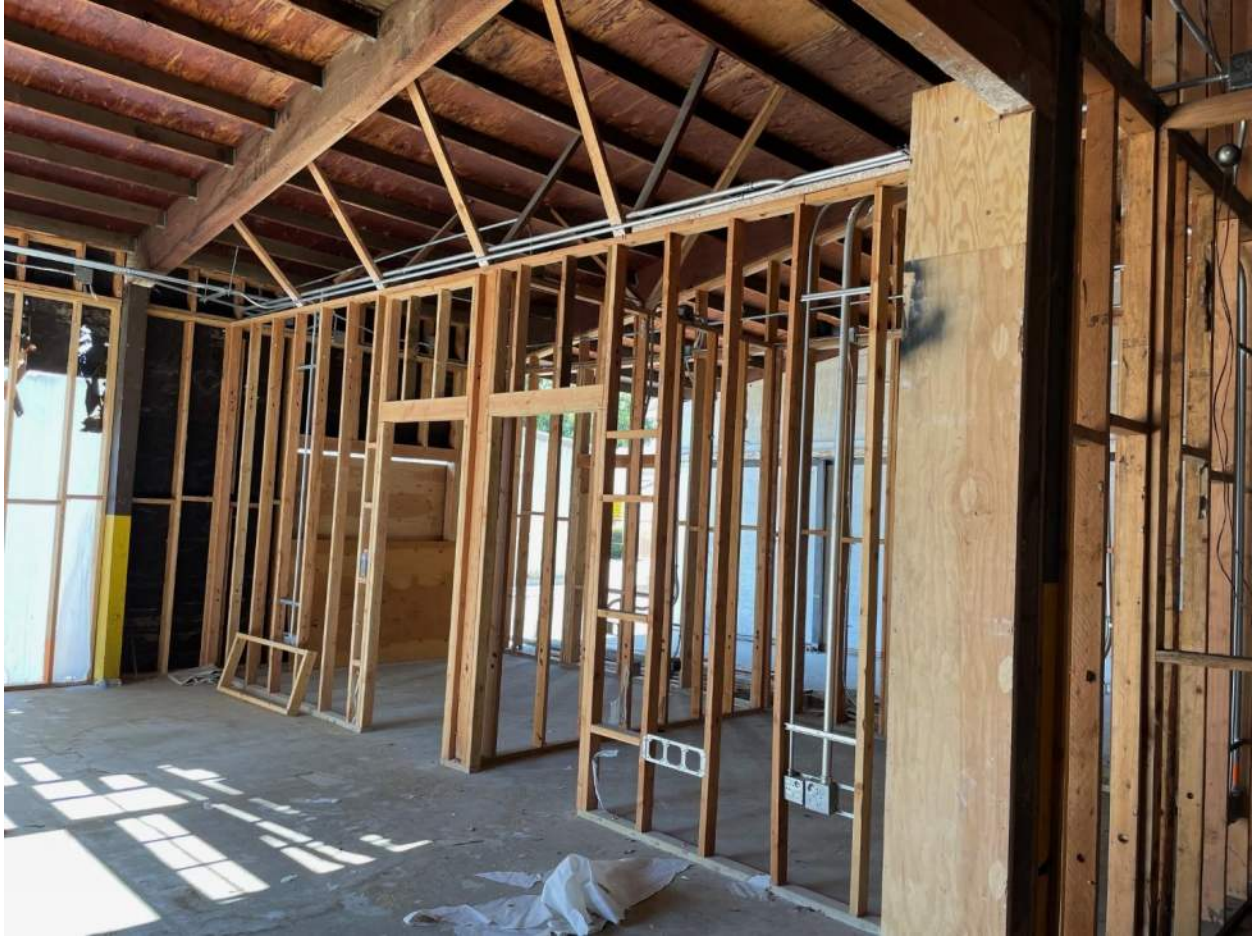
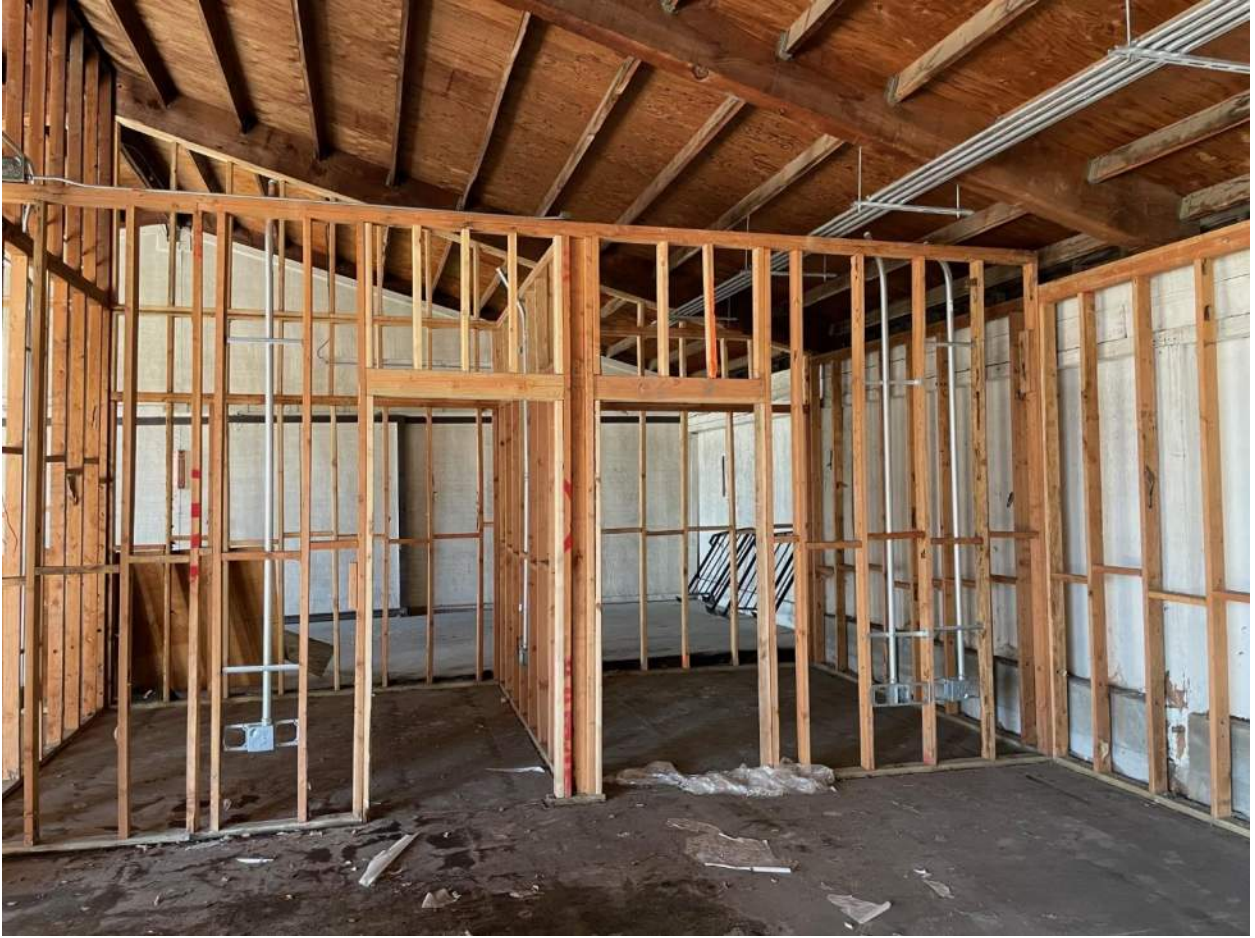
**Line B1-B1** This location is typical for the post and beam construction. The posts are not installed in a column base or other hardware but have the stem wall or footing concrete poured around them. This does not provide for any weather, pest, or deterioration protection. The southerly posts are also twisted at this location and at Line C-C. There is a north-south partition wall which is to remain. It has bracing to the roof system on the southerly side, but the north side needs to have bracing installed to roof system. Photos 5 and 6.

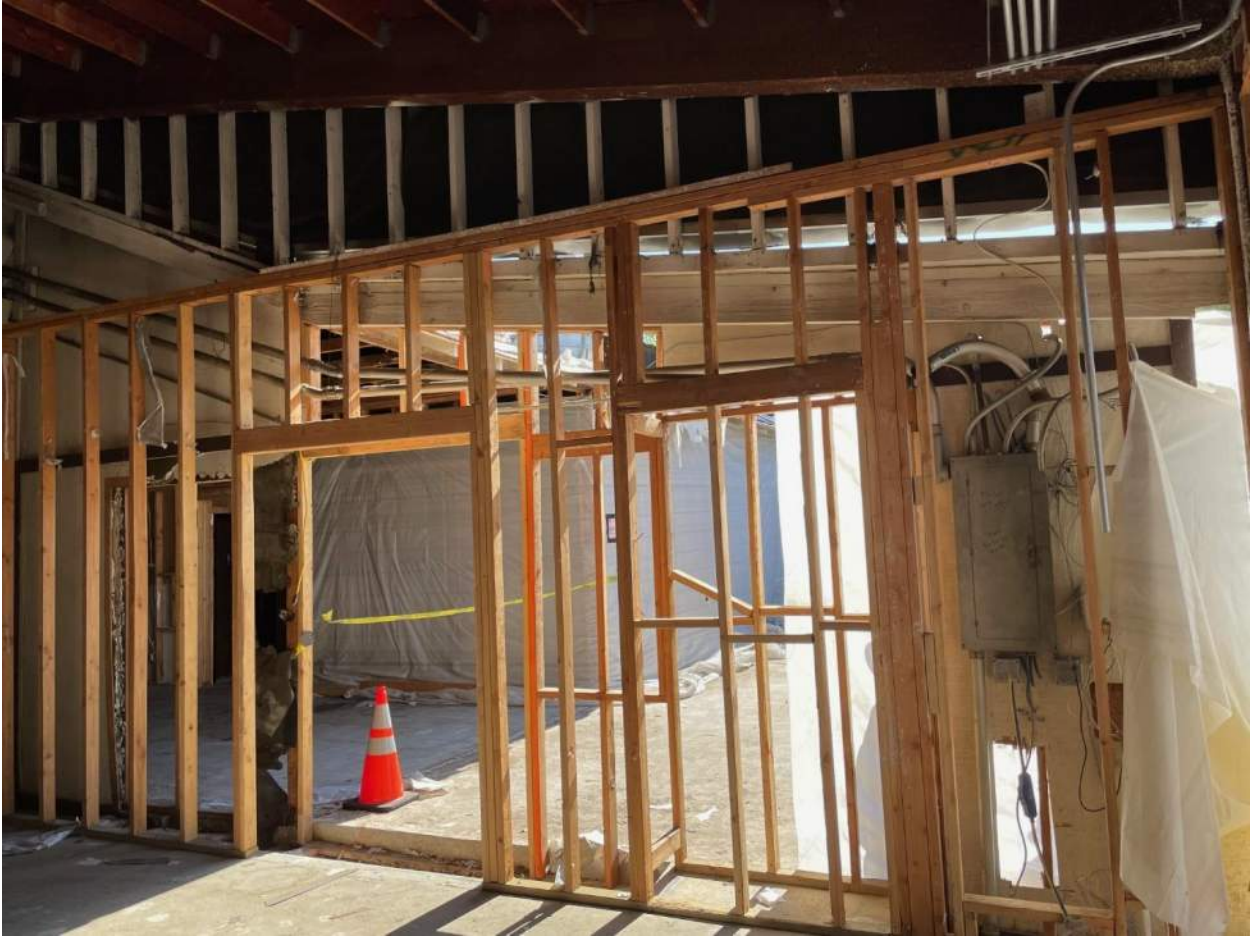
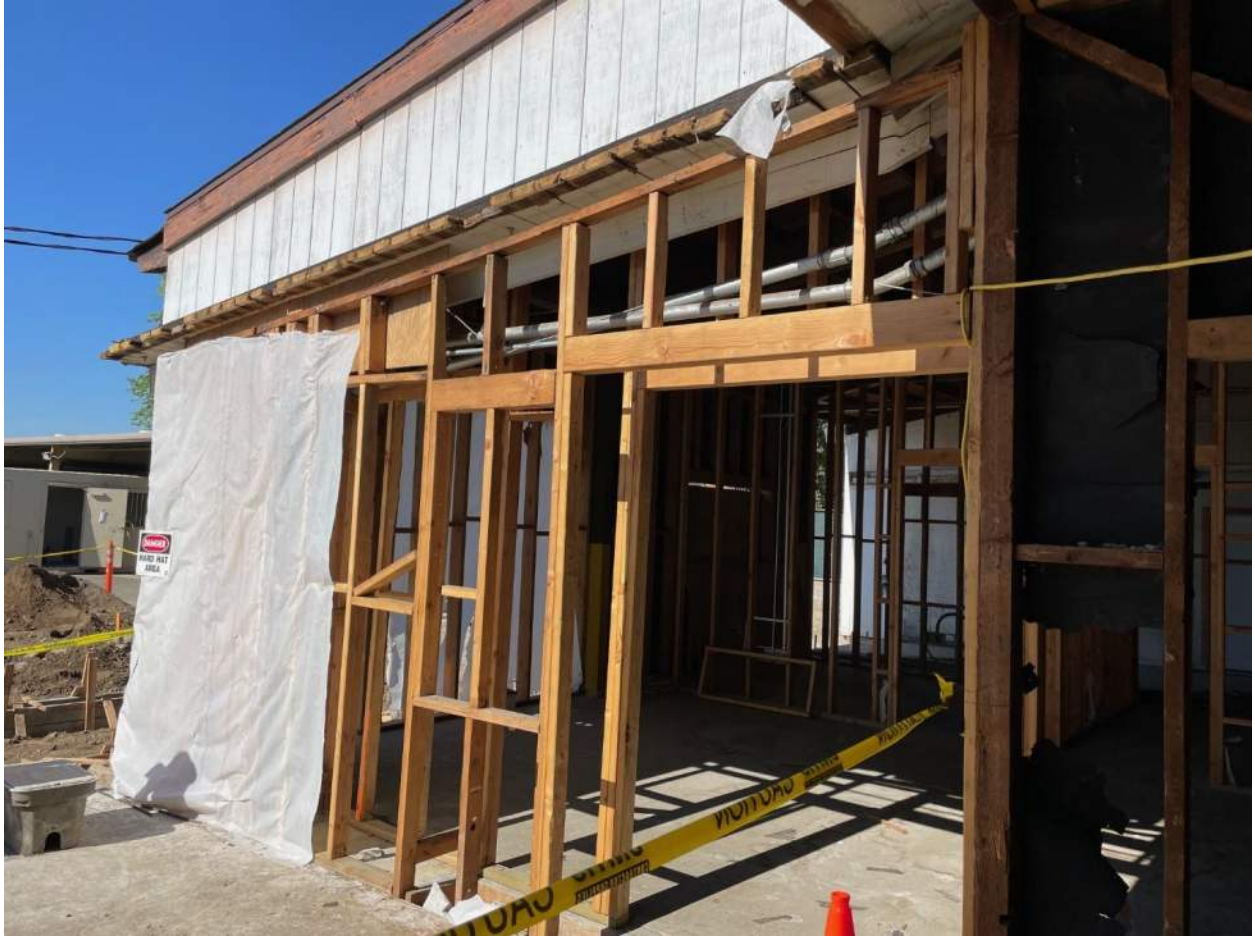
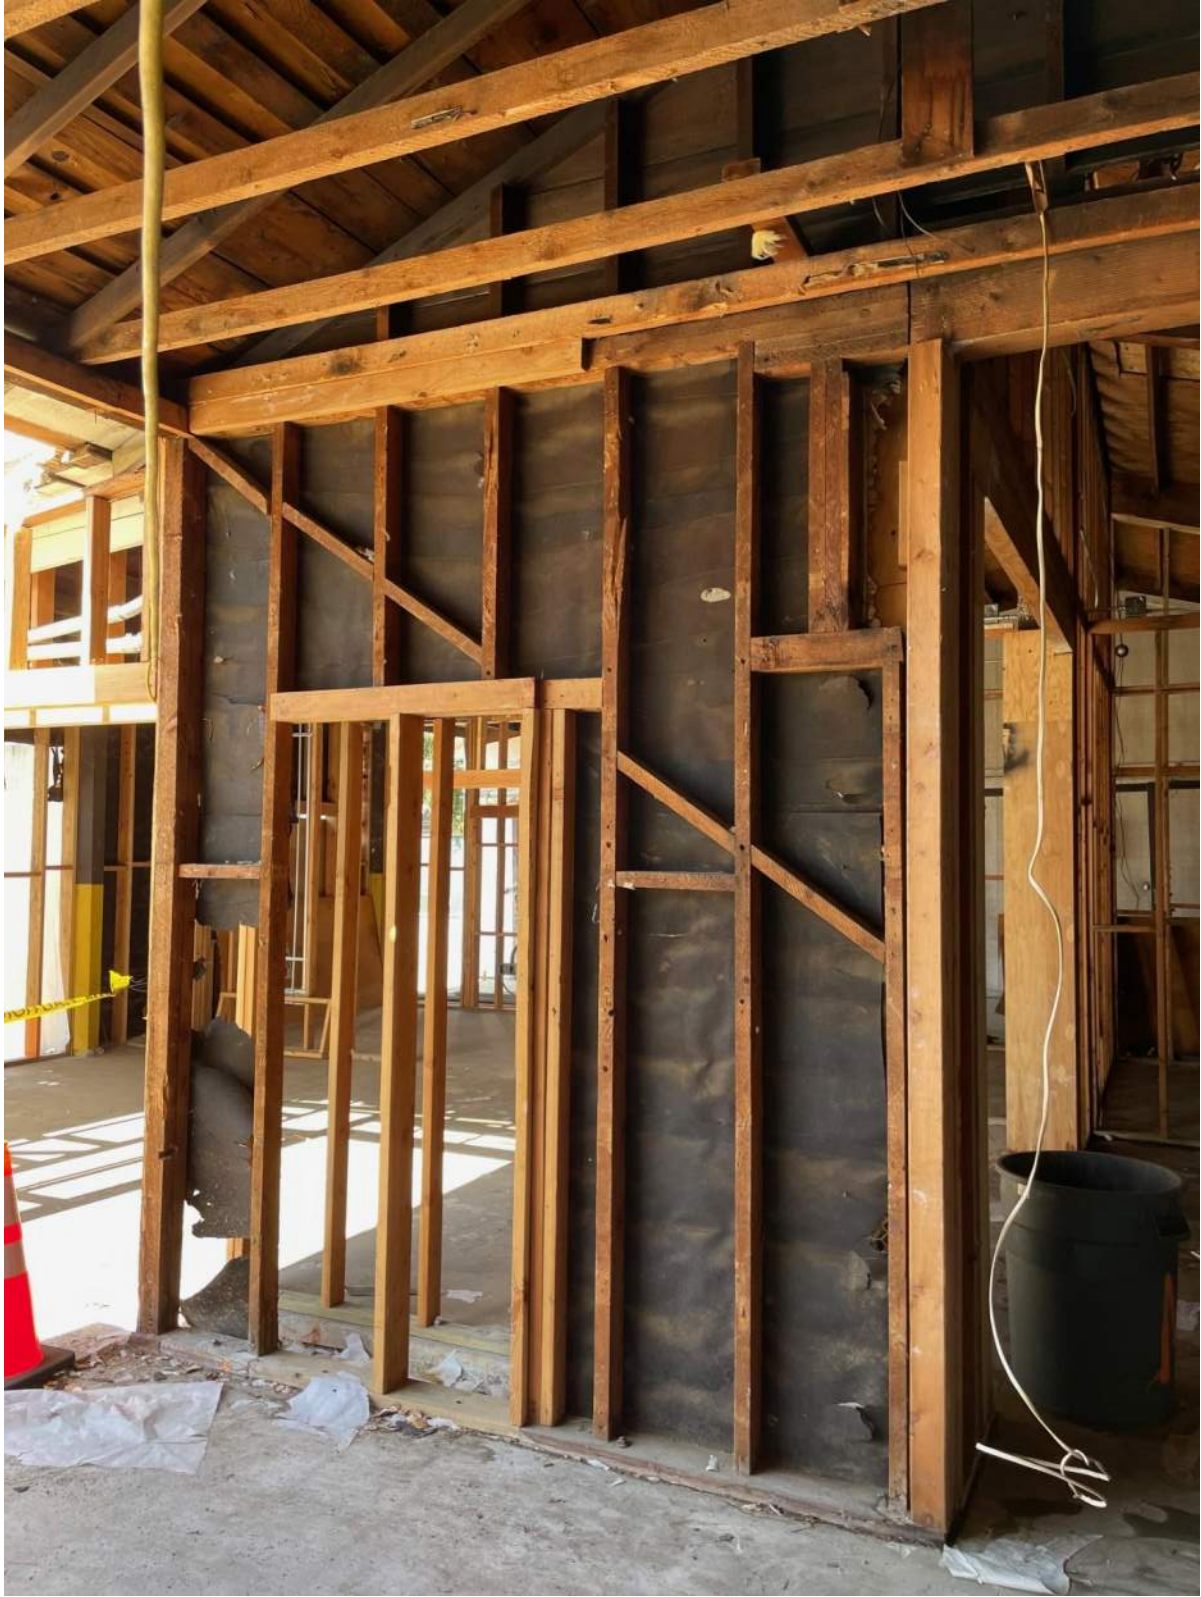
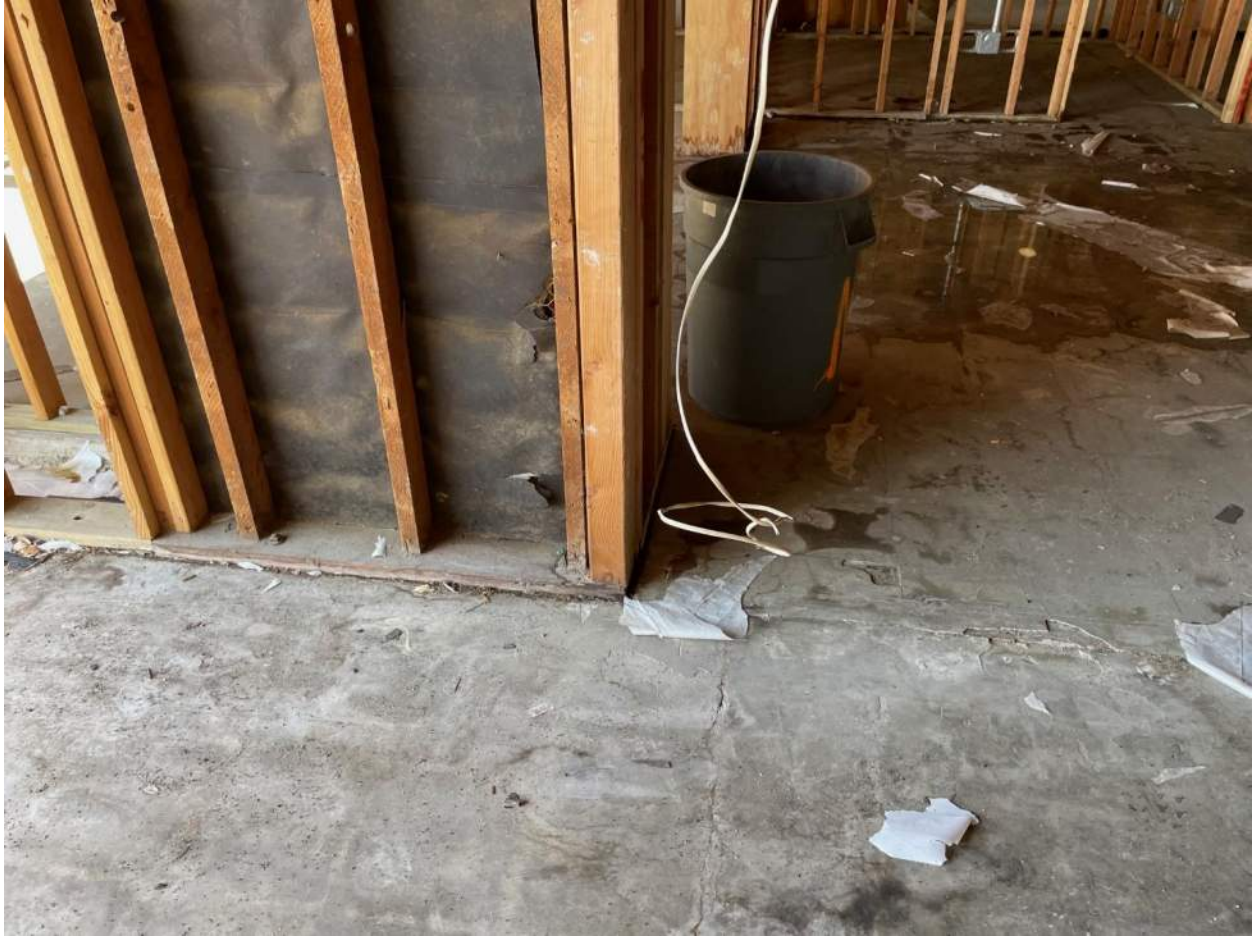
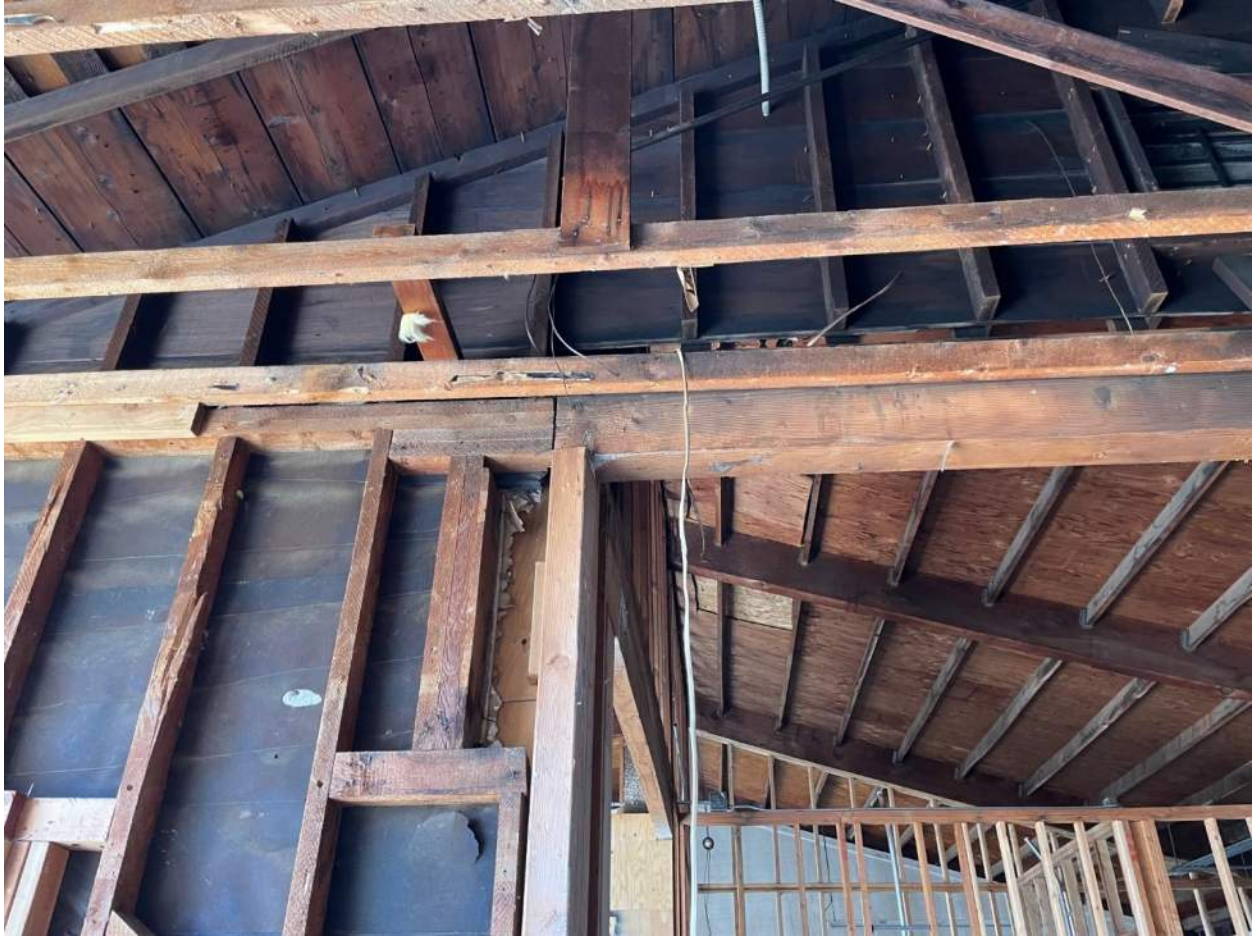
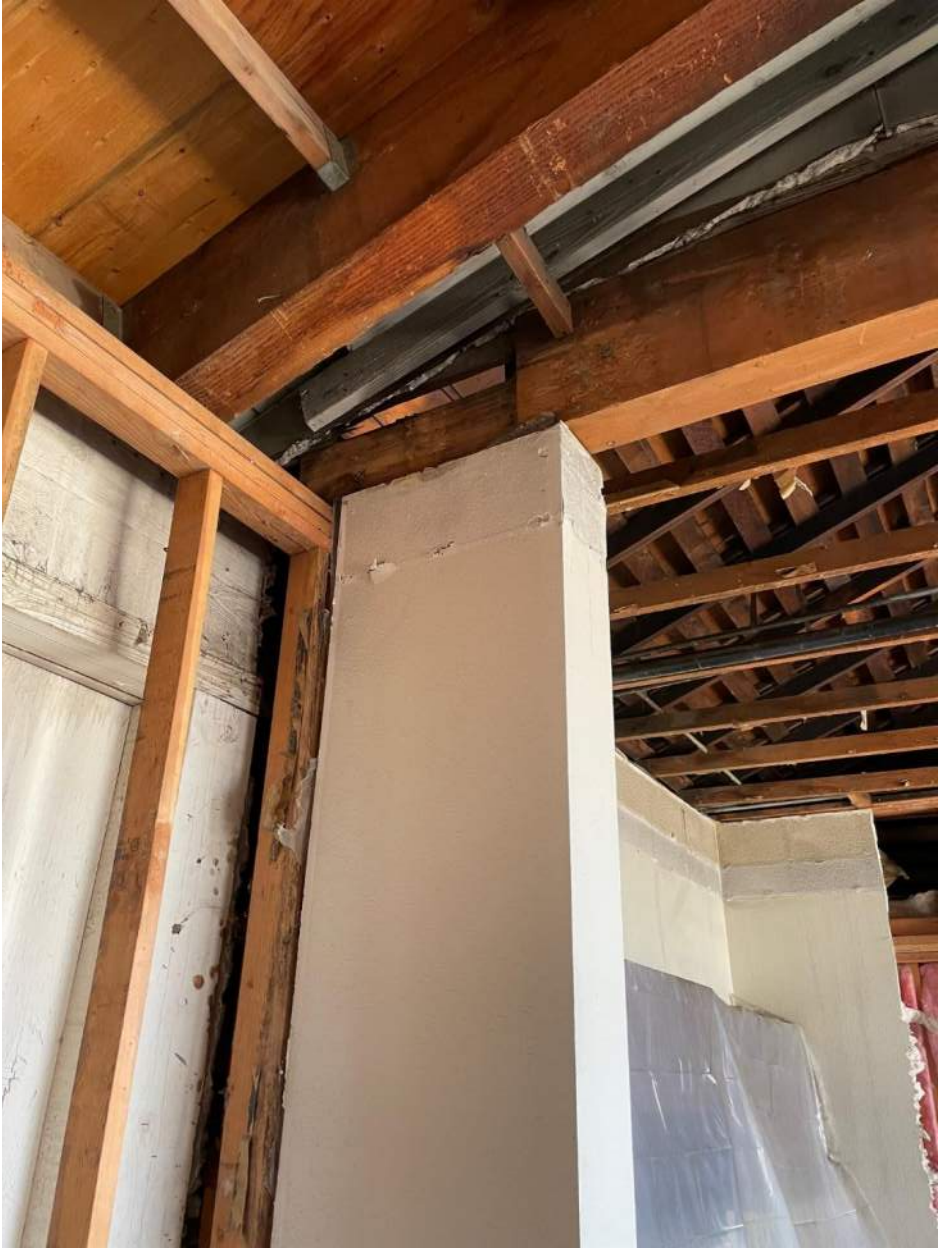
**Line C-C** There is the same issue with the posts' connection to the foundation. There need to be new connections from the beam to the post at the north wall and the post-to-beam for the beam in the center. There is a mixture of older and new studs in the middle section of the wall which will have to be furred if used as is. There is a double wall section on the south which sandwiches an electrical panel. The Easterly section attaches to nothing on the top so it will have to be corrected to match the bottom of the trusses. This area also has some unconventional construction for the

headers which will need to be corrected. The wall at the roof framing transition will need to extend as a demising transition between the different roof framing conditions. At the sandwiched wall there is a recess in the slab which will require correction to make the slab transition flat. I am not sure that the west section of the wall is necessarily required, if it is it needs to be braced to the roof structure. Photos 7 to 12 and 70 to 72.

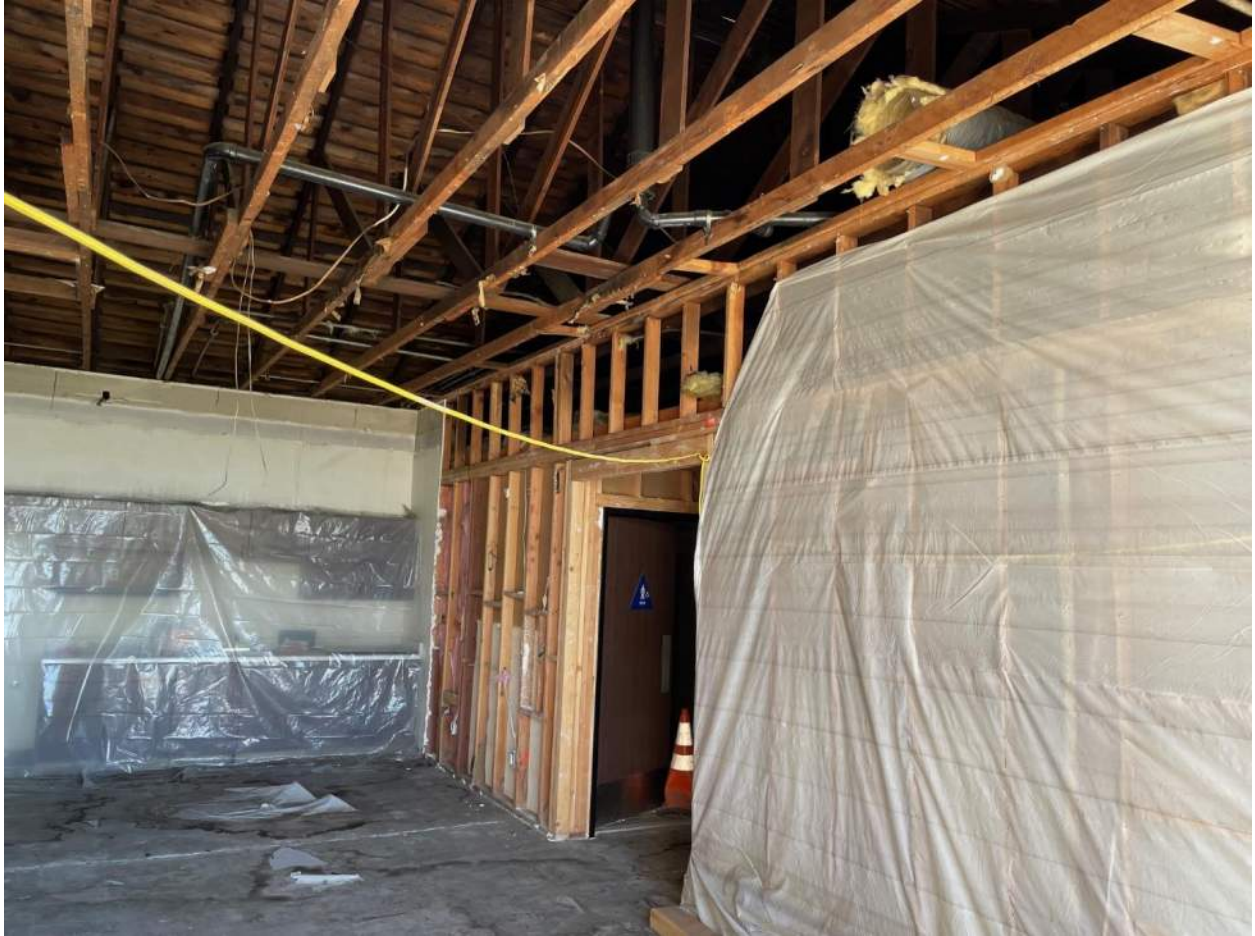
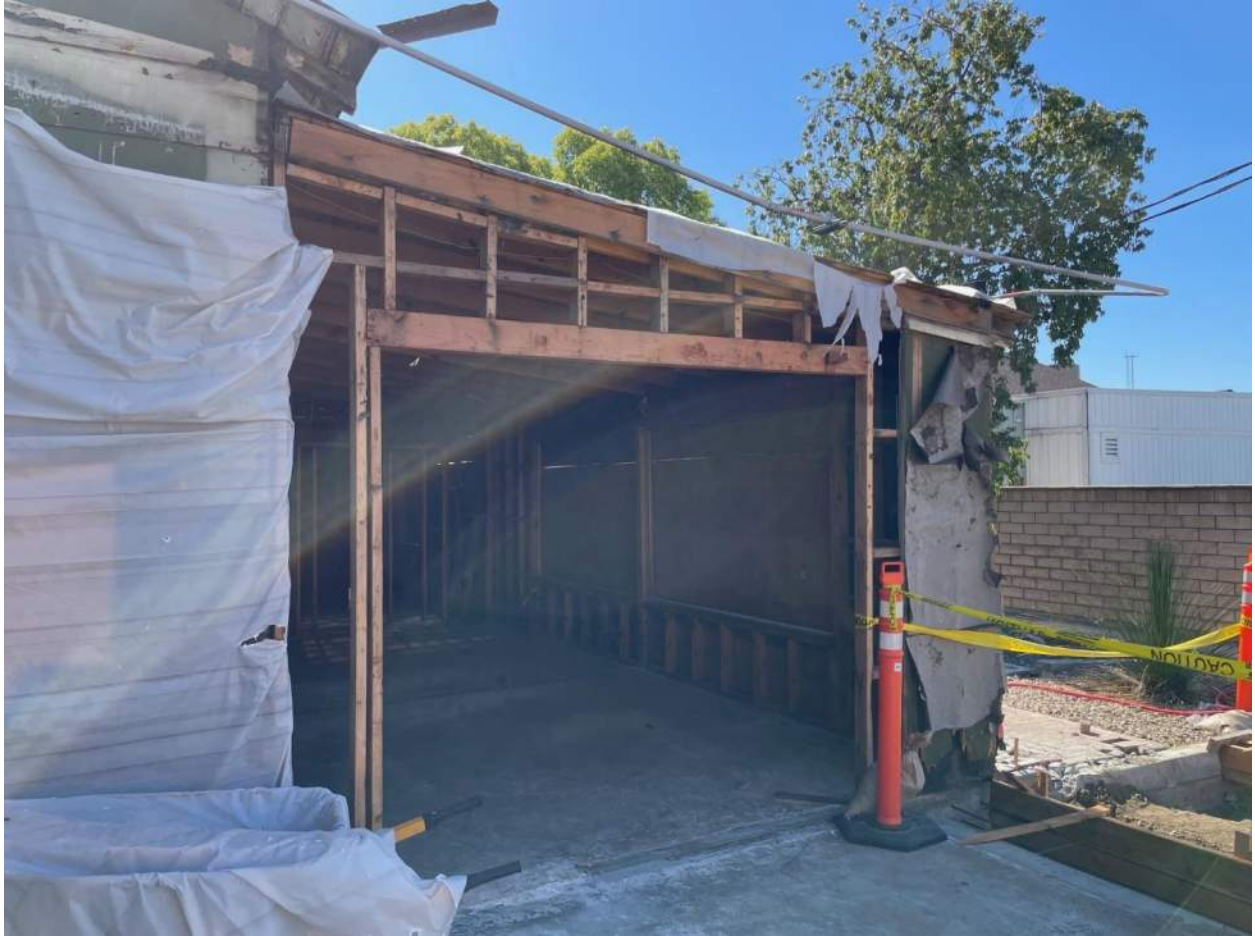
Line C1-C1 Wall is part of the existing restroom construction, tied with the existing ceiling joists at 8' and cripple wall above to go to new roof trusses. Photos 13 and 14.

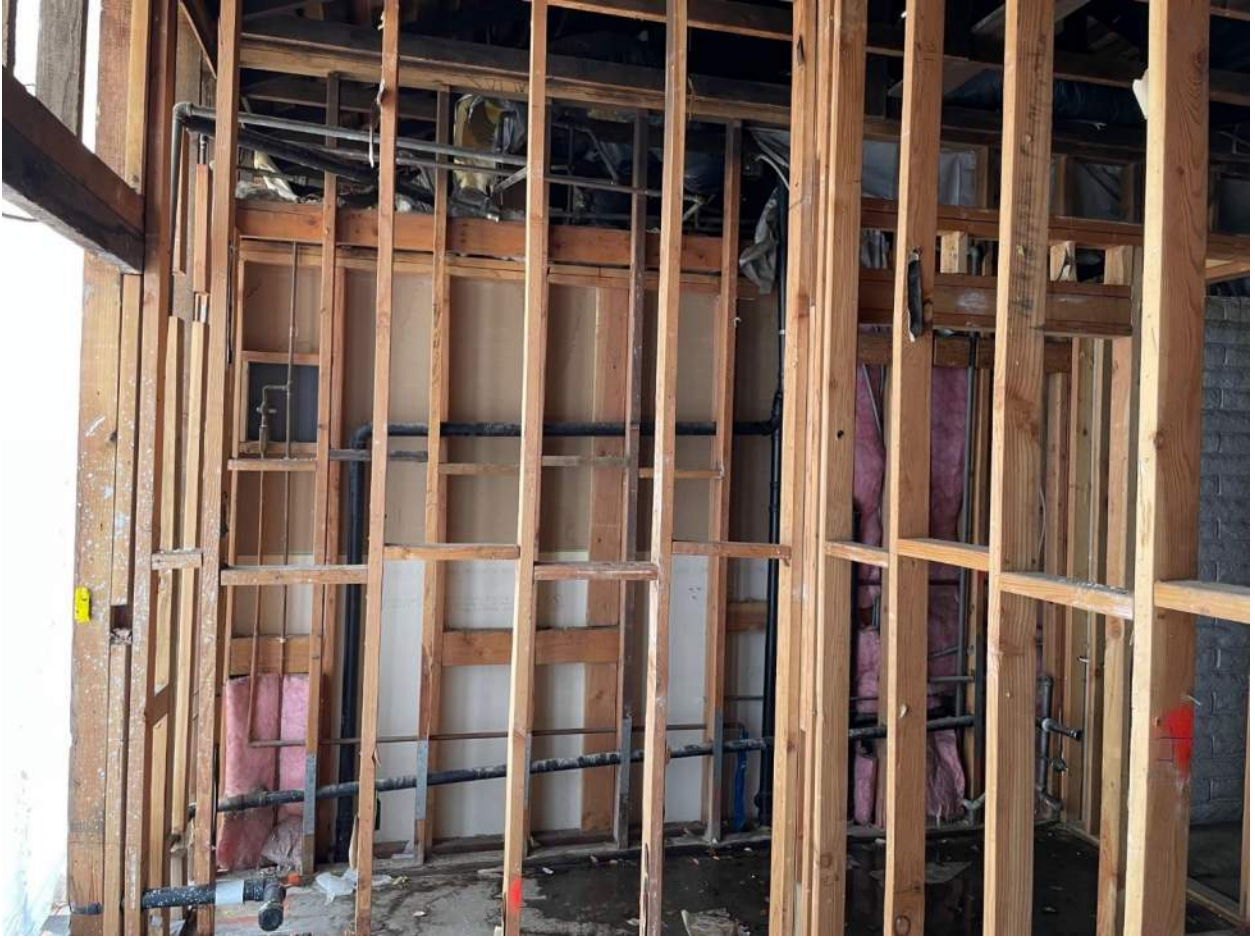
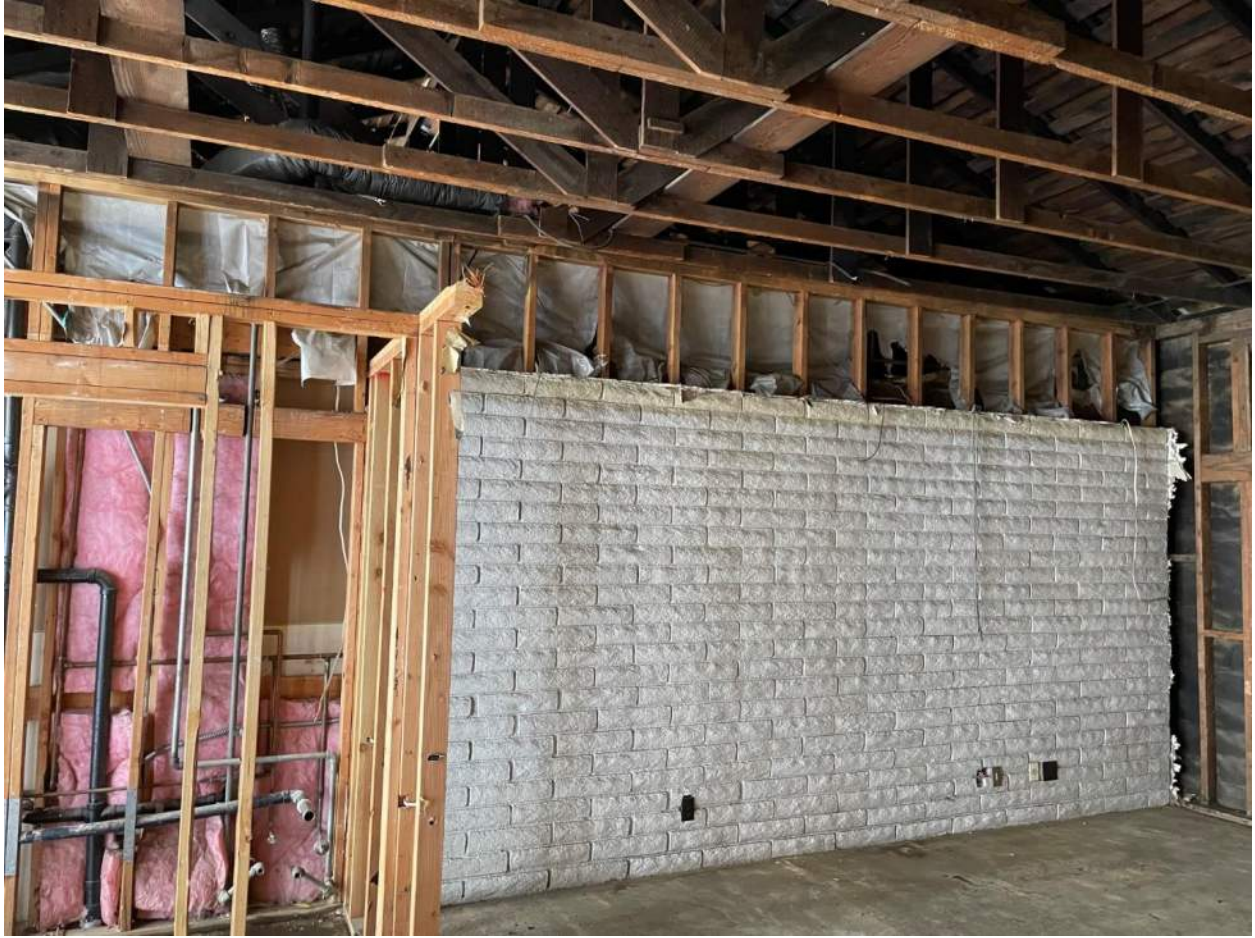
Line D-D Southerly section of wall has been removed with it and the rest of the wall extends to the bottom of the existing new trusses. Wall construction will need shear wall upgrades. Verify that the existing plumbing has been abandoned and removed. The existing masonry veneer could stay but will probably interfere with the framing and any upgrades. Photos 15 and 16.

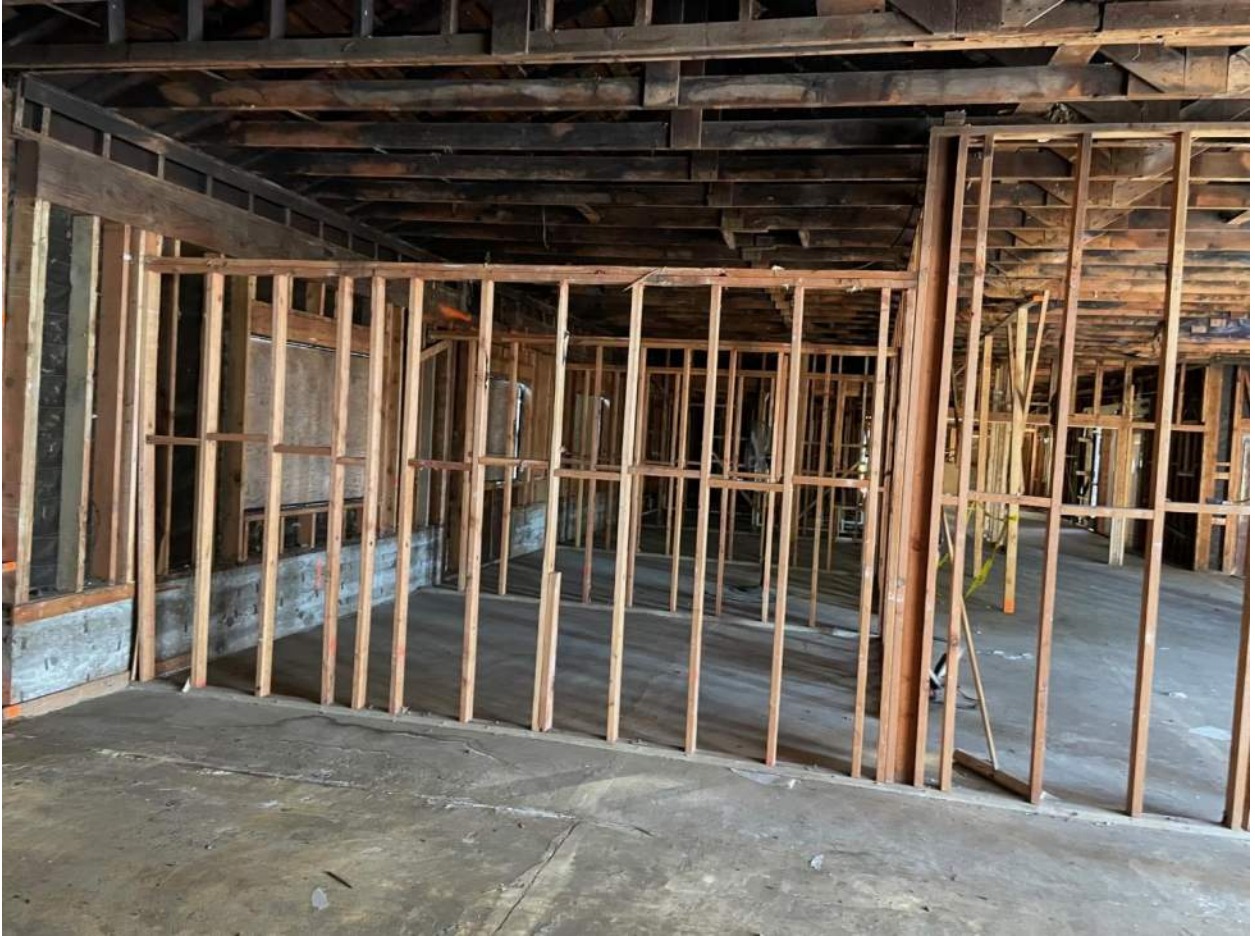
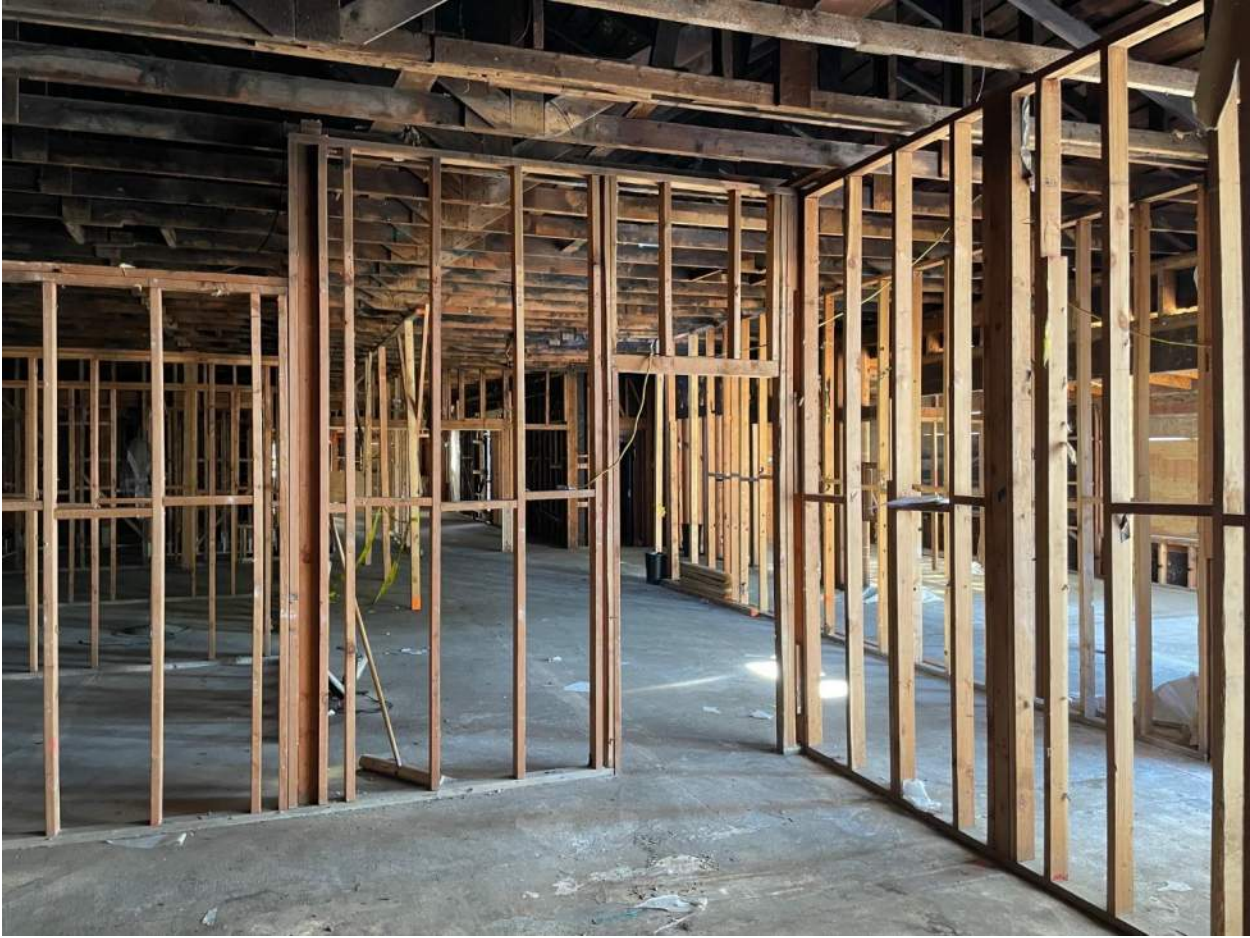
Line D1-D1 All of the north-south walls including Line D1-D1 up to Line E-E are set to be demolished for the new floor layout. This includes both those on the north and on the south of the building. Photos 17 and 18.
