## STRUCTURAL ASSESSMENT FOR 335 W. RIALTO AVE

RE: Structural Report for Public Works Building Fire Damage Restoration Project,  
335 West Rialto Avenue

## **GEOPHYSICAL EVALUATION** **CITY OF RIALTO PUBLIC WORKS REBAR SCANNING (GPR)**

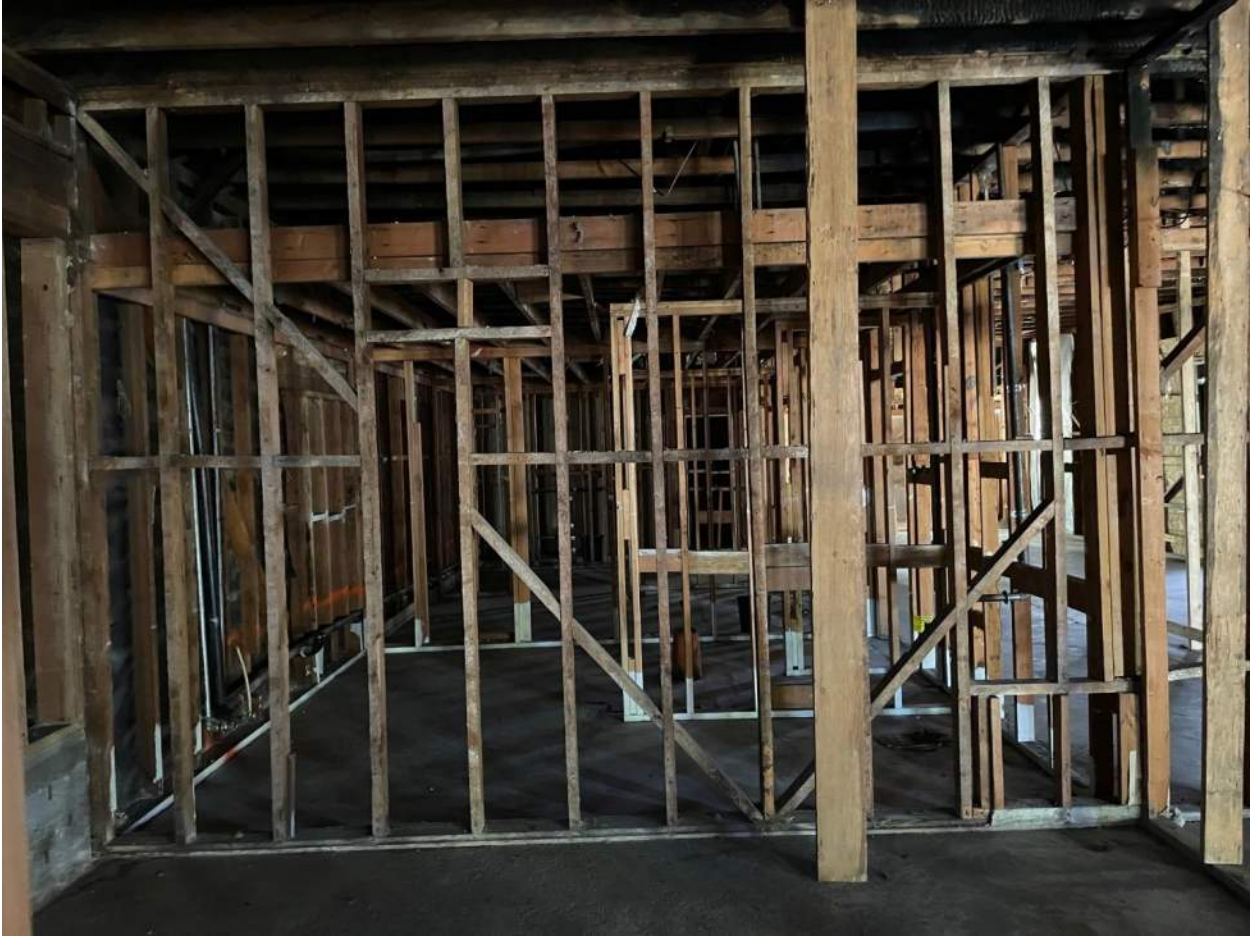
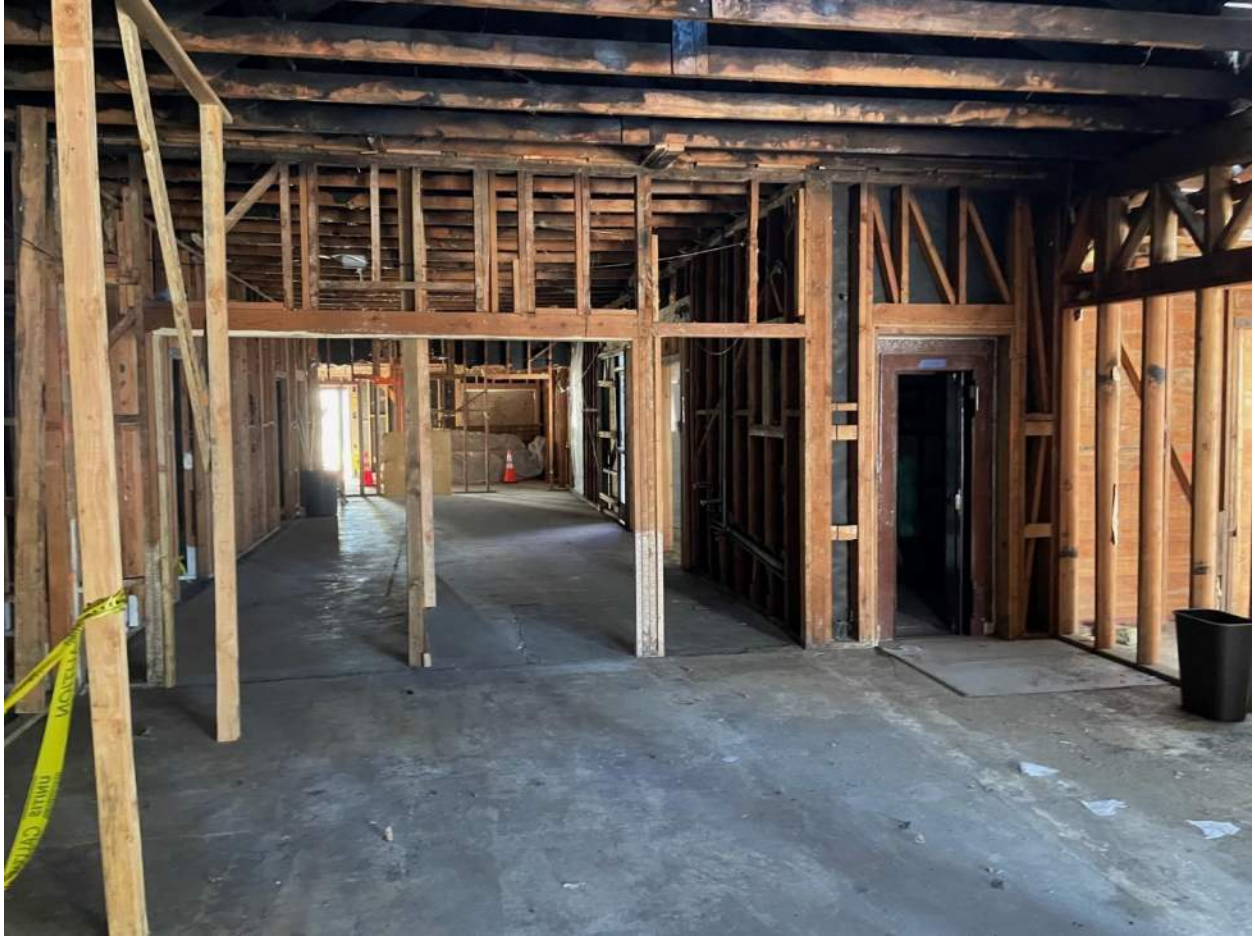
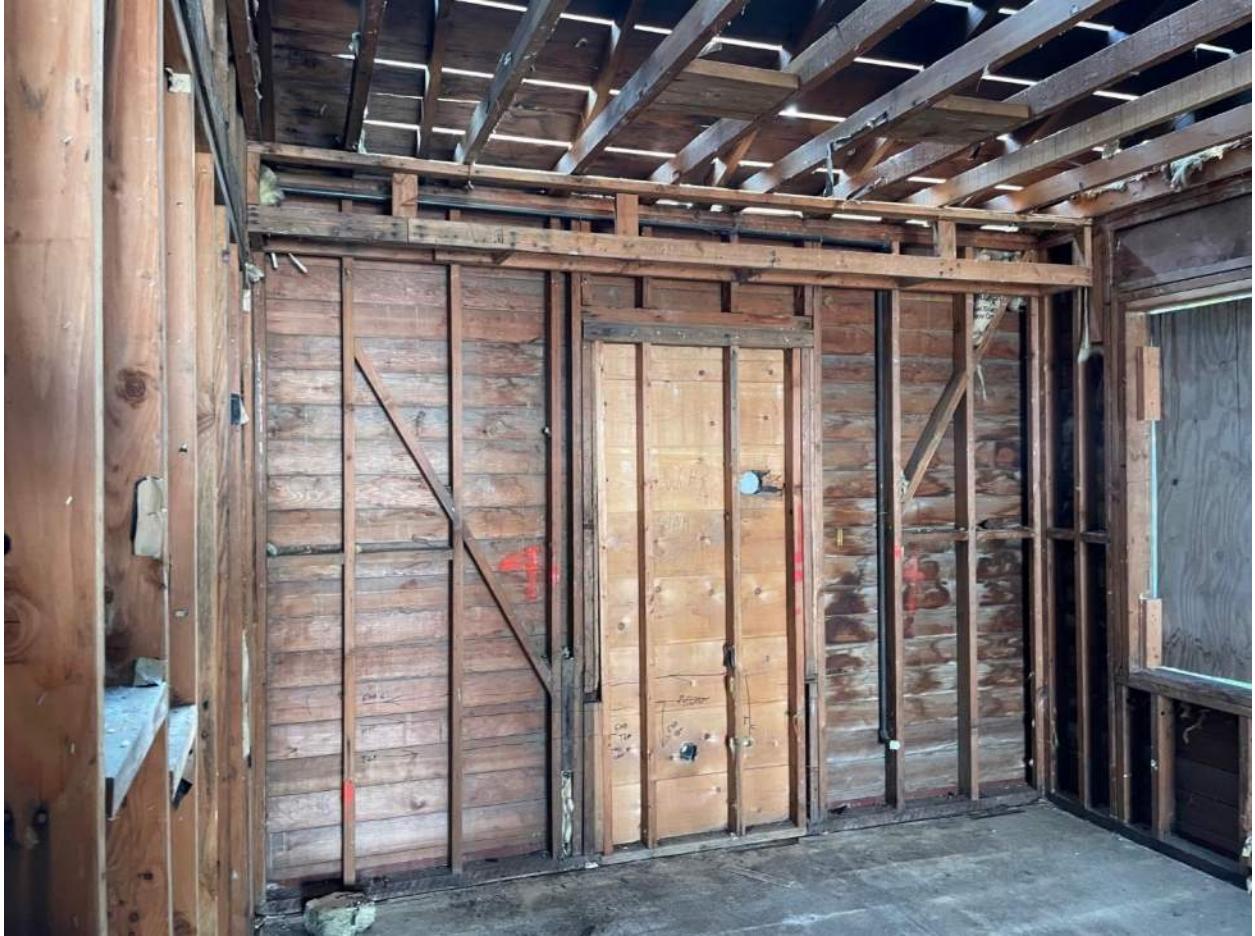
Line E-E The northerly wall needs to have upgrades for shear wall requirements. The southerly stud is about a foot short of the bottom of the new trusses. They will have to be replaced to run to the bottom of the new drag truss for shear transfer. Walls will need upgrade for the proposed shear walls for lateral resistance. Photos 19 to 21.

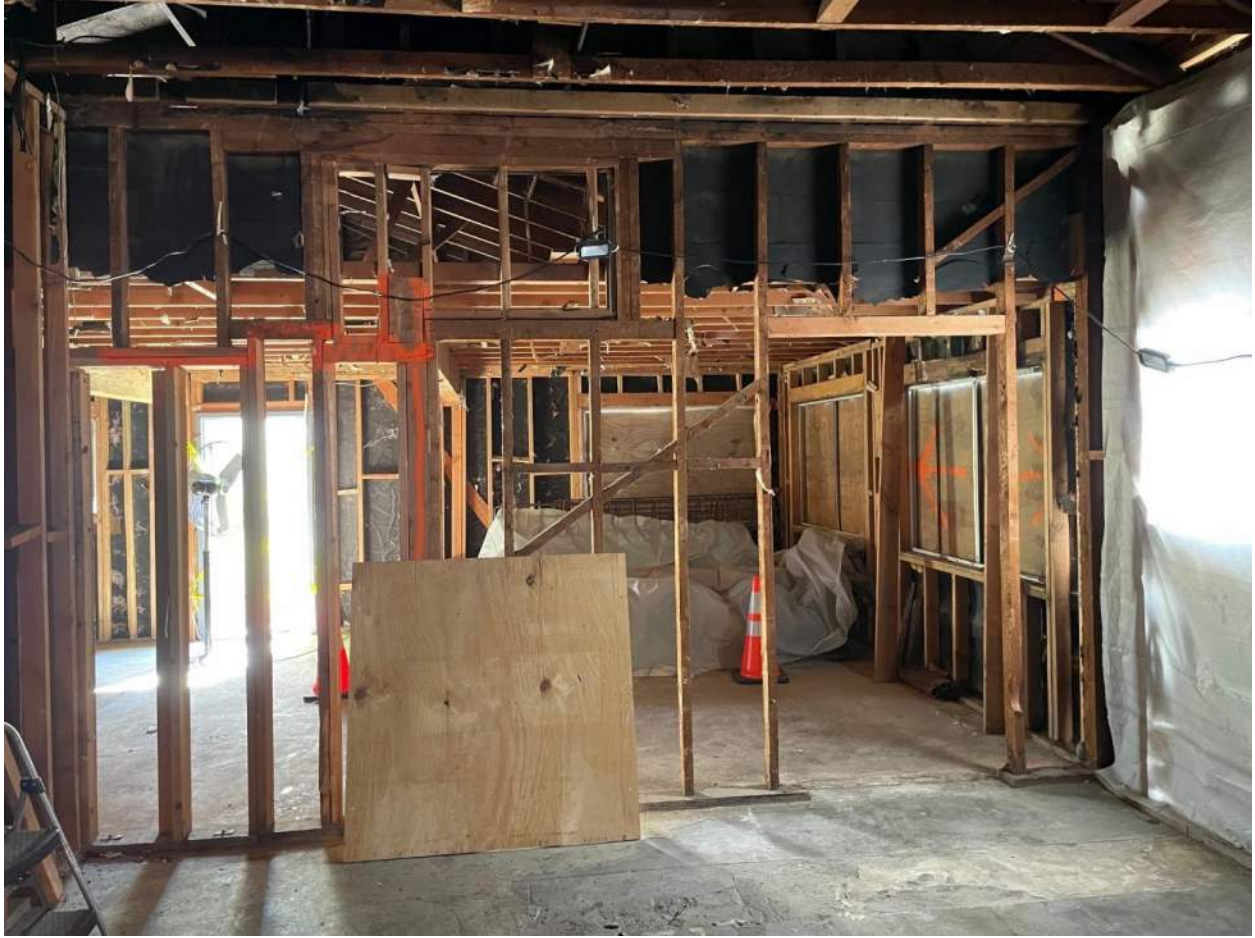
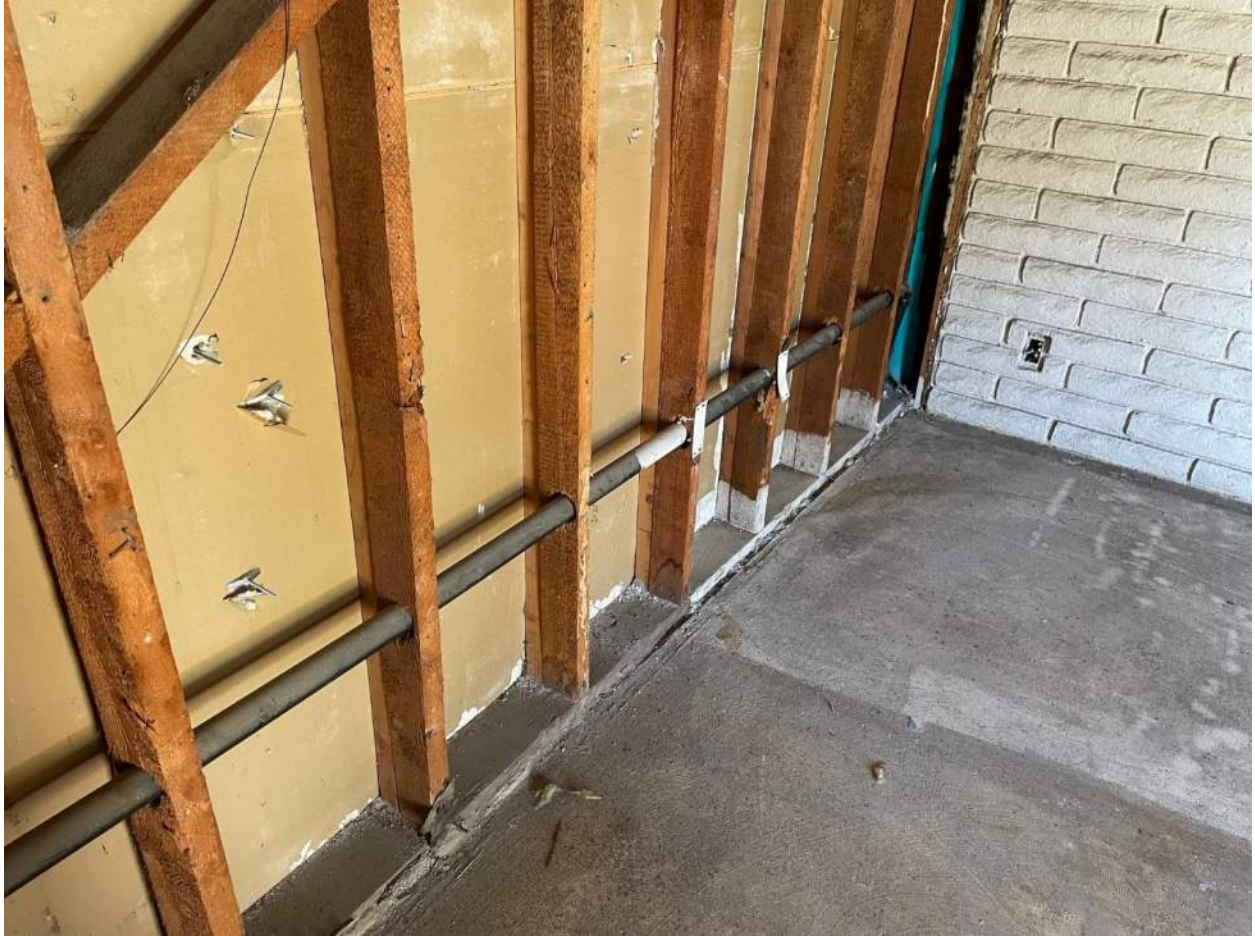
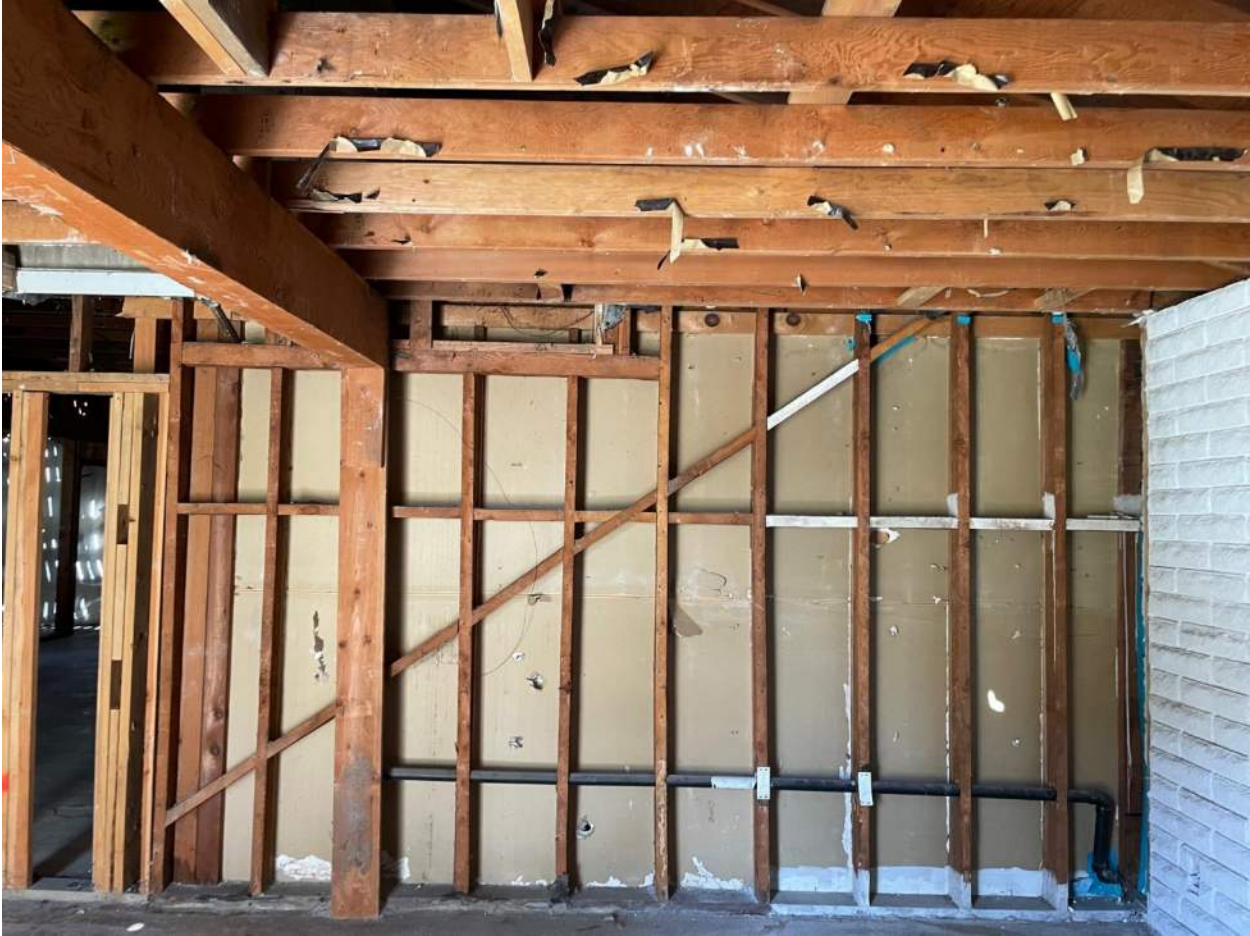
Line F-F The southerly part of the demising/shear wall is a hodgepodge of framing with limited consistency of the stud framing. This continues for the wall above the ceiling to the roof. The northerly section of the wall has all been cut for plumbing. The support for the roof support beams is nonexistent. The whole wall will need reframing or at least some type of supplement. Photos 24 to 26 and Photos 29 and 29.

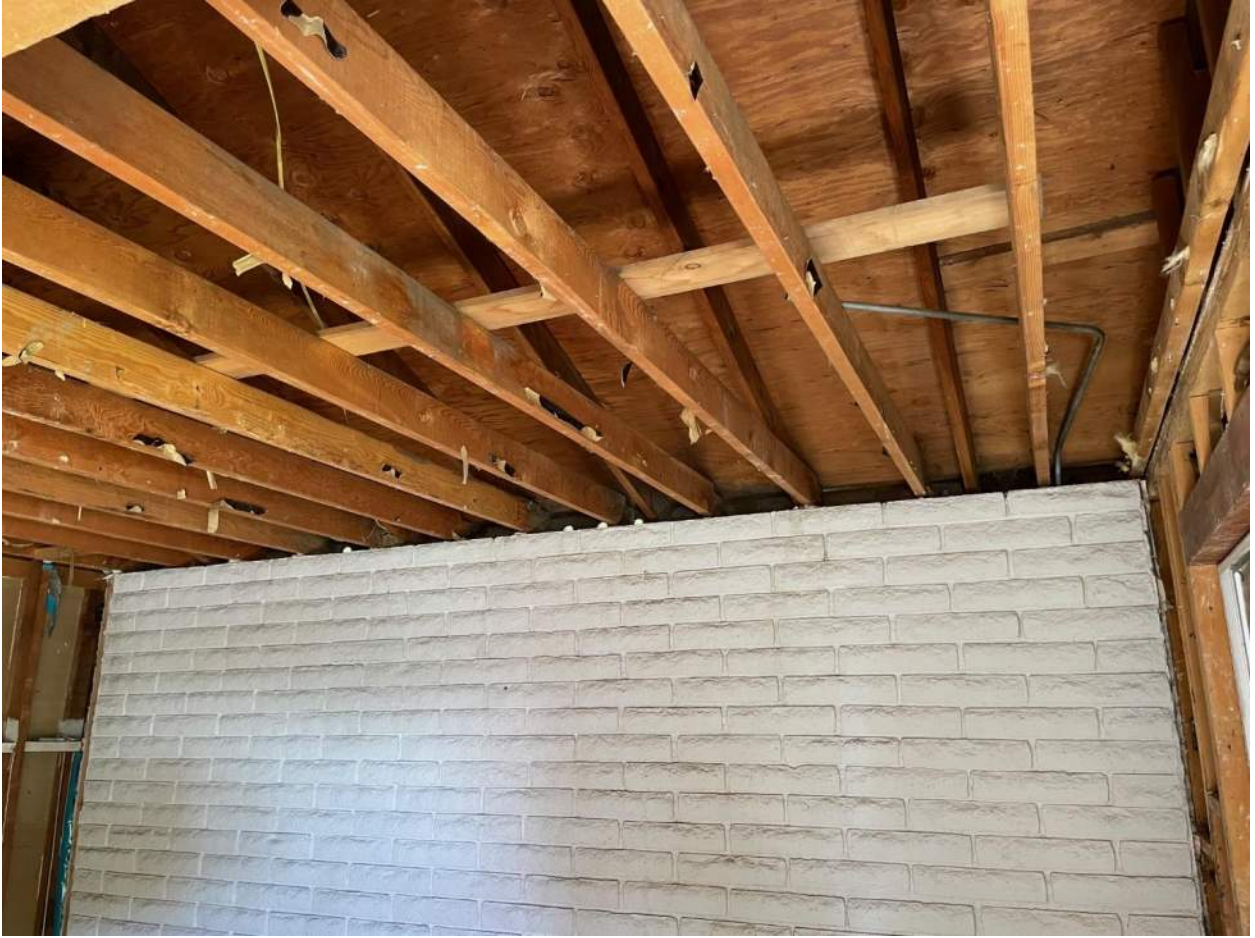
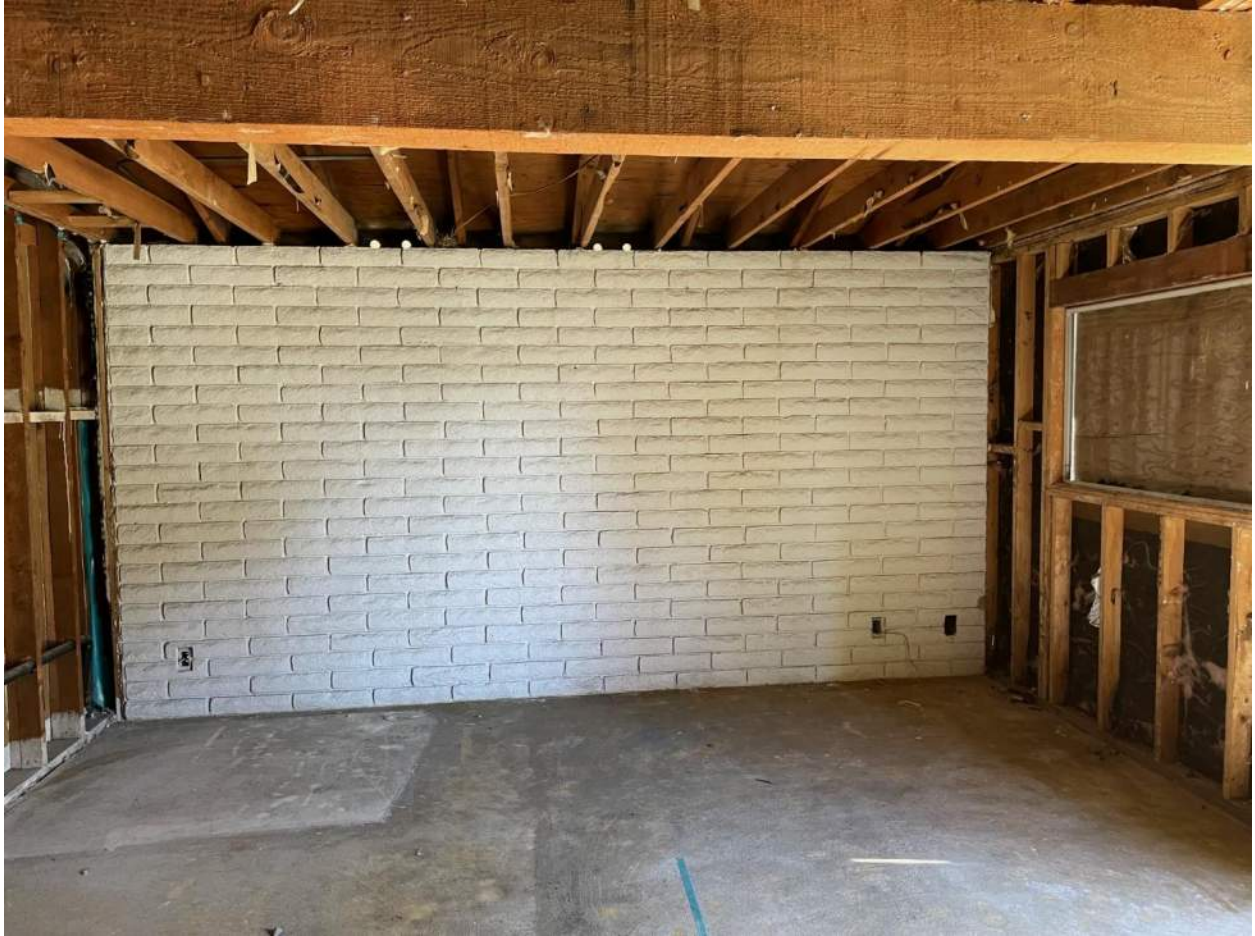
- Line 1-1 F to G      The wall is hidden by block veneer, so condition is unknown. Photos 27 and 33.
- Line 1.5 B1 to C      The beam to post needs to have positive connection at both ends Photos 64 and 65.

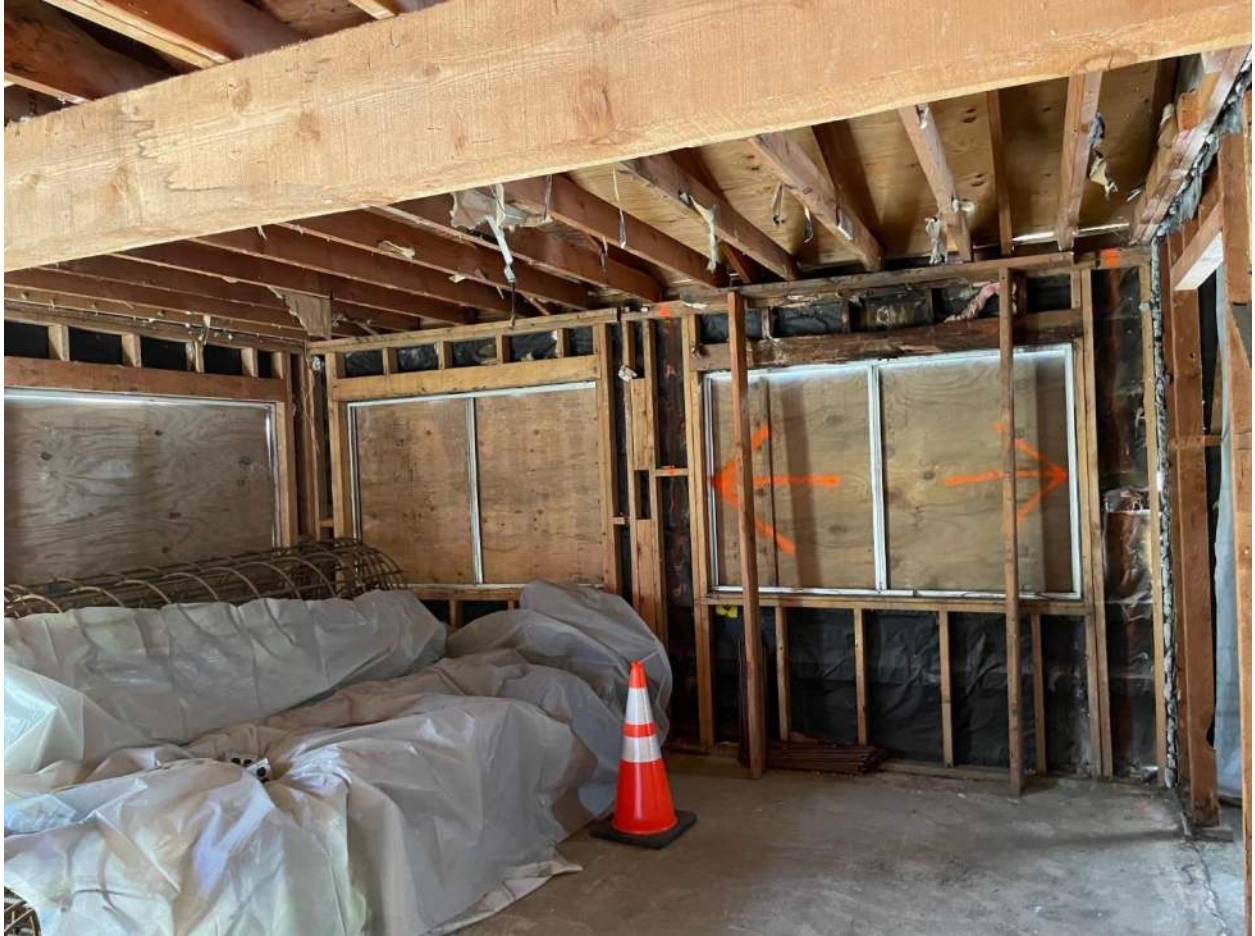
PICTURE 32

- Line 2-2 F to G      Wall has an 8' plate in relatively decent shape except the area over the westerly window has water damage. Photo 32.
- Line 3-3              Wall plate height is 8' and the walls all have large openings which will be reframed for new opening. These walls will have to be brought up to meet truss height. Photo 53.

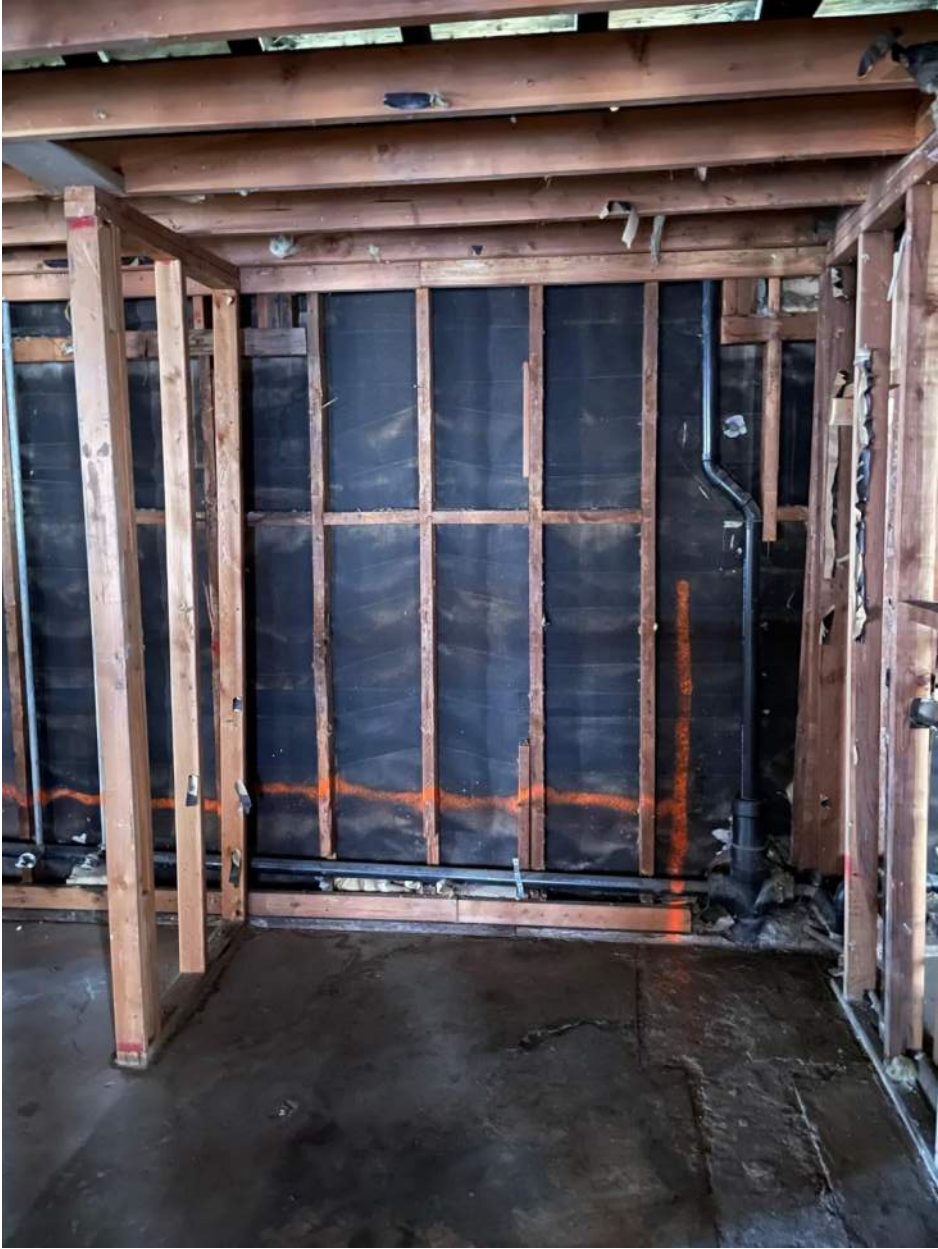
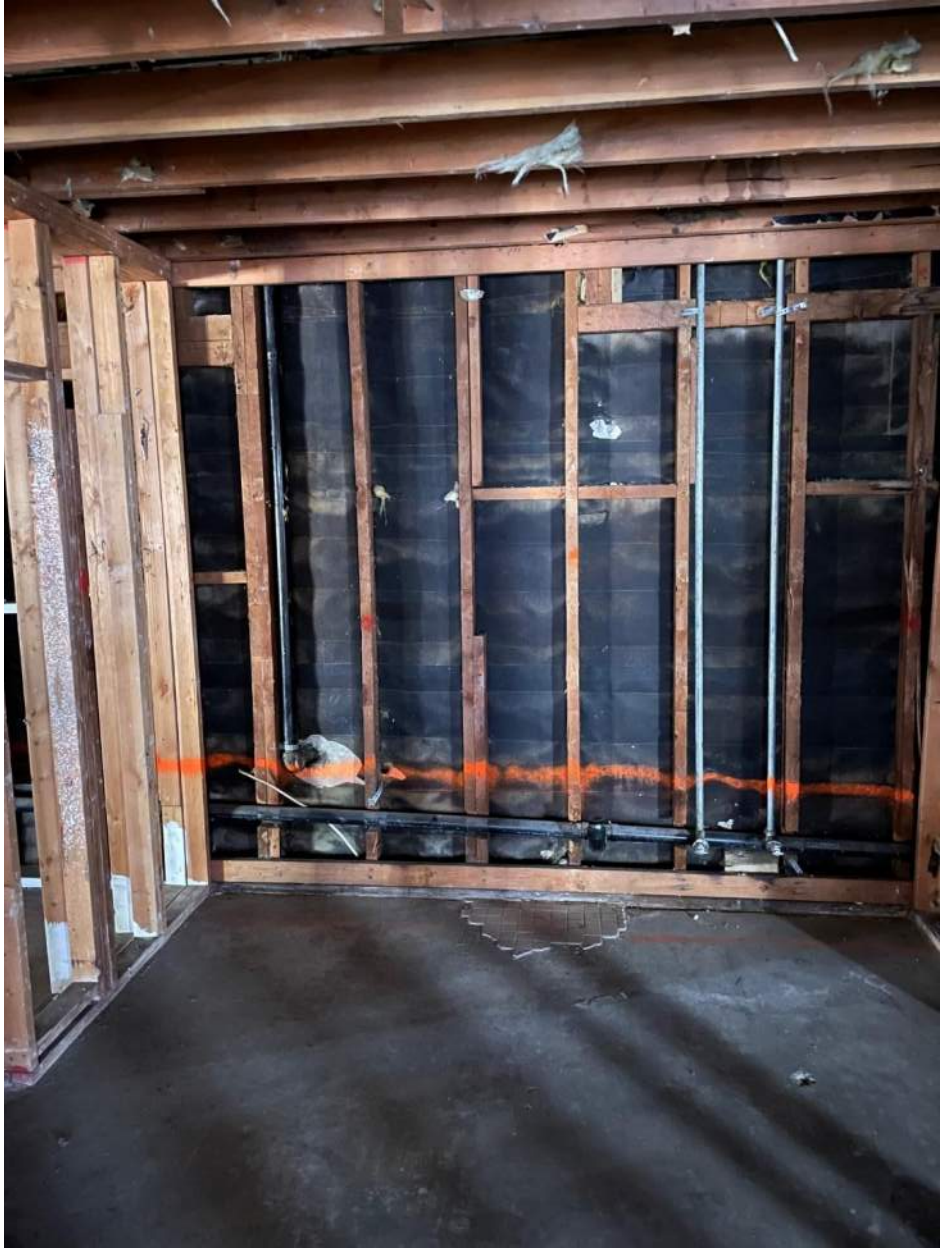
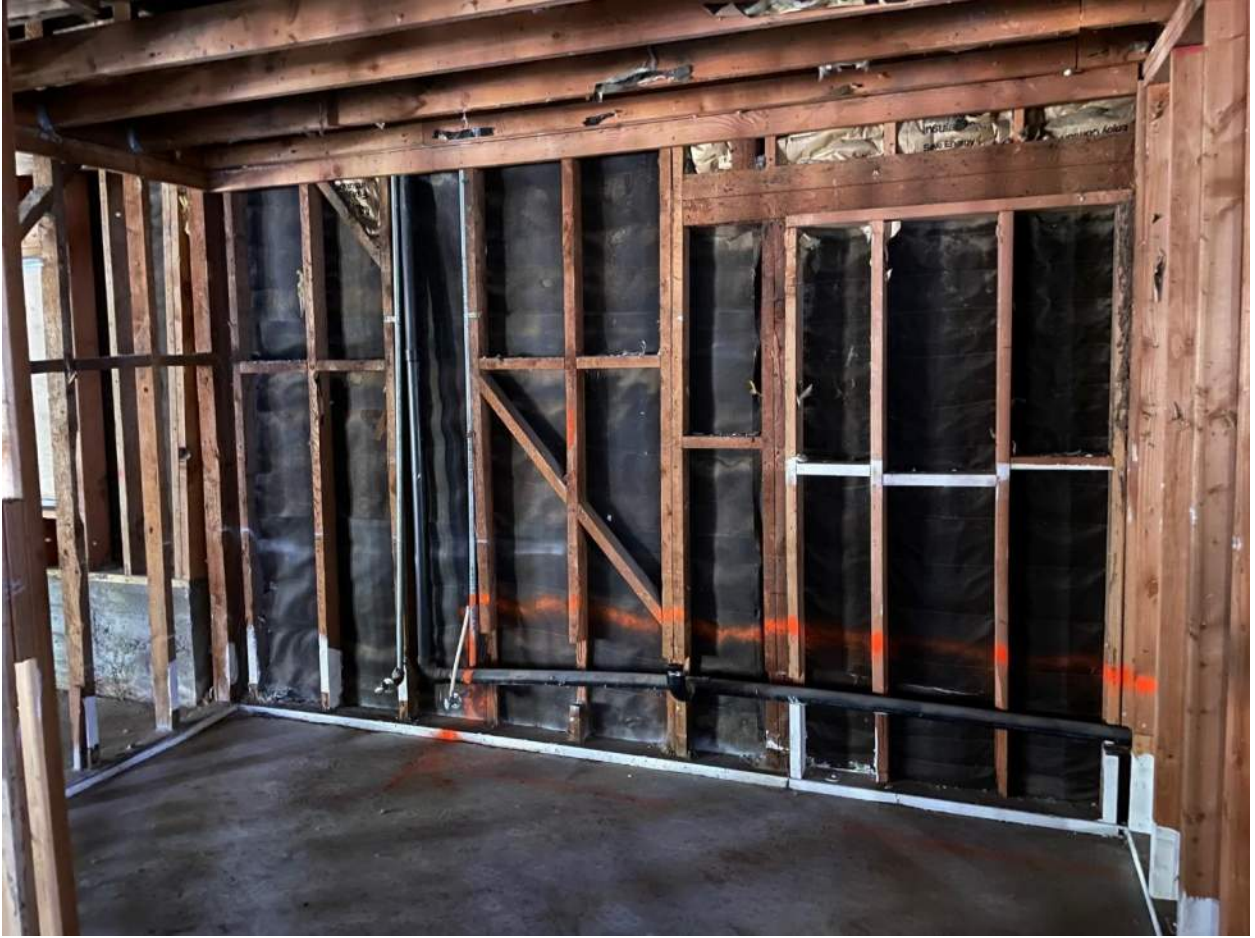
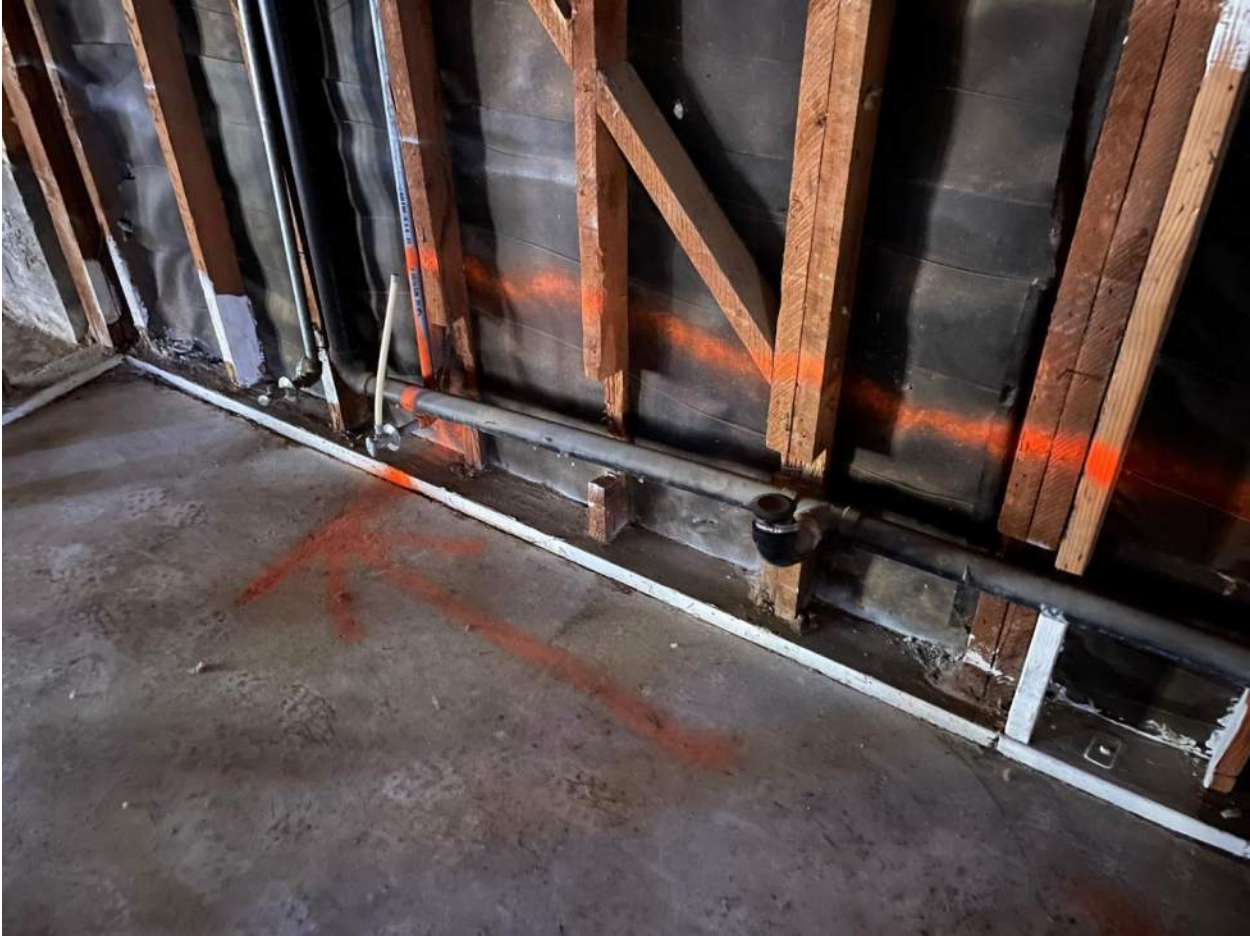
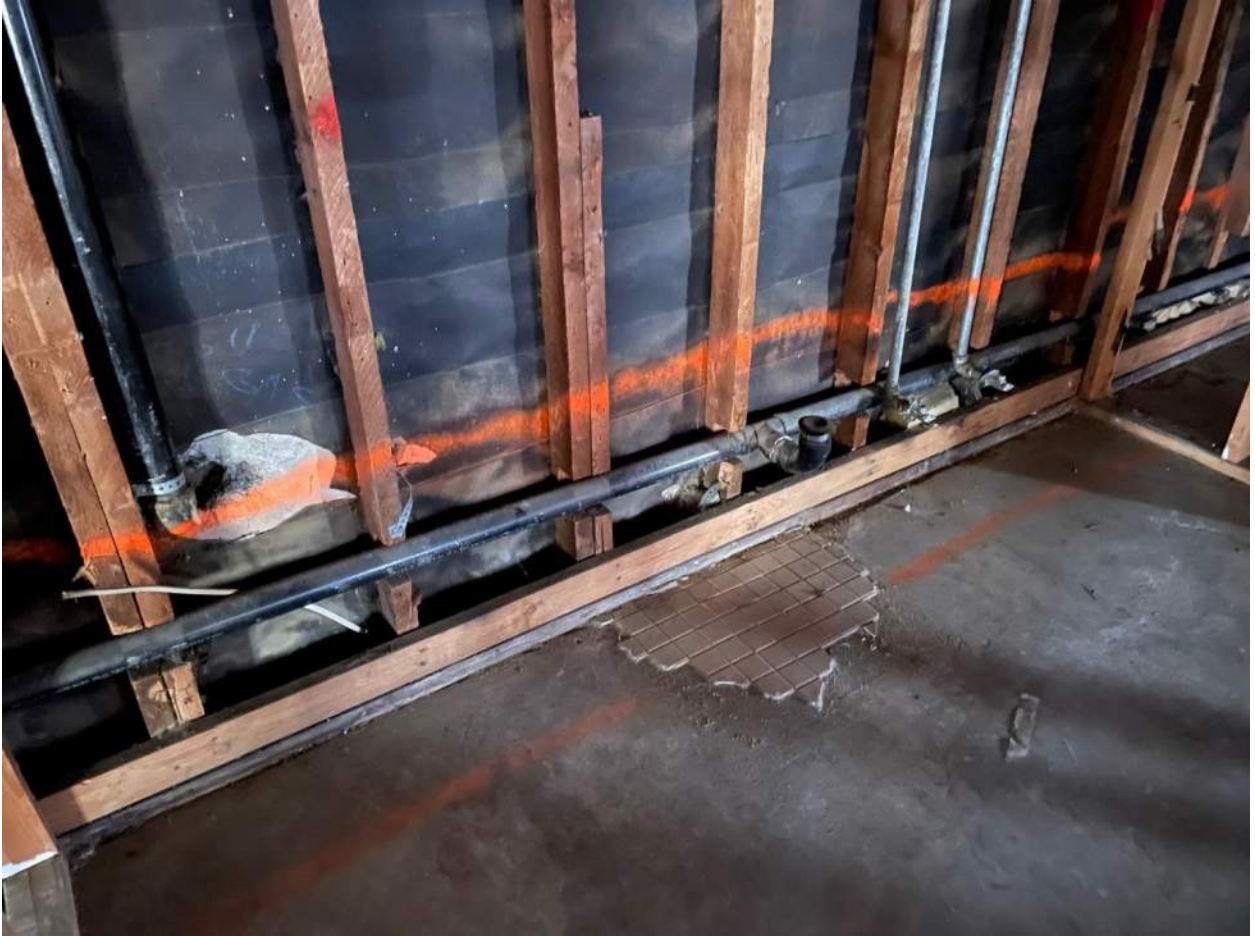
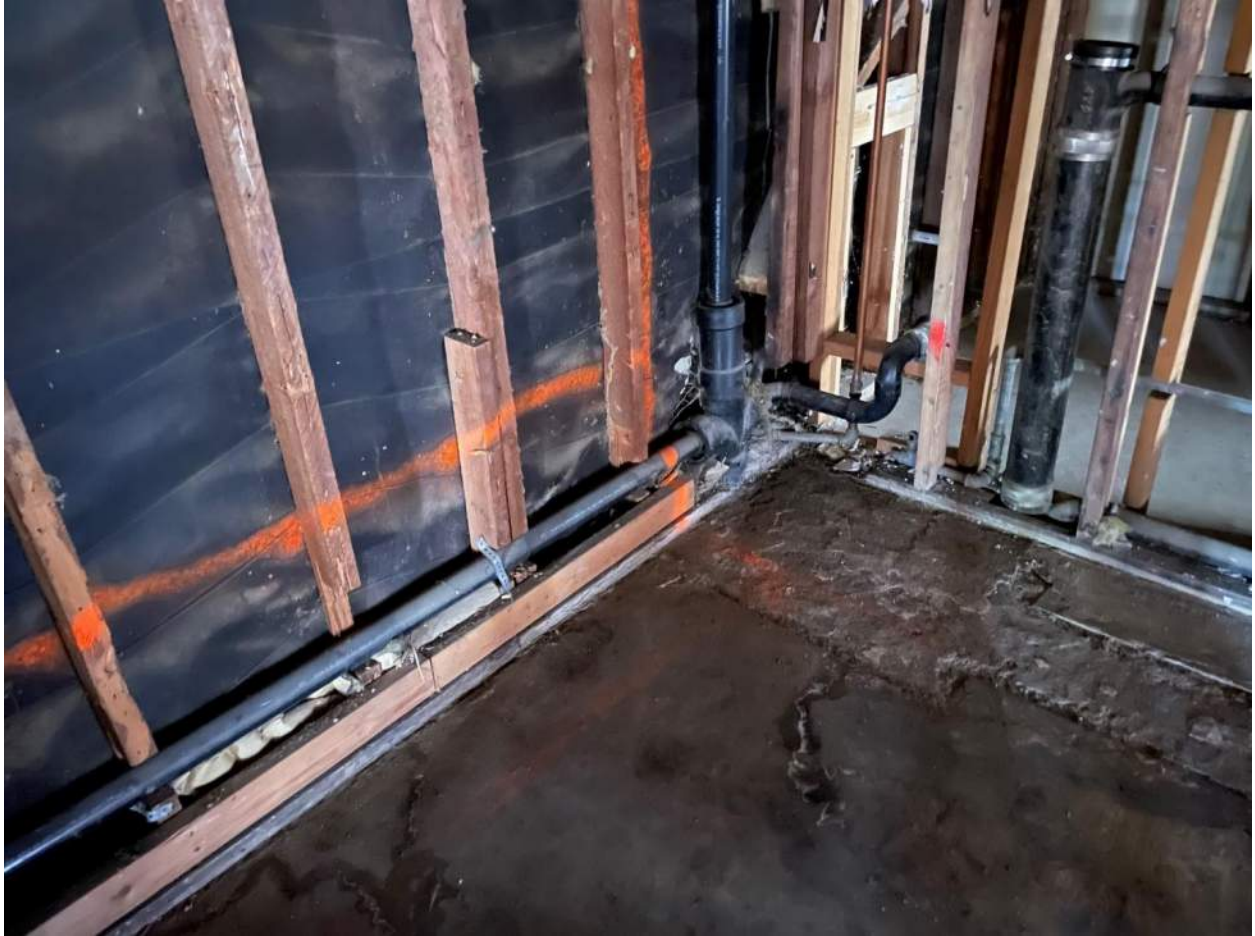
- Line 1-1 E to F      The walls sit on the slab and studs continue full height, there are a few locations where there is what may have been headers interrupting the continuity. For almost the entire wall section the bottom of the stud are cut up to about 2 1/2" leaving almost nothing for load support. The wall will need to be at least supplemented or potentially fully replaced. Photos 34 to 40.

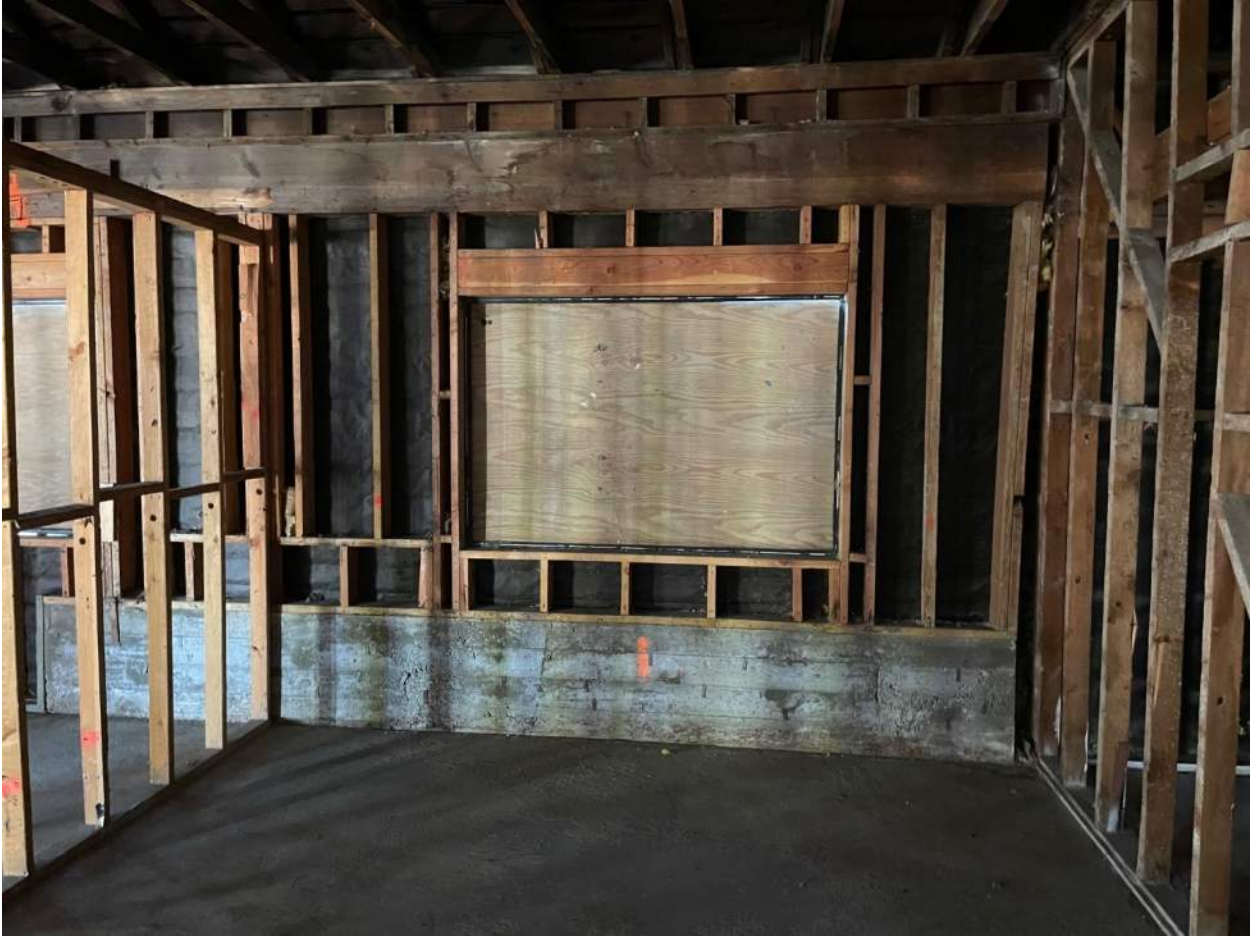
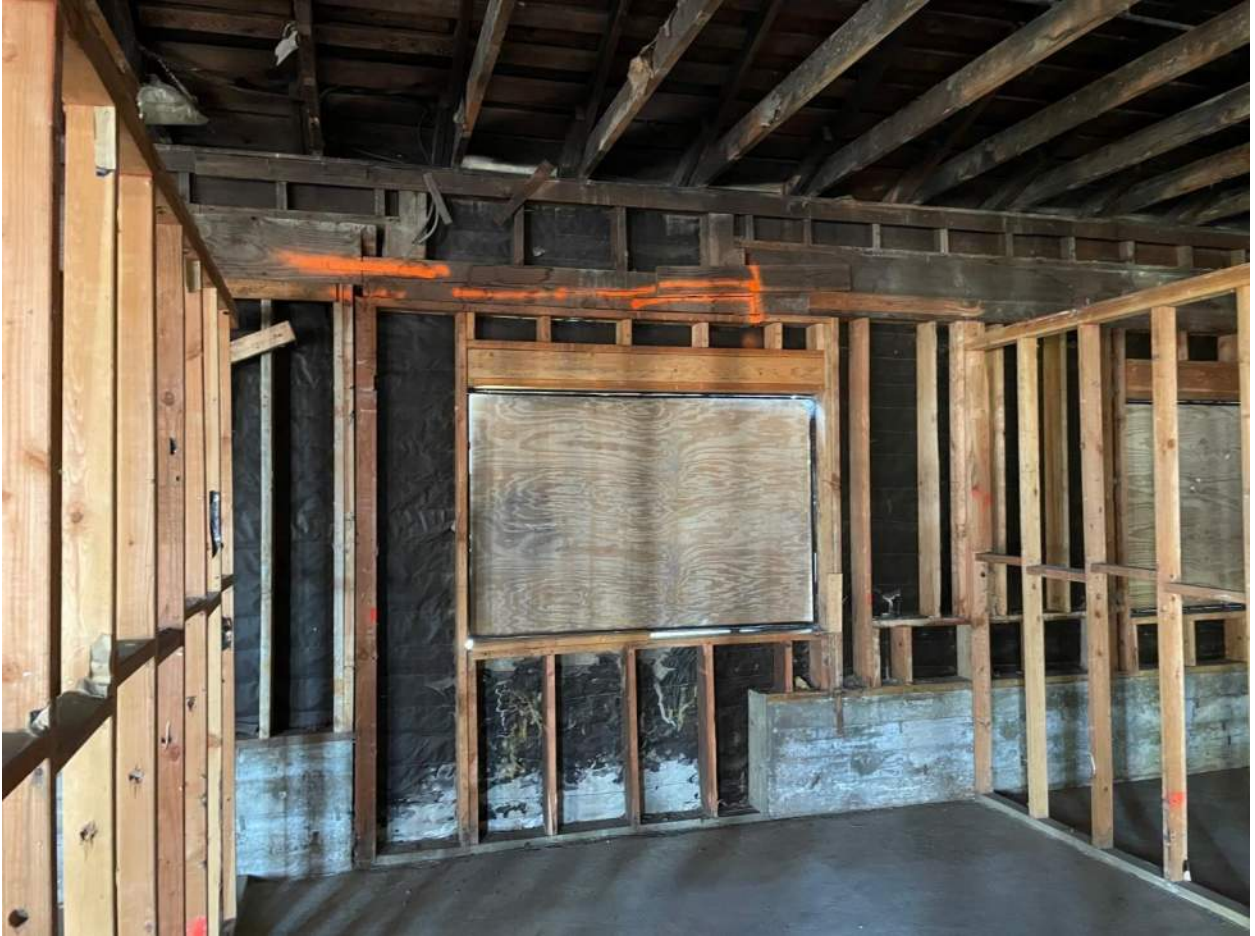
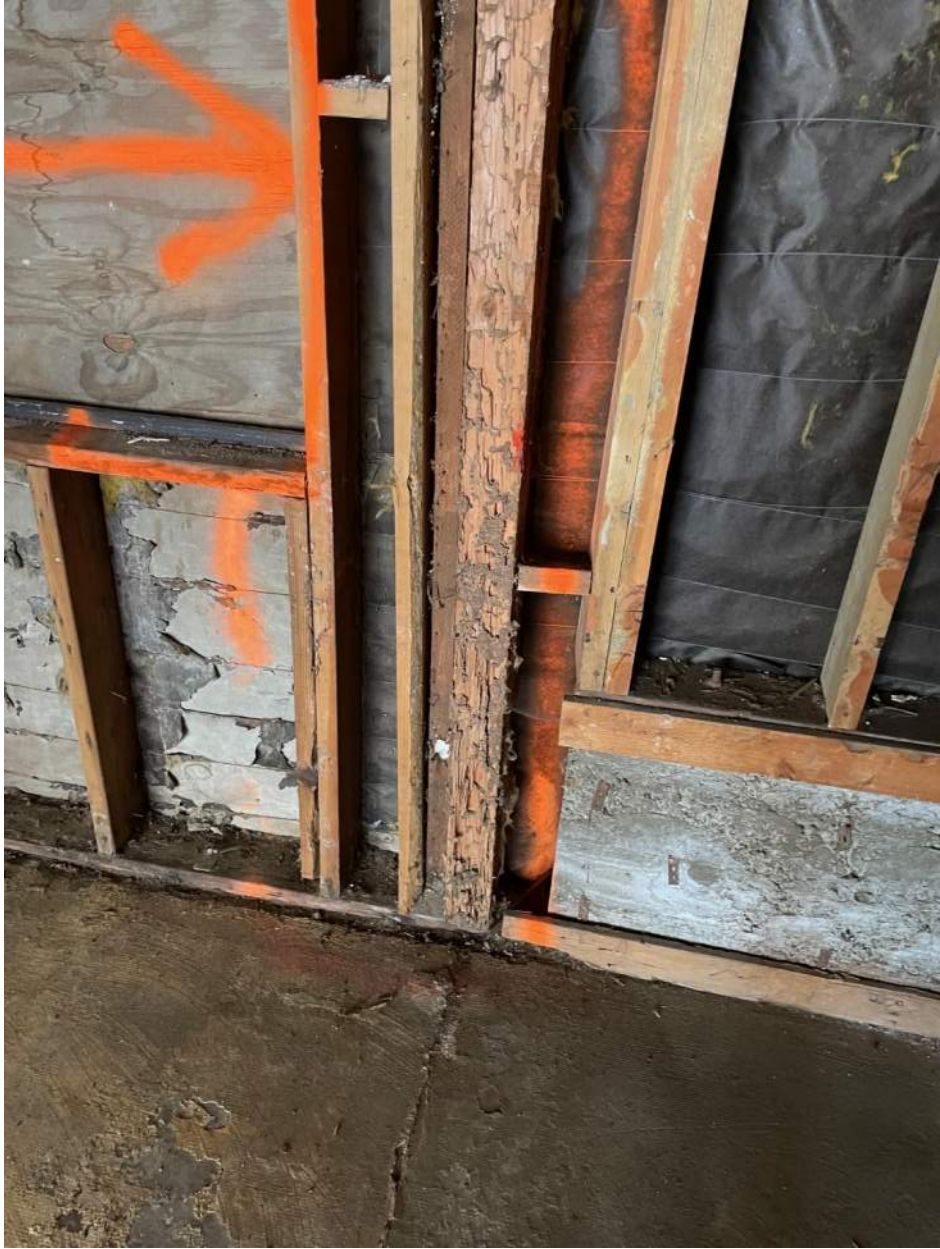
- Line 1-1 D to E      The walls are supported on the slab and a stem wall at various locations. There is an intermediate beam in the wall at about 8' above the floor with cripple fill to the bottom of the trusses. This creates somewhat of a hinge condition. The westerly end of this near Line D-D it is different with full height studs, but with a crazy conglomeration of multiple plates. These multiple plates area is also not level, which is also true at other locations along the wall. There is also some visible termite damage. It should also be noted that the windows will also be removing and are changing size which adds to the alteration of the wall. Photos 42 to 46.

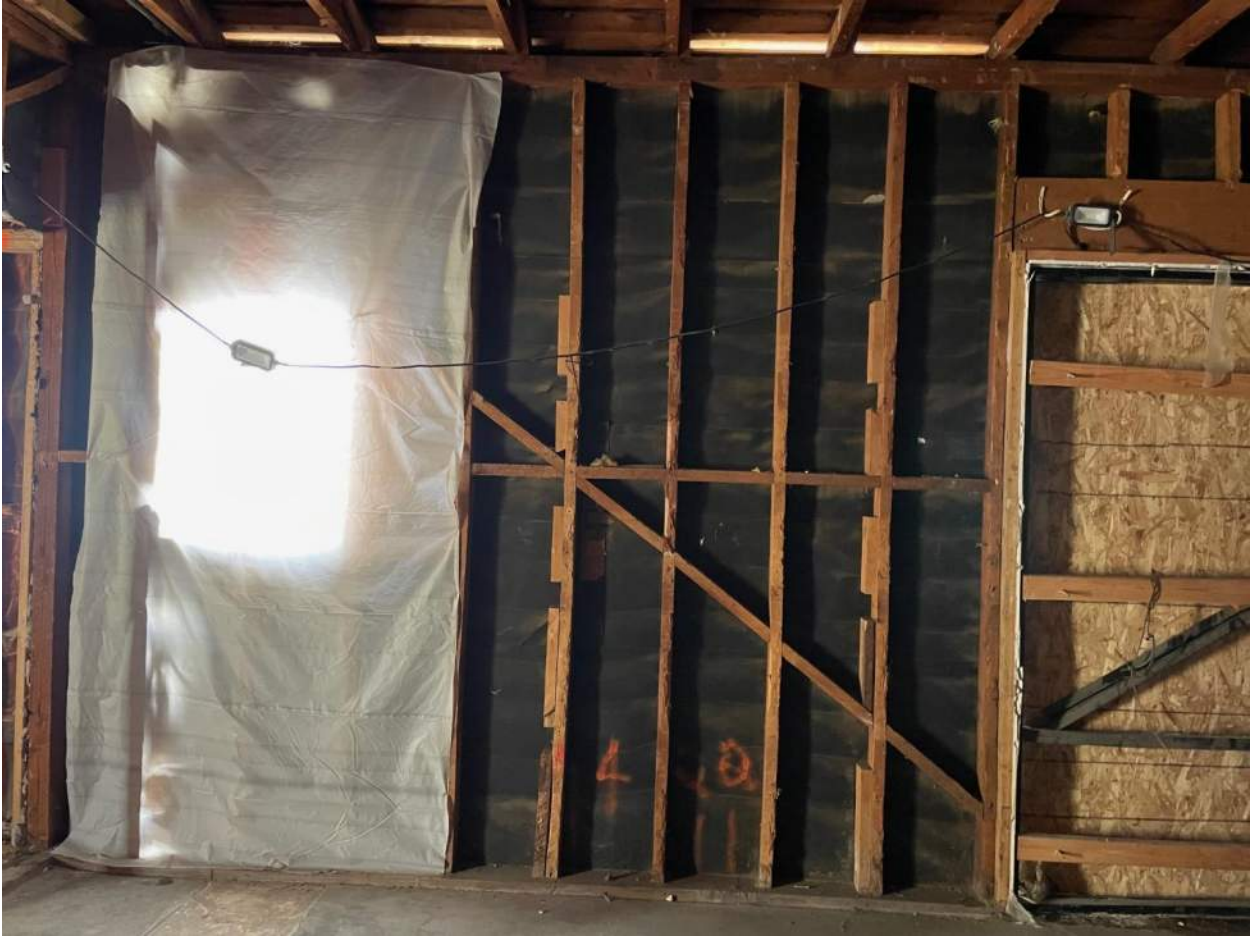
PICTURE 47

- Line 2-2 E to F      The wall is at truss height in good condition with a long header over openings in about the middle. The westerly end is all compromised by the plumbing installation. It would need to be supplemented or replaced. Photos 47 to 49.
