## STRUCTURAL ASSESSMENT FOR 335 W. RIALTO AVE

RE: Structural Report for Public Works Building Fire Damage Restoration Project,  
335 West Rialto Avenue

## **GEOPHYSICAL EVALUATION** **CITY OF RIALTO PUBLIC WORKS REBAR SCANNING (GPR)**

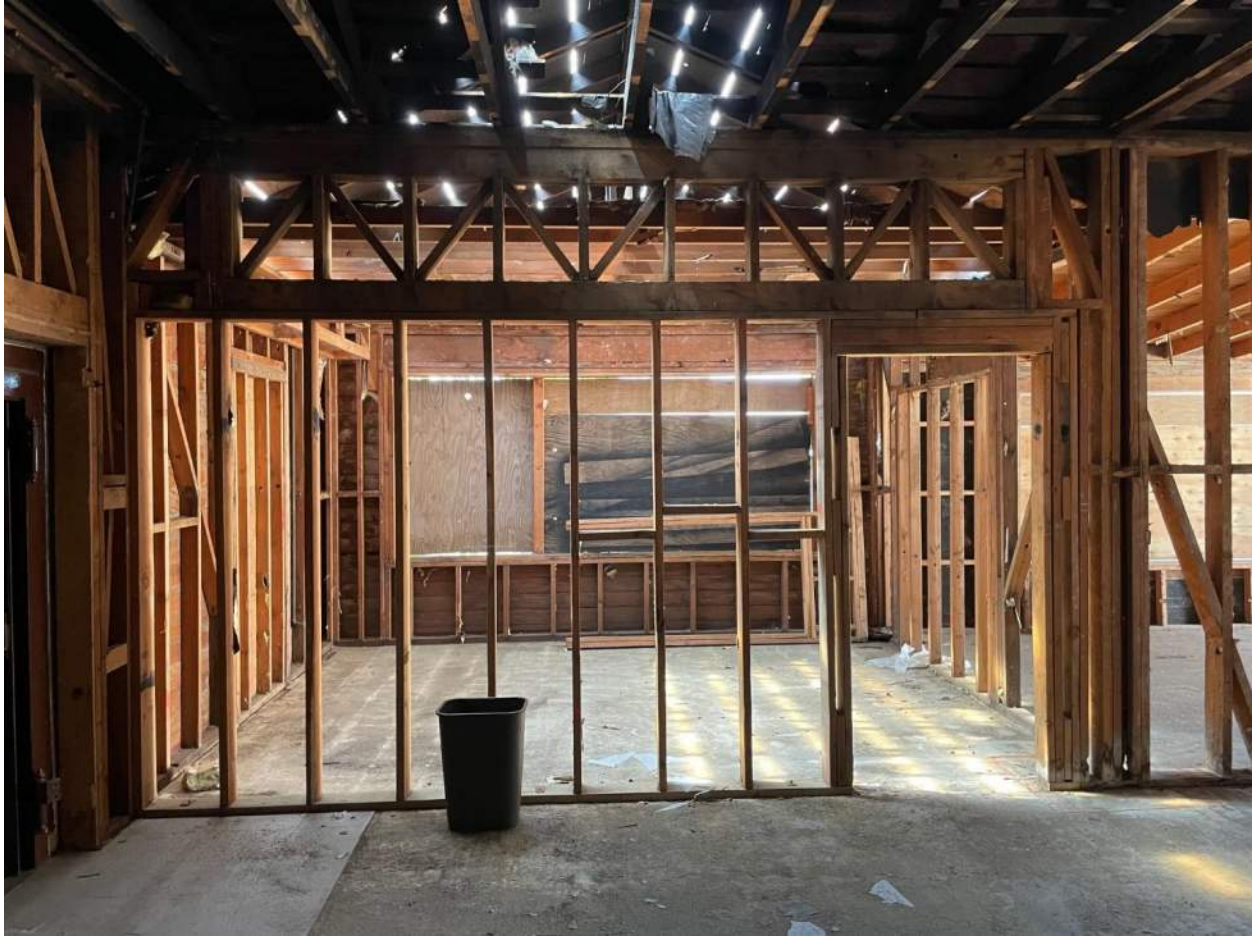
PICTURE 50

- Line 2-2 D1 to E      The potential interior bearing is moved to the south. These walls are full height to the stud bottom. There is a section though at the easterly end of the wall the is a form of truss for the upper 2'+/- it forms a type of hinge condition but also looks as if it is sagging. Some of the studs have been notched for utilities and may need supplementing or replacement. Photo 50.

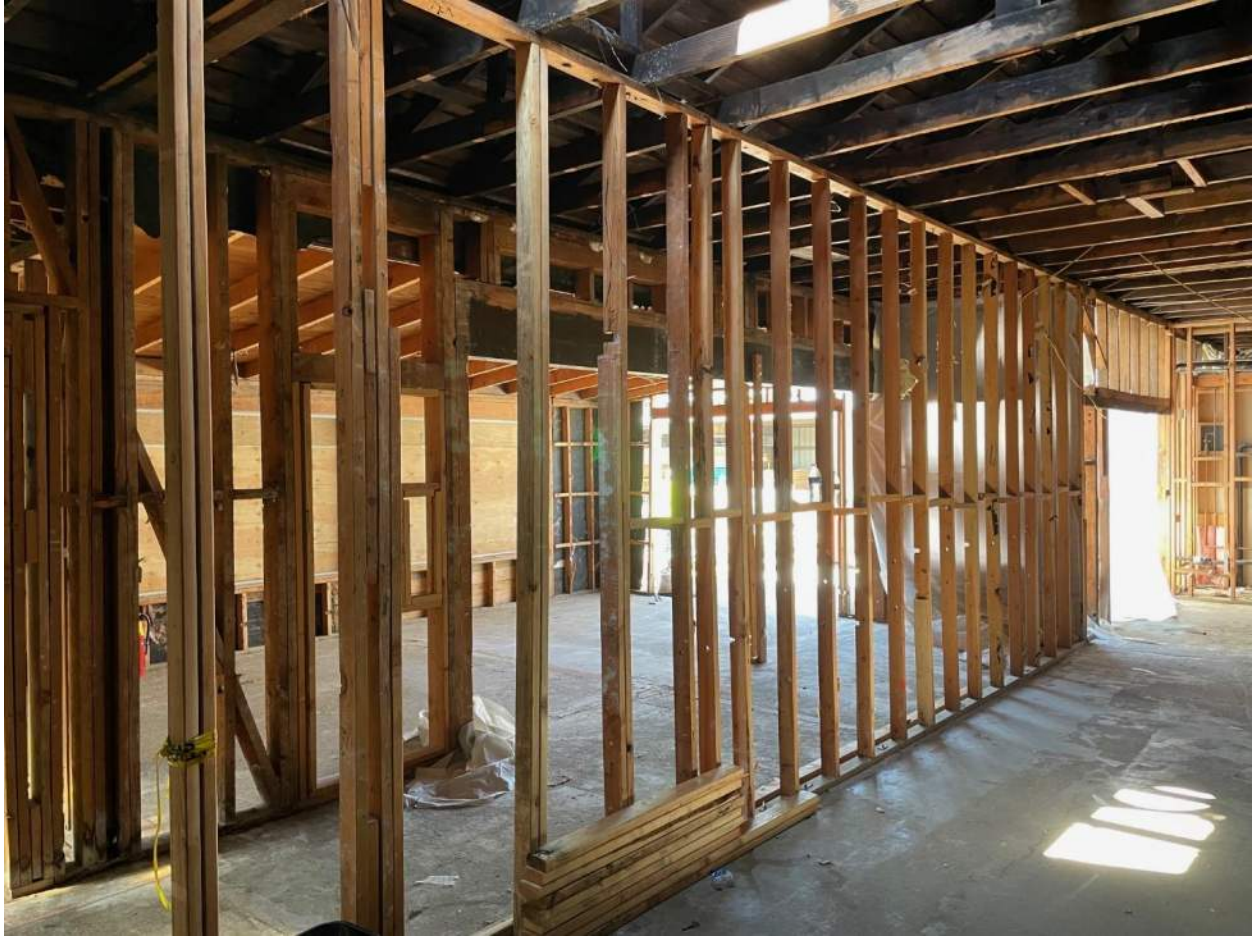
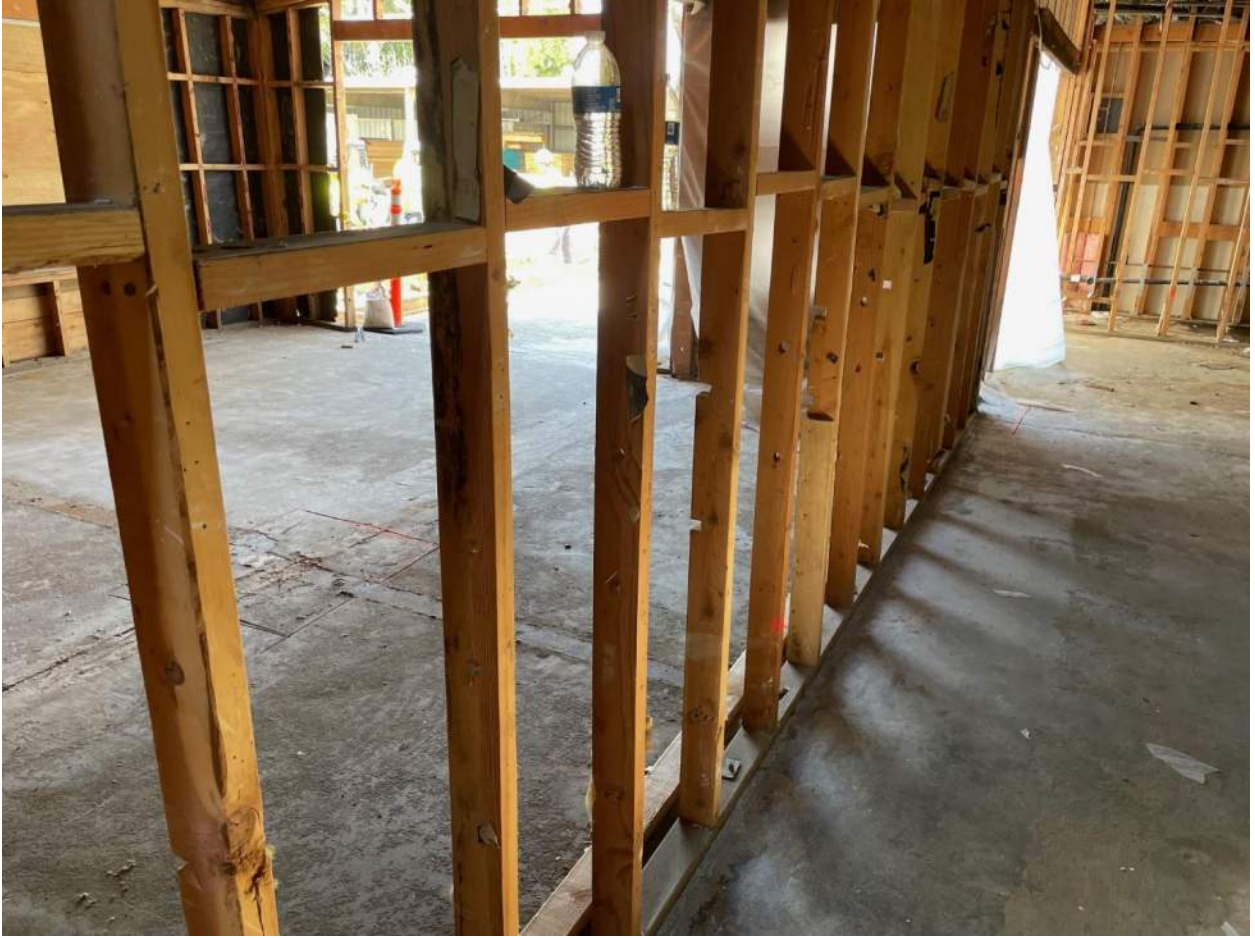
- Line 2-2 C to D1      The current wall is to the bottom of the trusses. There are beams proposed to be provided for intermediate truss support. Photos 51 and 52.

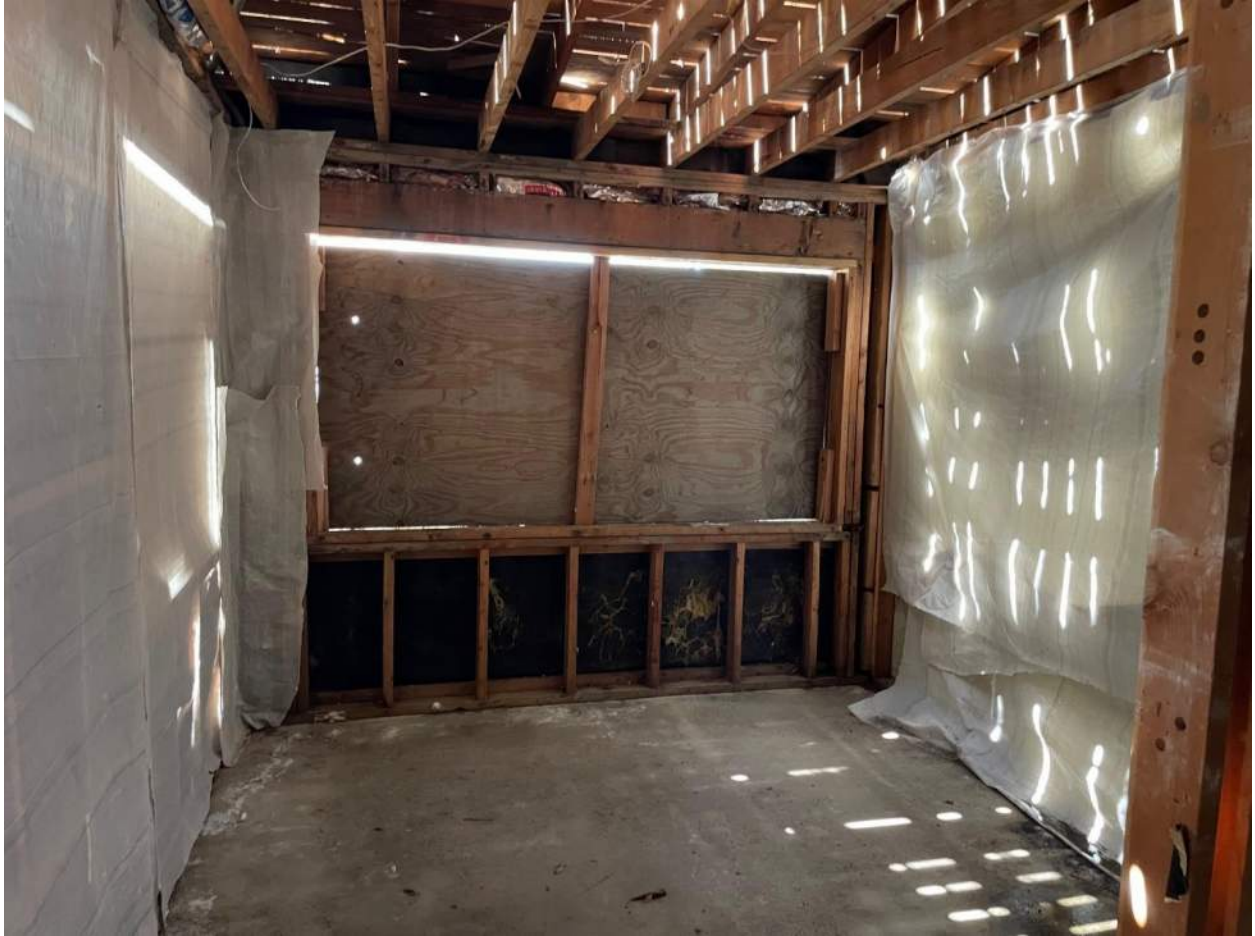
PICTURE 53

- Line 2-2 F to G      Wall has an 8' plate in relatively decent shape except the area over the westerly window has water damage. Photo 32.
- Line 3-3              Wall plate height is 8' and the walls all have large openings which will be reframed for new opening. These walls will have to be brought up to meet truss height. Photo 53.

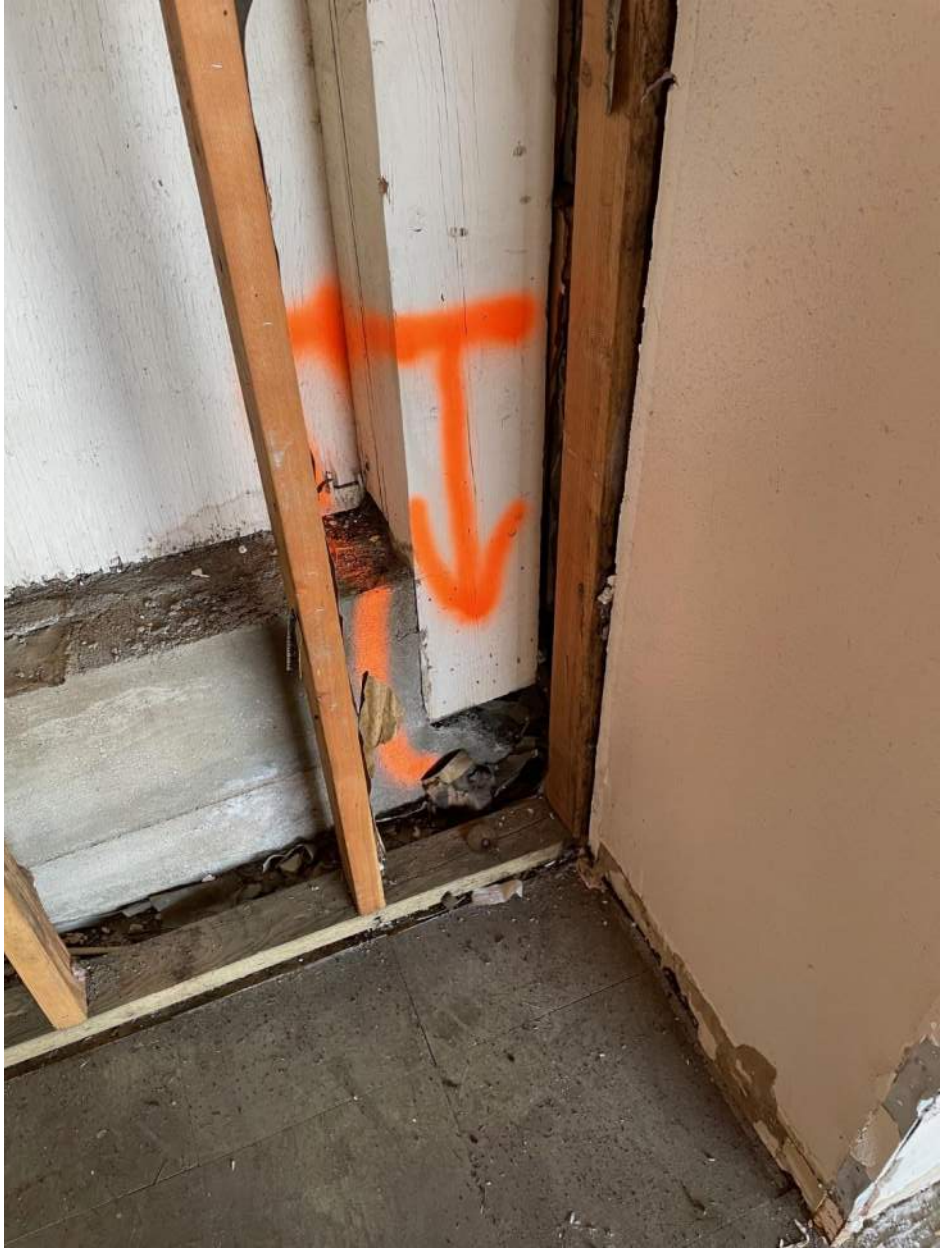
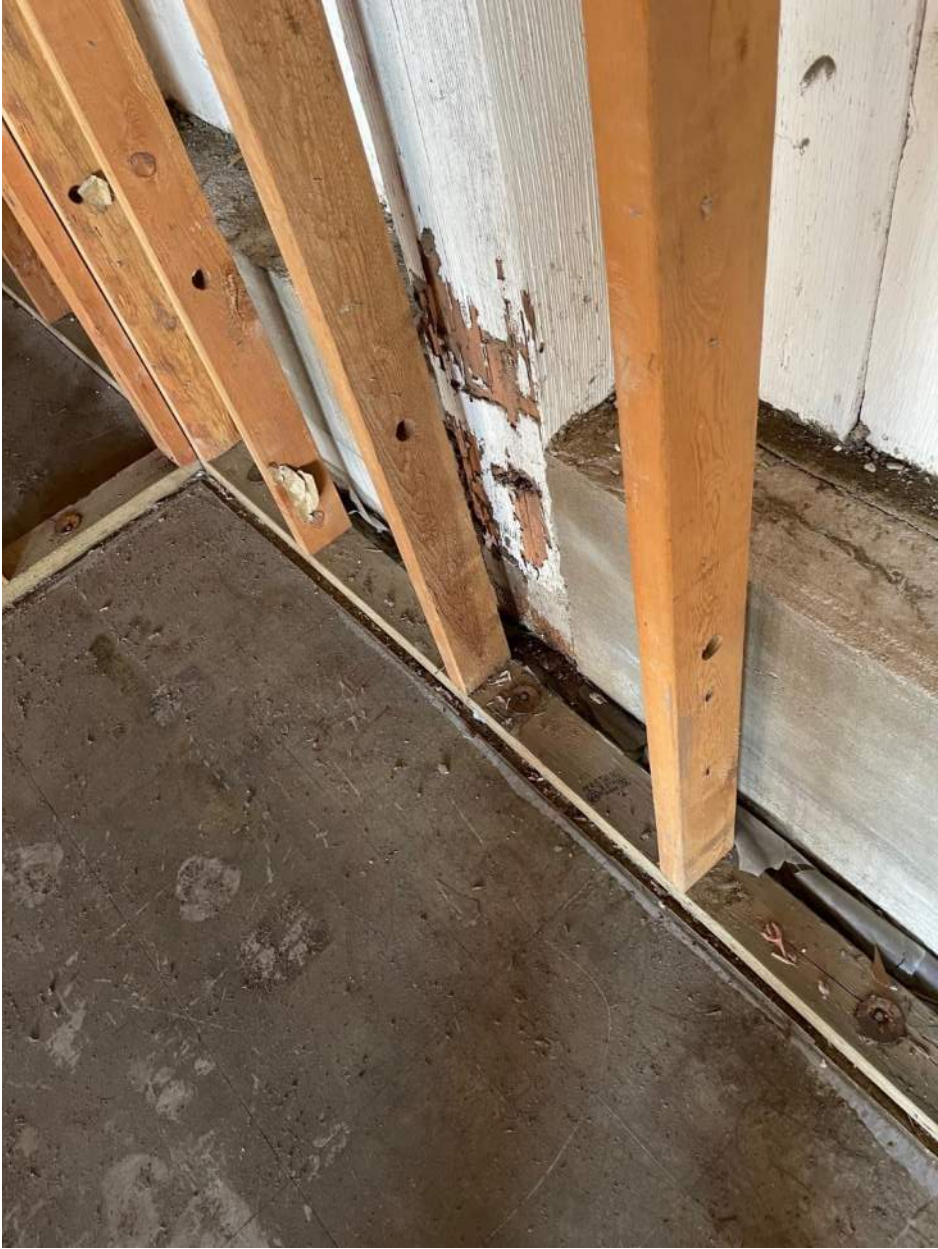
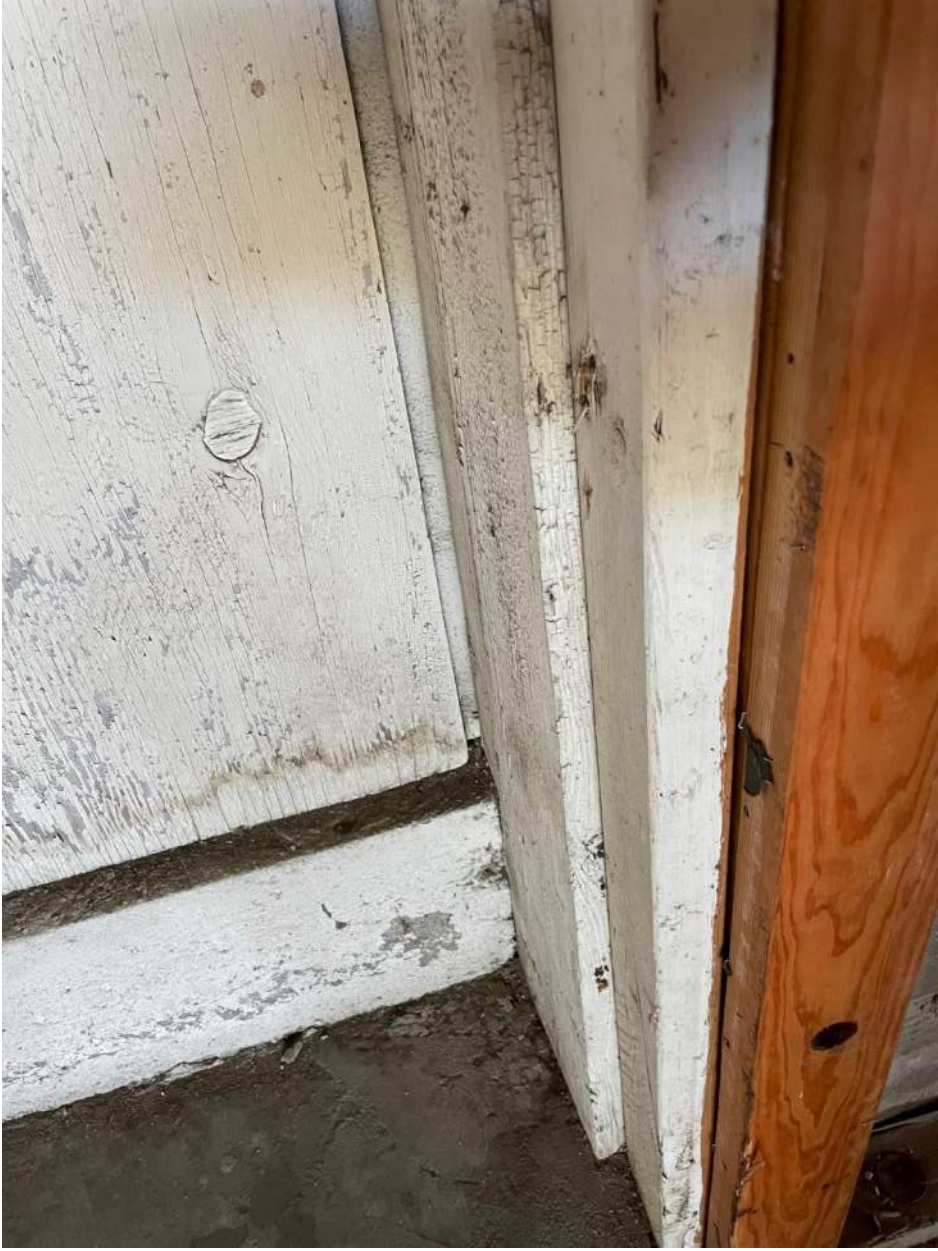
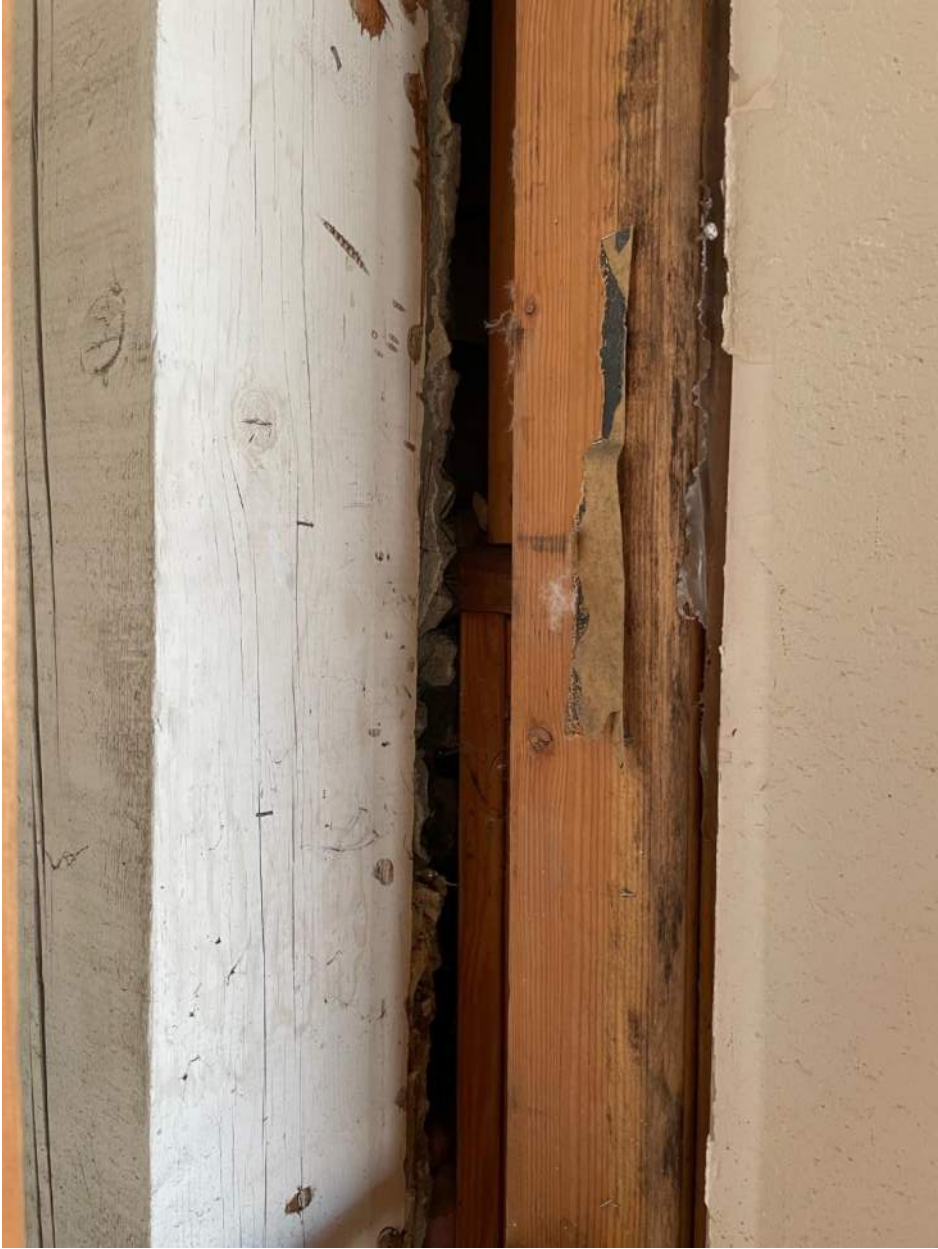
Line 1-1 C to D The wall is supported on a curb with a framed section at the top. It looks like there is a section of exterior studs behind the framed section which supports the exterior finish. This has not been exposed so the full condition of the wall is unknown. The posts for supporting the roof are embedded in the stem wall so a solution for

the proper attachment needs to be determined. Photos 57 to 63.

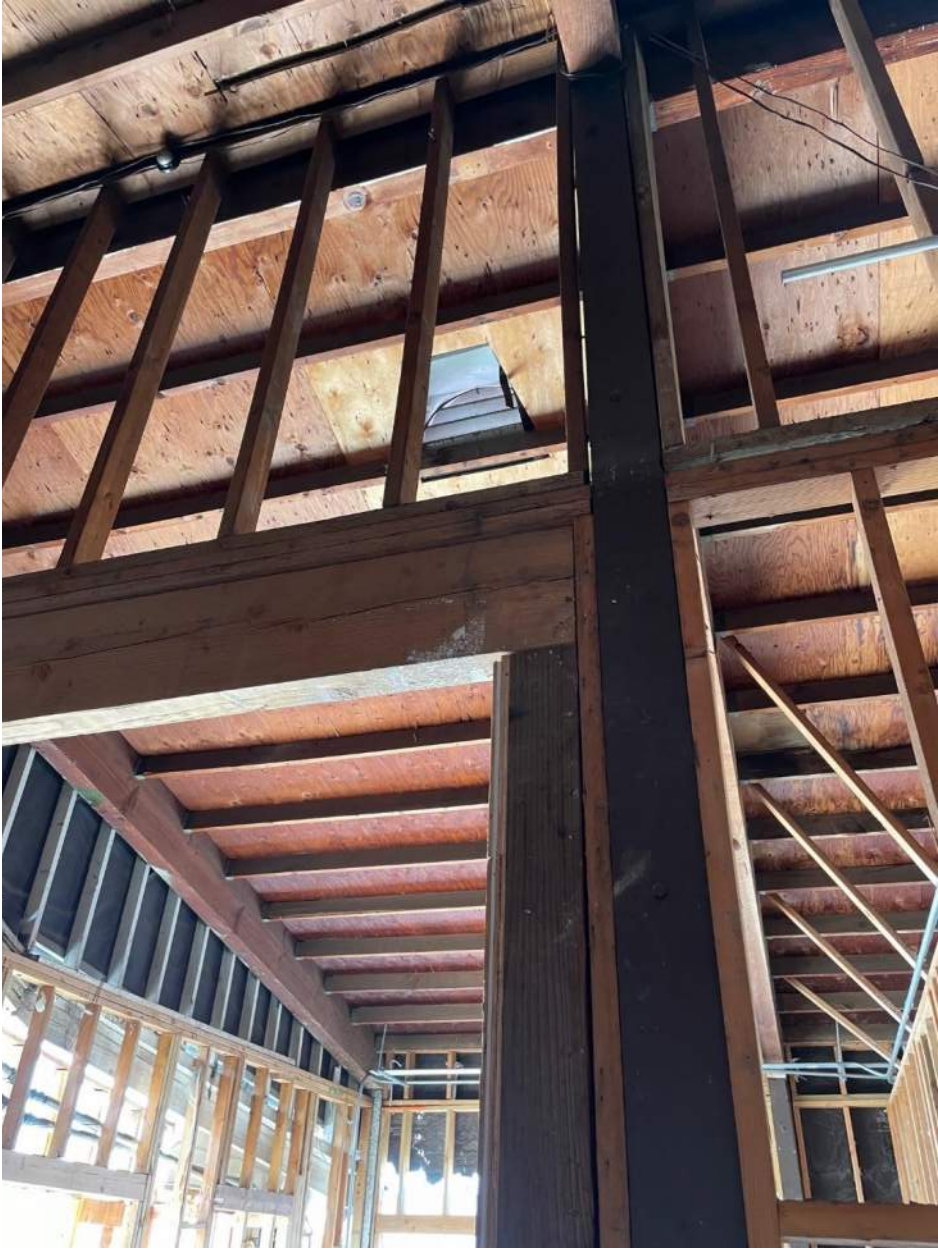
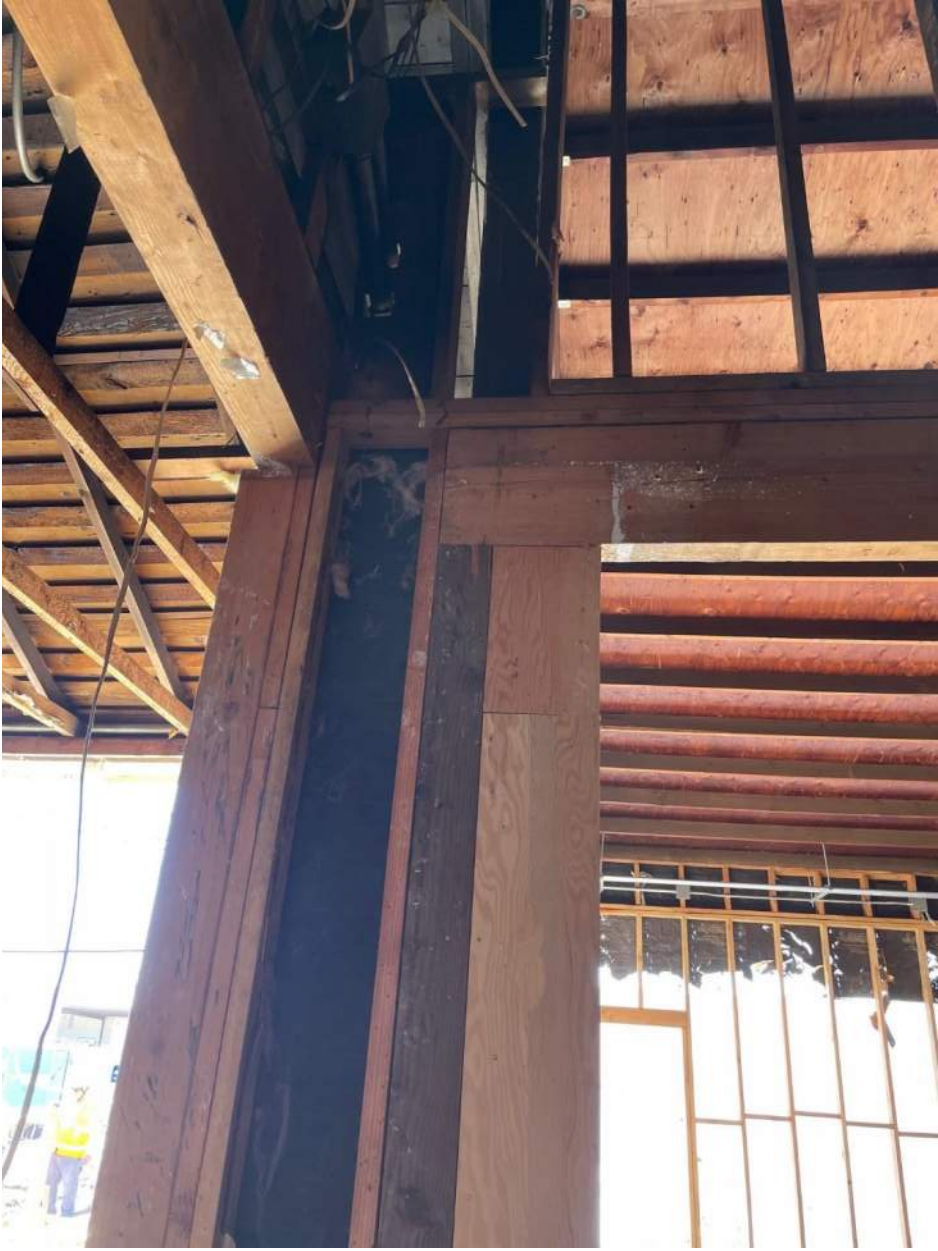
- Line 1-1 F to G      The wall is hidden by block veneer, so condition is unknown. Photos 27 and 33.
- Line 1.5 B1 to C      The beam to post needs to have positive connection at both ends Photos 64 and 65.

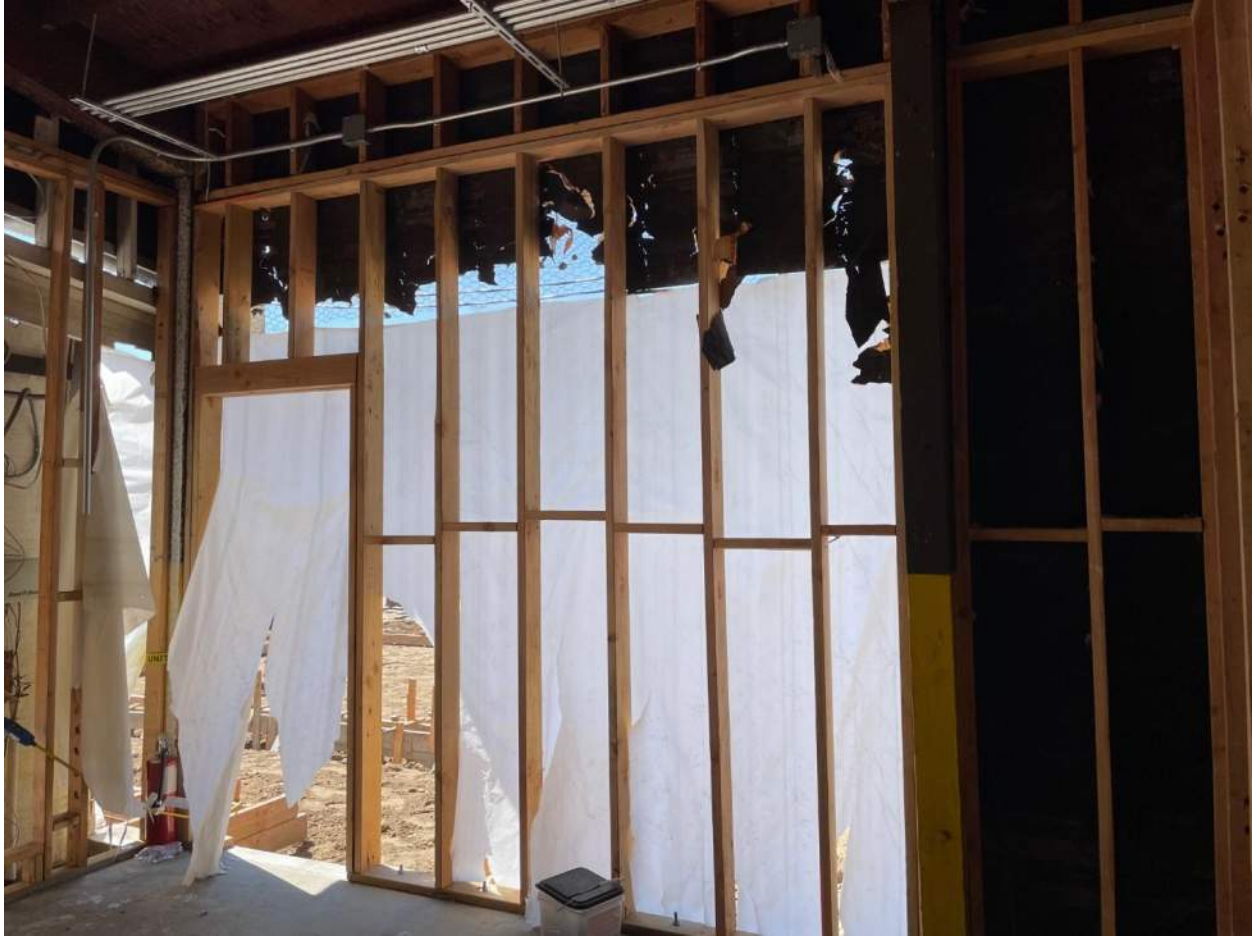
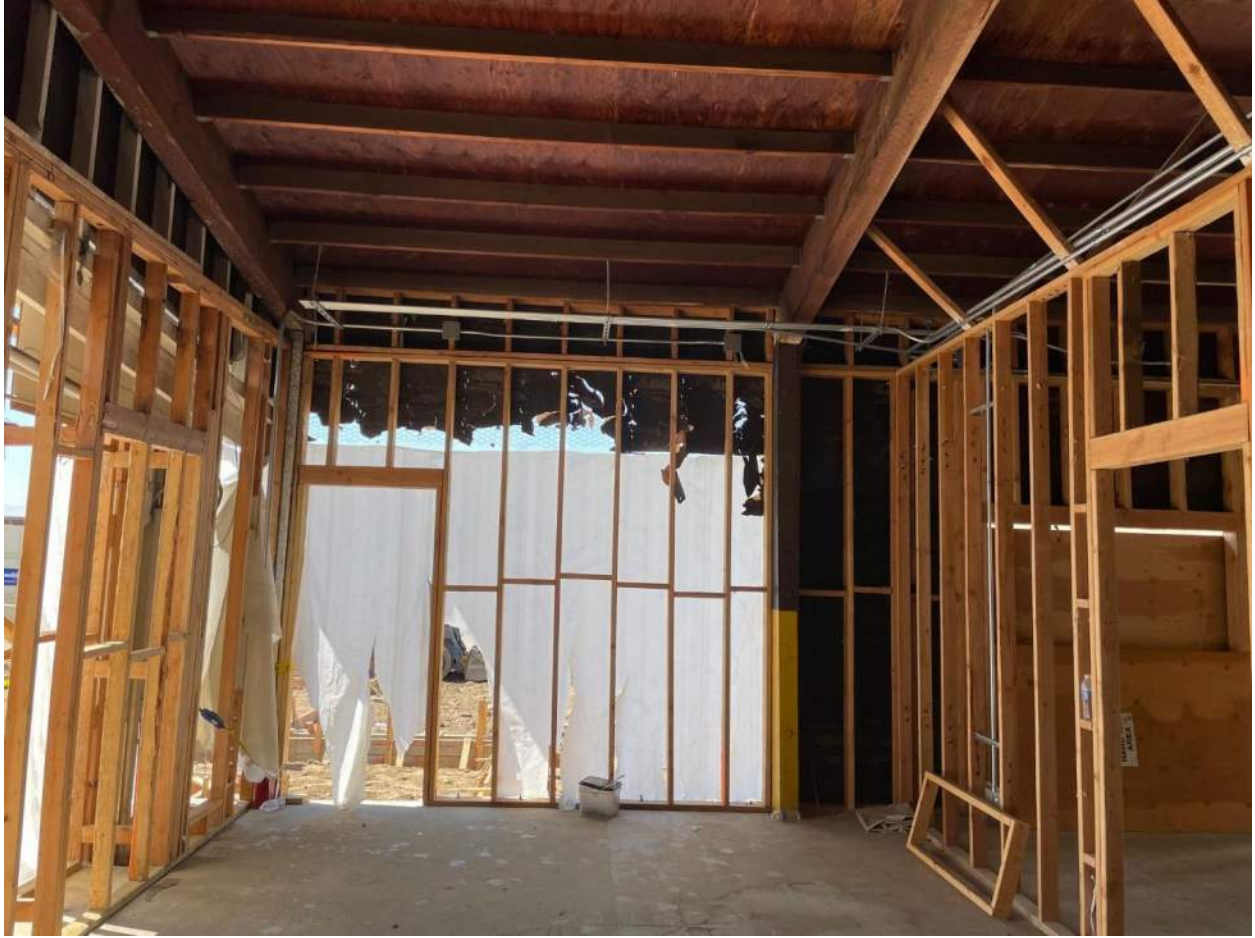
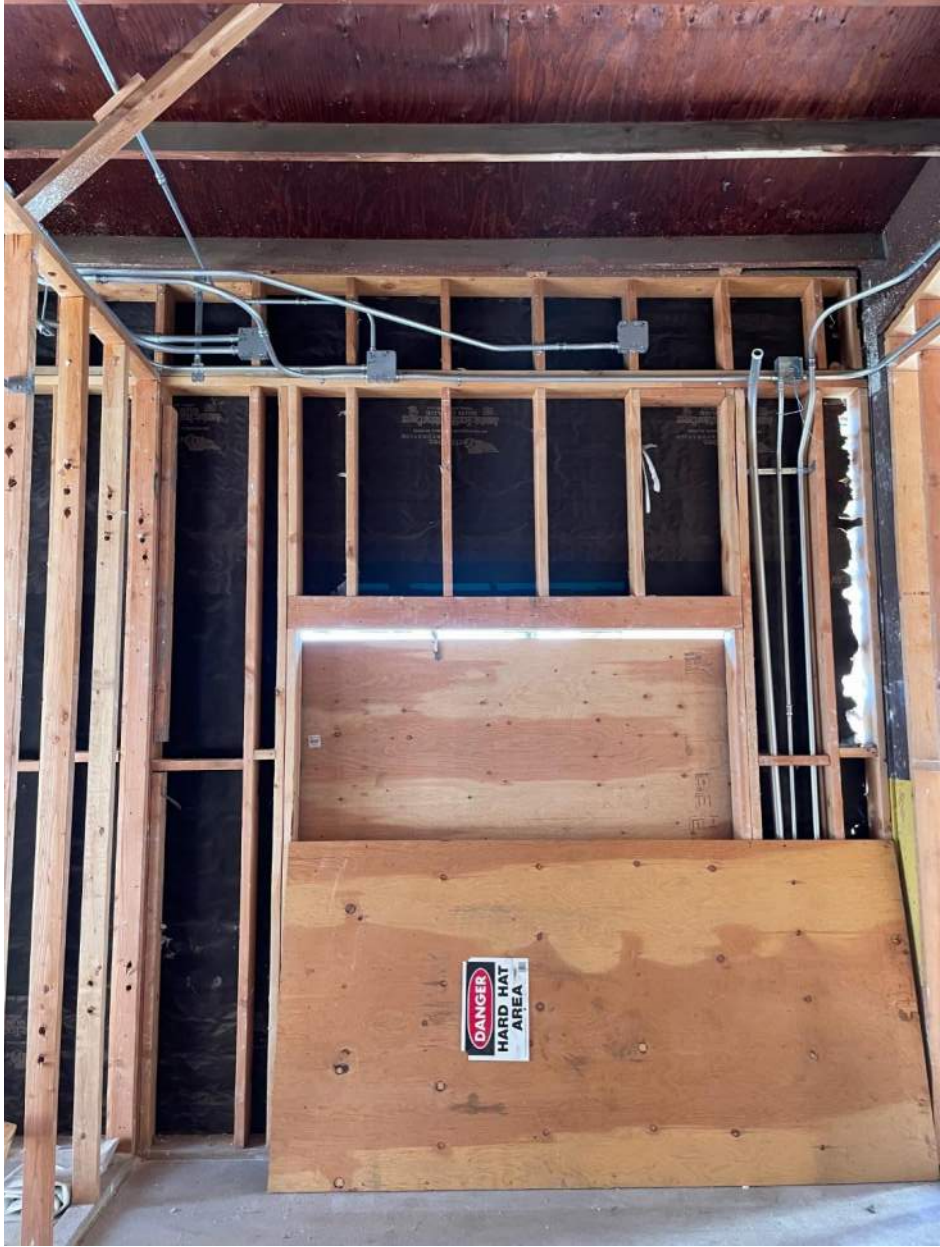
- Line 4-4 C to D      This wall is already removed since the building is being widened for consistent truss installation.
- Line 4-4 D to E      Wall plate height is 8' and the walls all have large openings which will be reframed for the new openings. These walls will have to be brought up to meet truss height. Photos 54 to 56.
- Line 4-4 B to C      The wall is infilled in the post and beam framing. The studs do not go to full height because they are broken by a double plate about 18" from the top. These will have to be checked to see if the double plates are sufficient for the lateral loads on the wall. Photos 66 to 68.

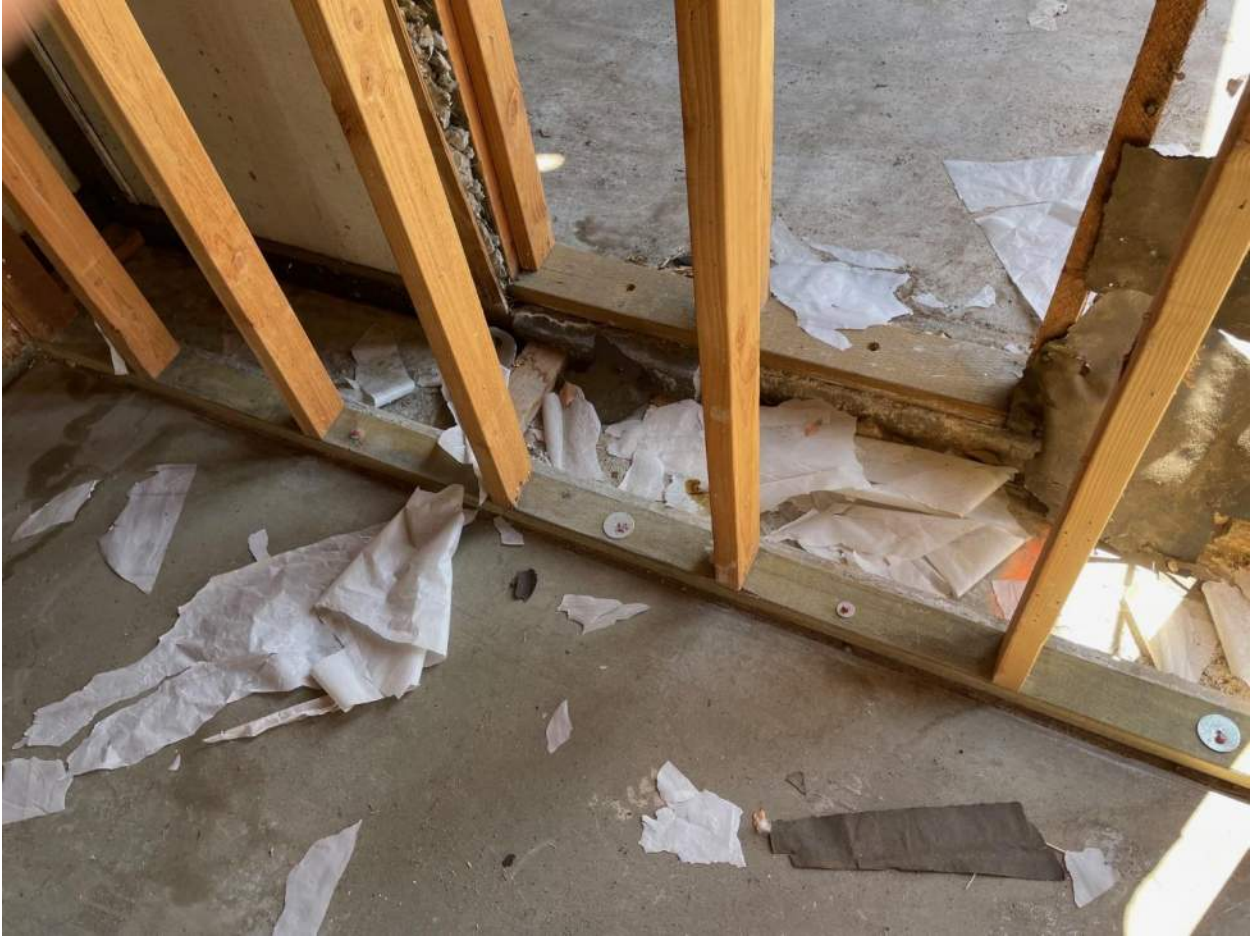
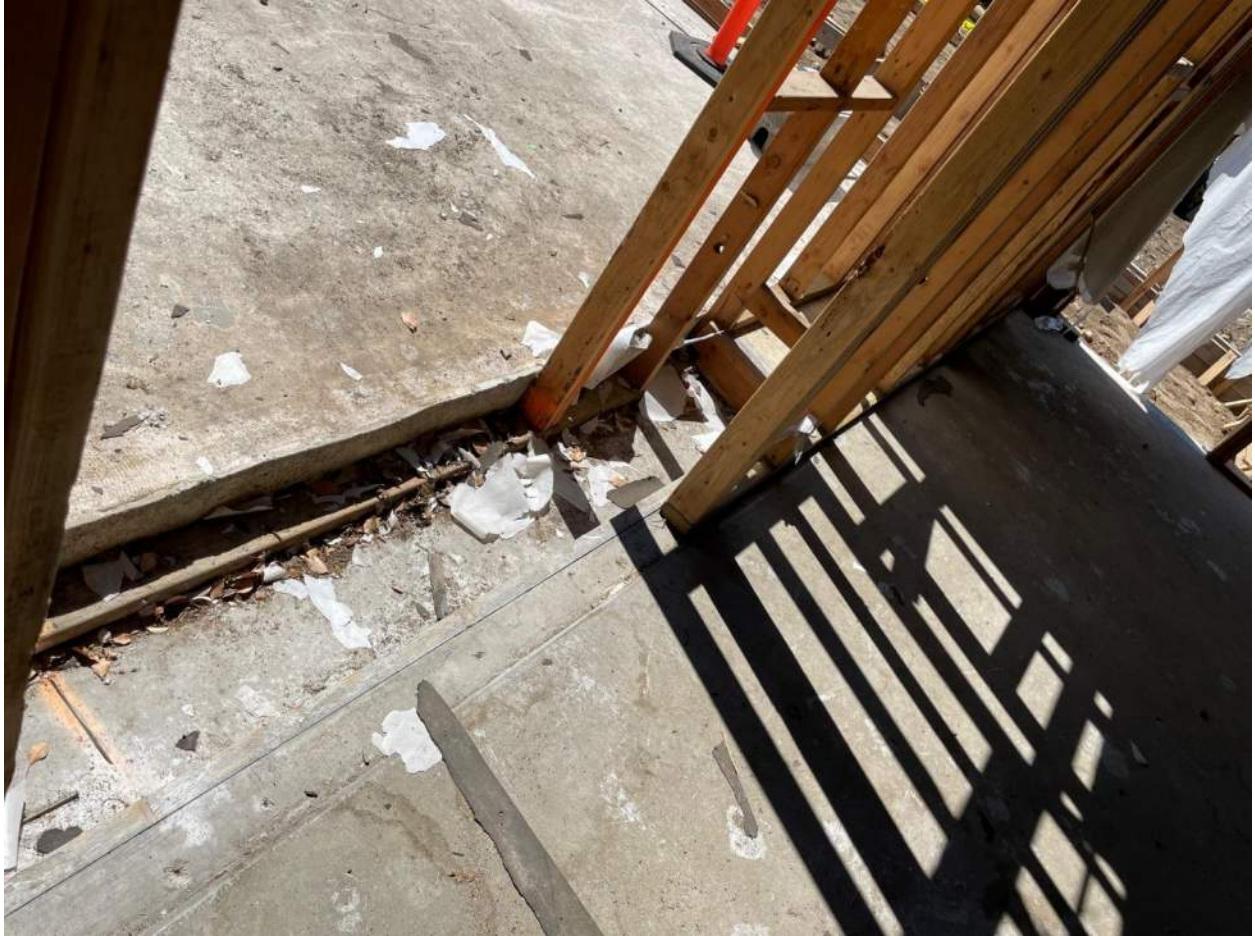
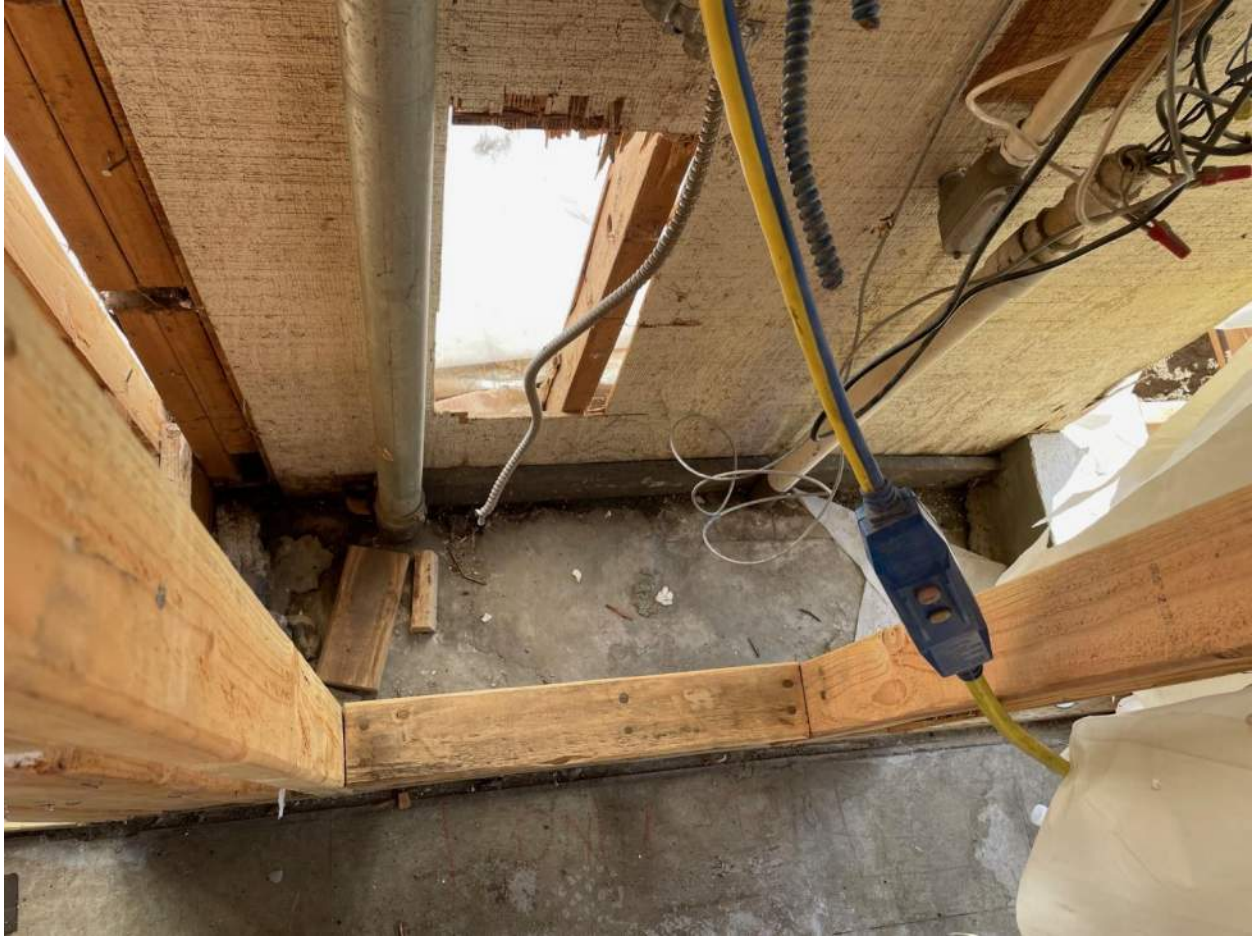
headers which will need to be corrected. The wall at the roof framing transition will need to extend as a demising transition between the different roof framing conditions. At the sandwiched wall there is a recess in the slab which will require correction to make the slab transition flat. I am not sure that the west section of the wall is necessarily required, if it is it needs to be braced to the roof structure. Photos 7 to 12 and 70 to 72.
