RIALTO PUBLIC WORKS DEPARTMENT

PARKS BUILDING REHABILITATION

CITY OF RIALTO - Parks Building Rehabilitation

Summary Report

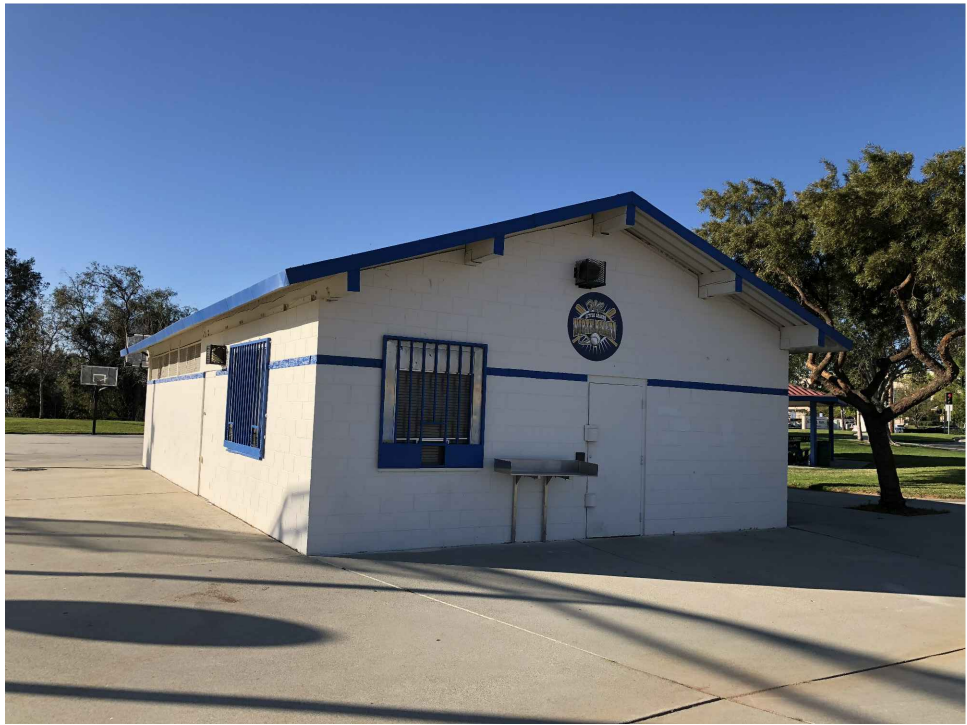
Existing Plan

BUILDING DESCRIPTION

1-story snack bar, kitchen, restroom building, gable roof (1111 SF)

- 1 Accessible route has concrete dipped at front entry. Greater than 1" of height difference
- 2 Entry has no threshold. Floor height difference is 1/2"
- 3 No accessible signage at entry
- 4 Non-conforming maneuvering clearance at accessible urinal
- 5 Lavatory sink is less than the required min of 17" width. Remove lavatory sink and provide new
- 6 Missing soap dispenser. Provide new soap dispenser
- 7 No existing mirror. Provide new mirror
- 8 Missing coat hook. Provide new coat hook
- 9 Non-conforming toilet paper dispenser location. Provide new toilet paper dispenser.
- 10 No accessible sign, typical at all rooms. Provide new accessible sign
- 11 Non-conforming accessible counter height. Remove existing and provide new.
- 12 Non-conforming accessible counter length. Remove existing and provide new
- 13 Non-conforming maneuvering clearance at condiment stand

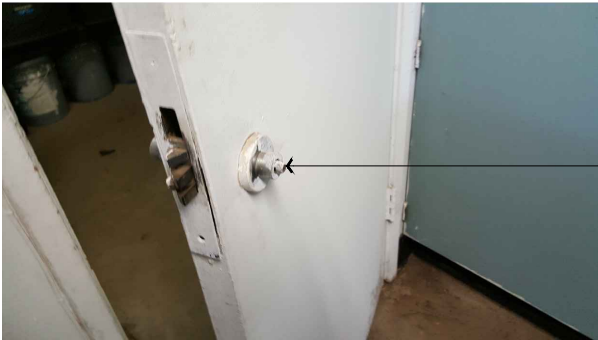
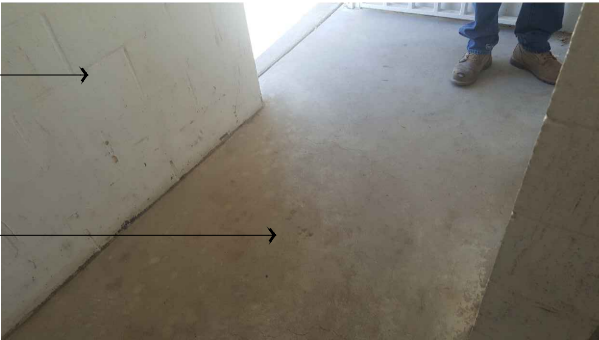
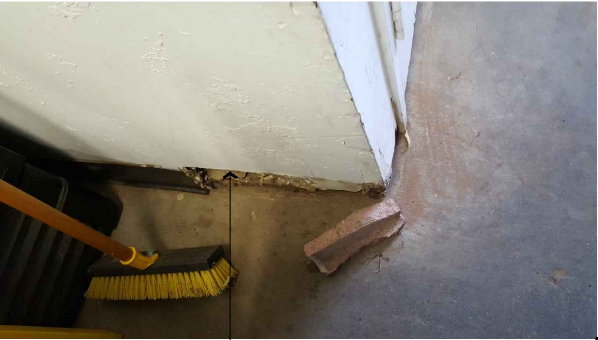
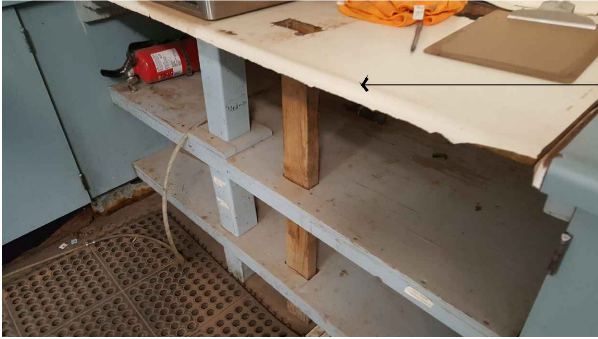
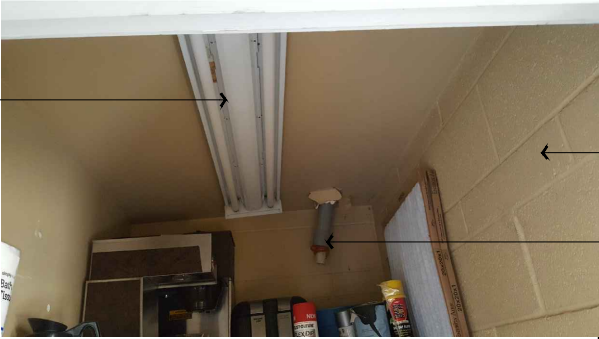
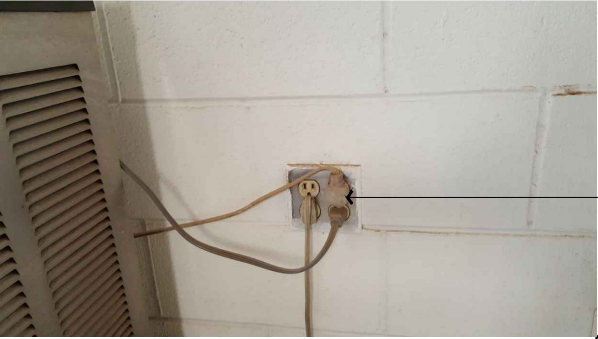
Deficiencies

KEYNOTES	BUILDING MAINTENANCE ISSUES
1	Water ponding at both restrooms
2	Unfinish floor thru-out. Provide new finish
3	Rusted door frame. Refinish & repaint door frame
4	Rusted gate frame. Refinish and repaint door frame
5	Non-functional hand dryer at both restrooms
6	Non-functional lights at both restrooms
7	Dilapidated toilet stall door
8	Missing Toilet seat at women's restroom
9	Graffiti at roof skylights
10	Detached condiment stand at snack bar
11	Broken screen at snack bar public counter
12	Doors needs door sweep thru-out to prevent dirt accumulation/getting into storage rooms
13	Repair gypbd. Wall
14	Repair casework thru-out
15	patch dry-wall ceiling penetration
16	Missing door handle at storage no. 2. & 3
17	Upgrade electrical outlets to GFCI
18	Repair roof access
19	Missing signage thru-out
20	Repair cracked beam
21	Repaint entire building
22	Tampered Photocell at roof. Relocate for security purposes
23	Repair broken pavement, typical thru-out

Description	Quantity	Unit	Unit Cost	Total
Item 01: Interior Floor Repair and Finishing				\$0
KN1 Level floor to mitigate water ponding @ men & women	2	locations	\$2,000.00	\$4,000
KN 2 Install epoxy floor sealer at entire building	600	sf	\$10.00	\$6,000
				\$0
Division Total				\$10,000

Item 02: Doors and Thresholds				\$0
KN 3 Rusted door frame- Repair/Refinish frame	1	ea	1000	\$1,000
KN 4 Rusted Gate- clean/Repaint	1	ea	1000	\$1,000
KN 12 - Install sweeps at storage rooms exterior doors	2	ea	500	\$1,000
KN 16 - Install door handle at storage rooms exterior doors	2	ea	800	\$1,600
				\$0
Division Total				\$4,600

Item 09: Toilet Partitions/Urinal Screens				\$0
KN 7 - Replace toilet stall door	1	ea	\$4,000.00	\$4,000
				\$0
Division Total				\$4,000
Item 10: Drywall				\$0
KN 13 repair gypsum wall	1	ls	\$4,000.00	\$4,000
KN 15 repair gypsum ceiling	1	ls	\$2,000.00	\$2,000
				\$6,000
Division Total				\$6,000

Item 12: Casework Repair/Replacement				\$0
KN 14 Remove/replace casework	1	ls	\$40,000.00	\$40,000
				\$40,000
Division Total				\$40,000
Item 13: Electrical				\$0
KN 13 install lights at both restrooms	1	ls	\$12,000.00	\$12,000
KN 17 Upgrade outlet to GFI/replace conduit to meet code	1	ls	\$10,000.00	\$10,000
KN 22 relocate photocell at roof	1	ls	\$500.00	\$500
				\$22,500
Division Total				\$22,500

Item 14: Repair Roof Access				\$0
KN 18 Repair roof access	1	ls	\$2,500.00	\$2,500
				\$2,500
Division Total				\$2,500
Item 15: Repair Visible Cracked Beams (Fill in cracks and apply Paint/Sealer)				\$0
KN 20 Repair cracked beam (fill in and paint)	1	ls	\$10,000.00	\$10,000
				\$10,000
Division Total				\$10,000
SUBTOTAL				\$128,600

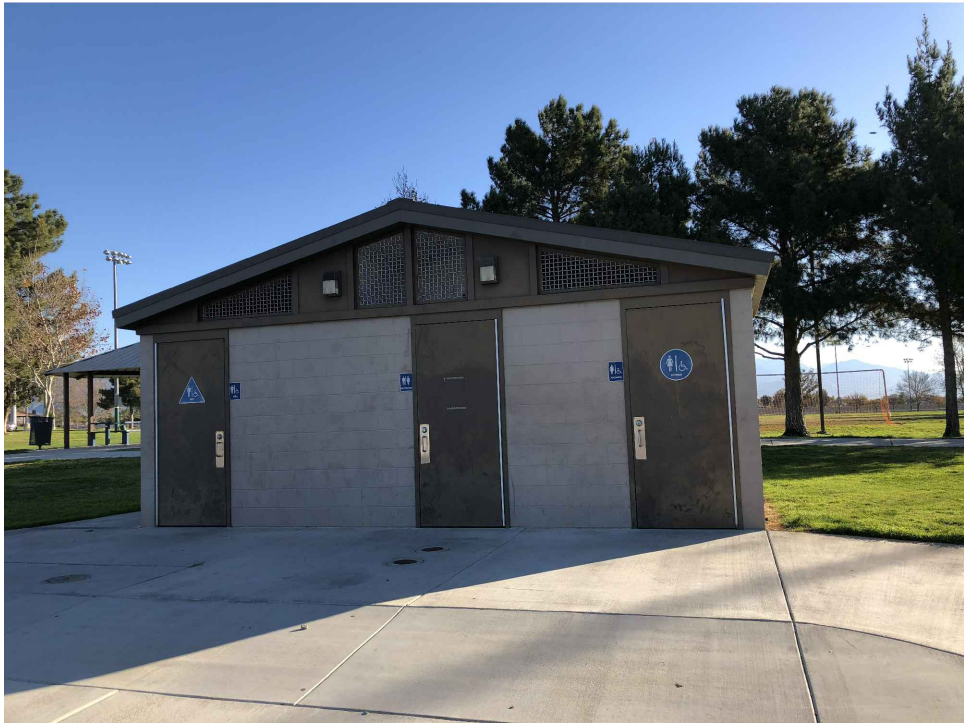
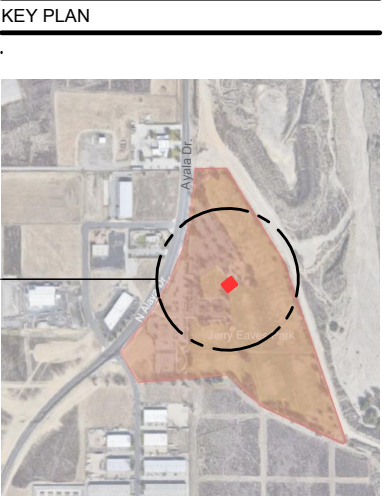
Existing Plan

- KEY NOTES
- 1 No coat hook at all stalls
 - 2 No mirror
 - 3 Verify maximum opening force for entry door
 - 4 Non-conforming maneuvering clearance accessible stall

BUILDING DESCRIPTION

1-story restroom (with all-gender) building, gable roof (253 SF)

- mens restroom
- womens restroom
- family restroom
- plumbing chase

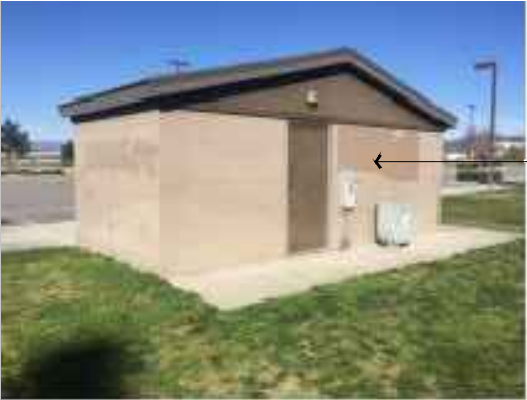
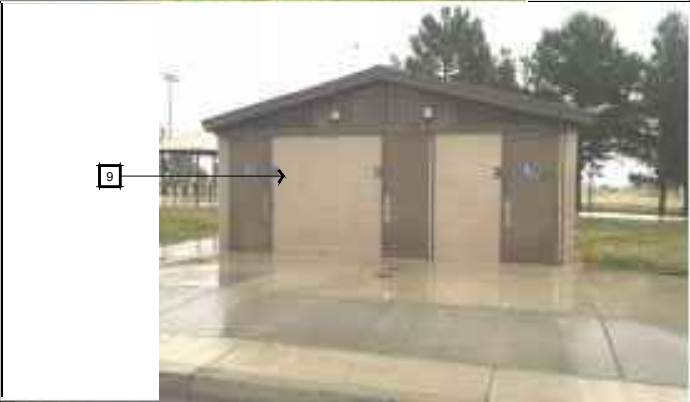
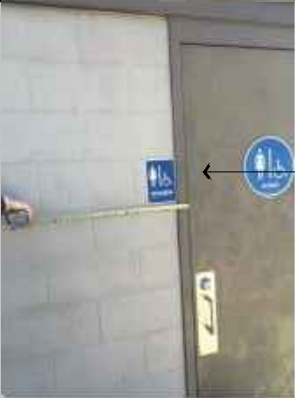
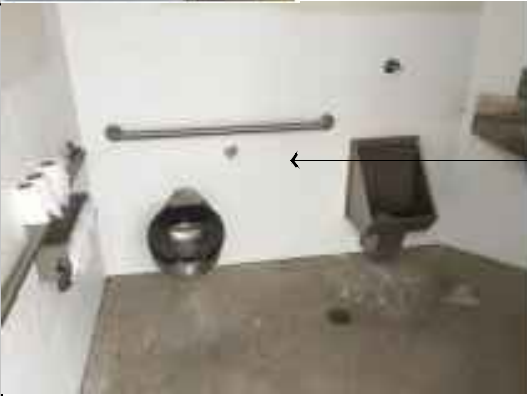
Deficiencies

KEYNOTES	
	MEN'S RESTROOM BUILDING ADA DEFICIENCIES
	1 No Coat hook at all stalls
	2 Missing mirror
	3 Verify max opening force for entry door
	4 Less than 60" clear width at accessible water closet due urinal
KEYNOTES	
	WOMEN'S RESTROOM BUILDING ADA DEFICIENCIES
	5 No Coat hook at all stalls
	6 Missing mirror
	7 Verify max opening force for entry door
	9 Accessible signage has no fair

Description	Quantity	Unit	Unit Cost	Total
Item 01: Interior Floor Repair and Finishing				
NO PHOTOS				\$0
				\$0
Division Total				\$0
Item 02: Doors and Thresholds				
				\$0
KN 4 No self closing door men - Provide door closer	1	ea	\$1,000.00	\$1,000
KN 7 No self closing door women- Provide door closer	1	ea	\$1,000.00	\$1,000
				\$0
Division Total				\$2,000
Item 05 Restrooms Accessories				
				\$0
KN 1, 2 Missing mirror and coat hook	1	ea	\$700.00	\$700
KN 5, 6 Missing mirror and coat hook	1	ea	\$700.00	\$700
				\$0
Division Total				\$1,400
Item 18:No Conforming Maneuvering Space at Snack Bar/kitchen				
				\$0
KN 4 Nonconforming wall CMU @ men accessible stall	1	ls	\$15,000.00	\$12,000
KN 8 Nonconforming wall CMU @ women accessible stall	1	ls	\$15,000.00	\$12,000
				\$0
Division Total				\$24,000
SUBTOTAL				\$27,400

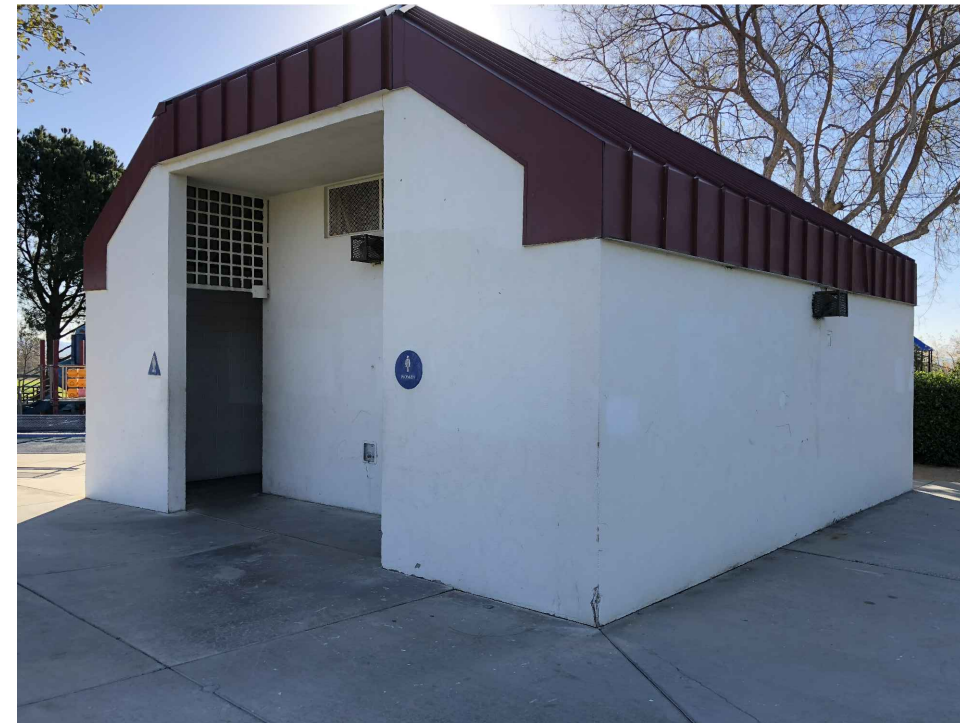
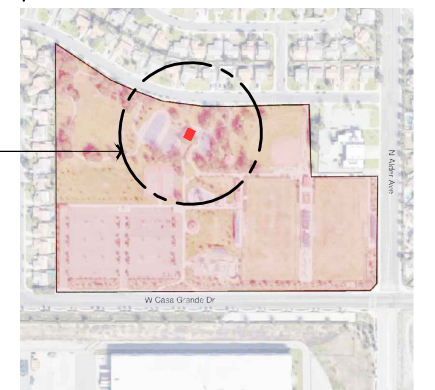
Existing Plan

BUILDING DESCRIPTION

1-story restroom building, gable roof (639 SF)

- 1 Trip Hazard at entry of restroom. Inconsistent concrete floor level
- 2 Room Signage has no contrast. Signage is in wrong location
- 3 Non-conforming signage height. Highest height of character is at 60"
- 4 Gate privacy wall does not meet minimum clearance of 48" Currently at 44" clear
- 5 Non-functional lavatory water push button
- 6 Missing sink pipe insulation at lavatory
- 7 No existing mirror Provide new mirror
- 8 No soap dispenser
- 9 Missing coat hook Provide new coat hook
- 10 Missing door at accessible stall
- 11 Non-conforming urinal height

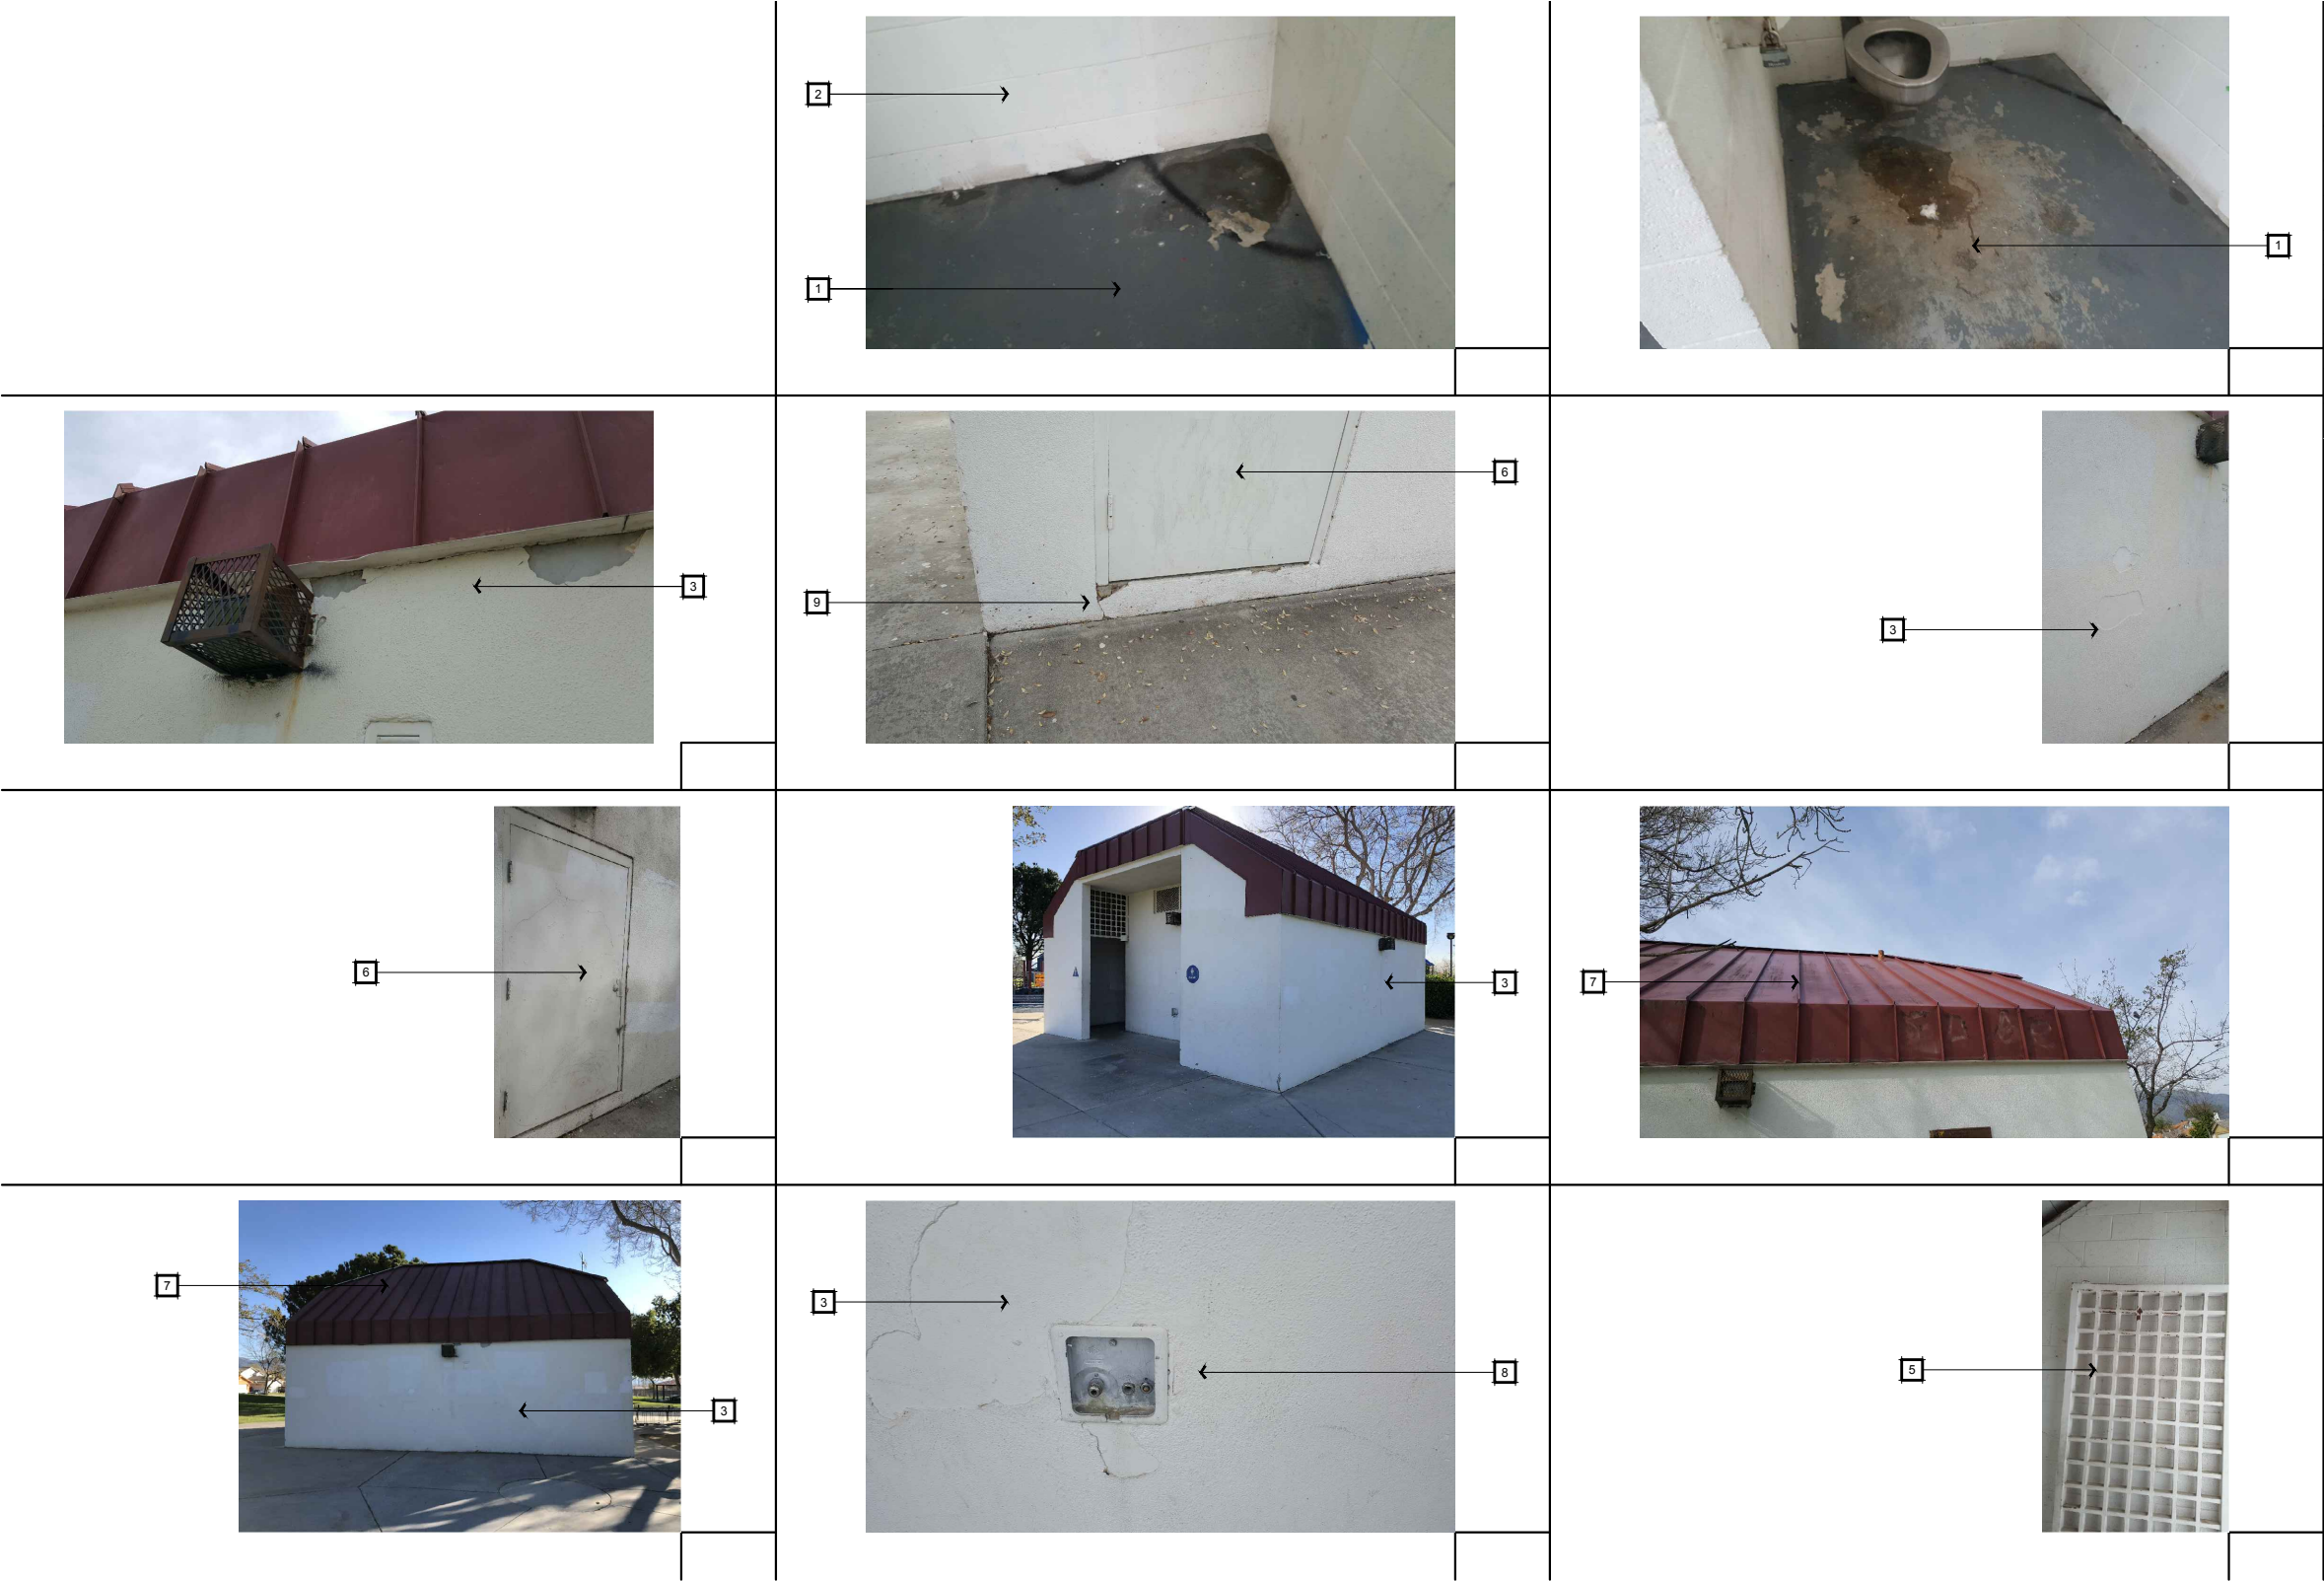
Deficiencies

KEYNOTES	
BUILDING 1 MAINTENANCE	
1	Floor needs to be refinished thru-out
2	Wall needs to be repainted thru-out
3	Plaster repair thru-out the building
4	Both restroom has no lights
5	Gate is rusted and needs to be refurbished
6	No door handle at all exterior doors
7	Roof repair
8	Missing panel cover for utilities
9	Cracking at storage door slab

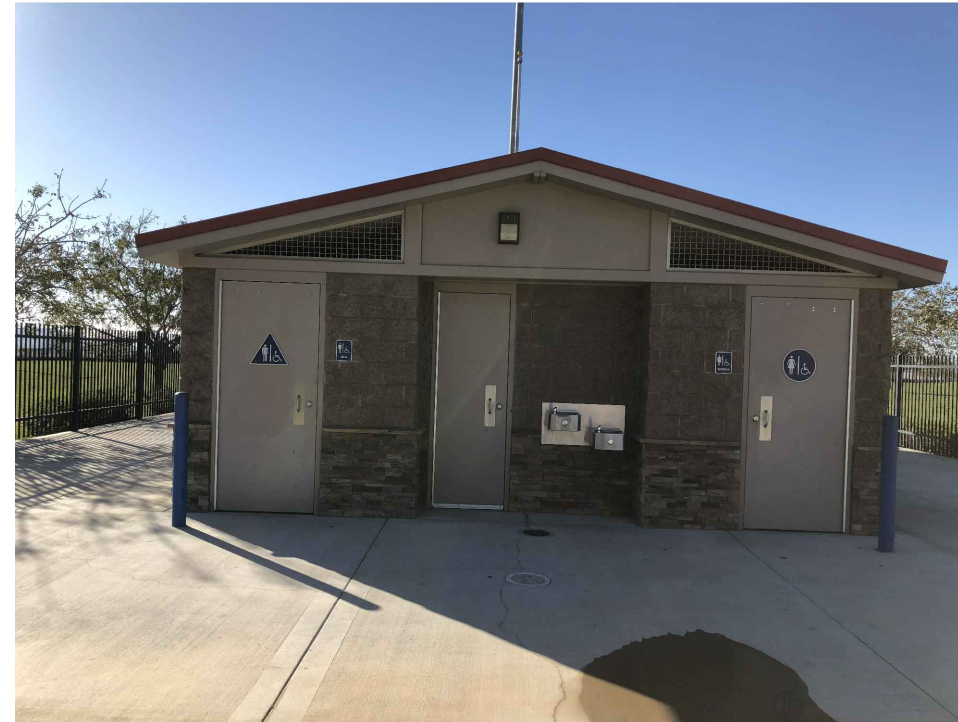
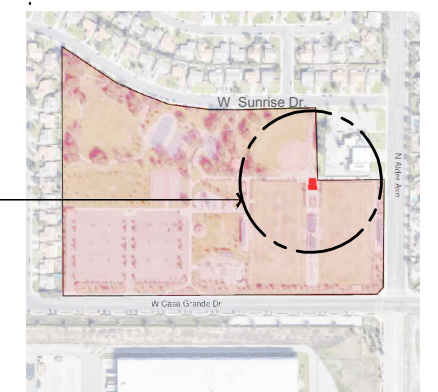
CITY OF RIALTO - Fergusson Park Snack Bar & Restroom Bldg. 2

BUILDING DESCRIPTION

1-story snack bar, kitchen, restroom building, gable roof (932 SF)

- 1 Missing coat hook Provide new coat hook
- 2 No existing mirror Provide new mirror
- 3 Verify max. opening force fore entry door
- 4 Missing pipe insulation
- 5 Non-conforming maneuvering space. Min. at 60". 4'-2" existing.
- 6 Non-conforming maneuvering space at HI/LO drinking fountain

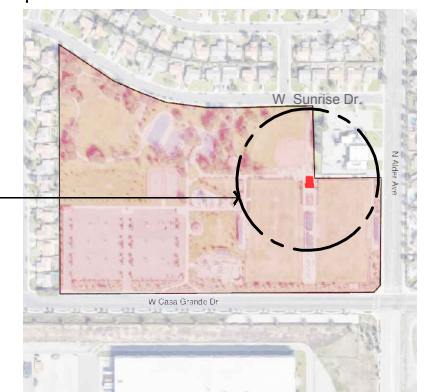
CITY OF RIALTO - Fergusson Park Snack Bar & Restroom Bldg. 2 | Recommendations

- 1 Provide new coat hook
- 2 Provide new mirror
- 3 Verify max. opening force fore entry door
- 4 Provide pipe insulation
- 5 Remove urinal
- 6 Remove existing sink and counter top.
- 7 New urinal
- 8 New wall
- 9 Relocated drinking fountain for ADA accesses
- 10 Demolish wall and replace with new partition
- 11 Provide signage for Unisex restroom
- 12 Provide ADA signage in snak bar counter

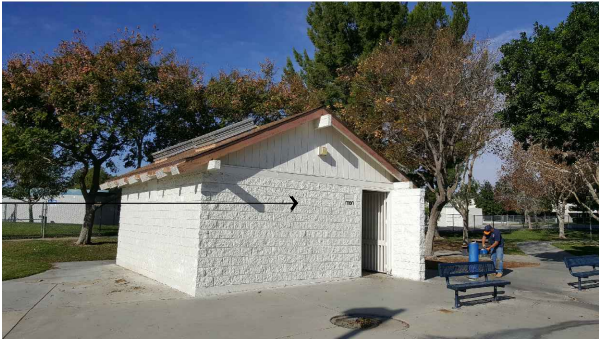
Deficiencies

</div>	<div>KEYNOTES</div> <div>MEN'S RESTROOM BUILDING ADA DEFICIENCIES</div> <div><div>1</div>No Accessible signage</div> <div><div>2</div>Missing pipe protection at lavatory sink</div> <div><div>3</div>No soap dispenser</div> <div><div>4</div>No mirror</div> <div><div>5</div>Non-conforming accessible stall dimension</div> <div><div>6</div>No coat hook</div> <div><div>7</div>No self-closing door</div> <div><div>8</div>Missing grab bar</div>
--	--	---	---

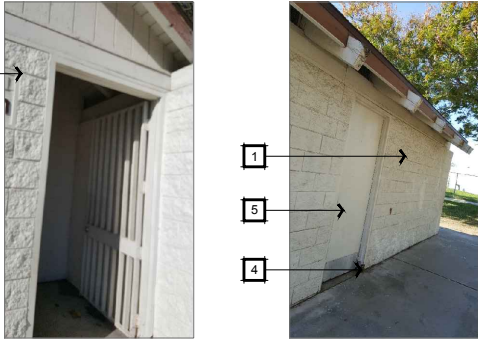
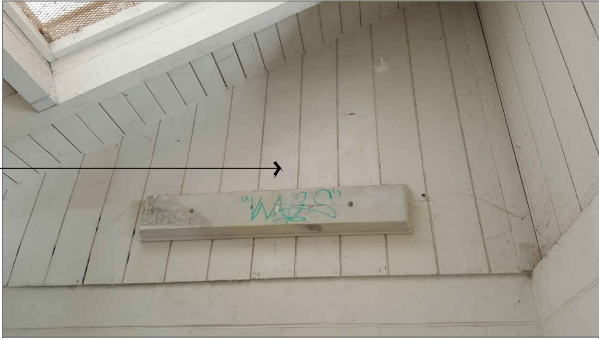
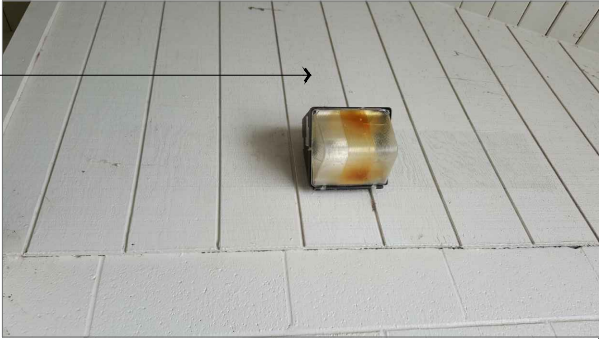
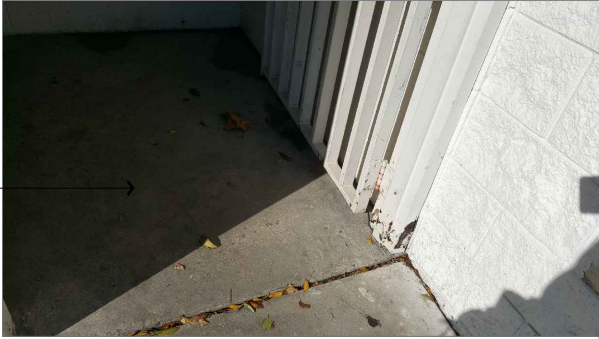
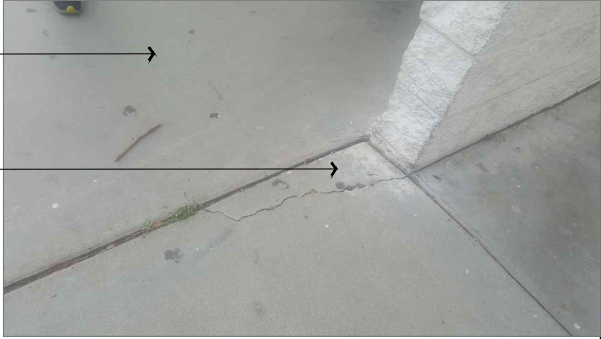
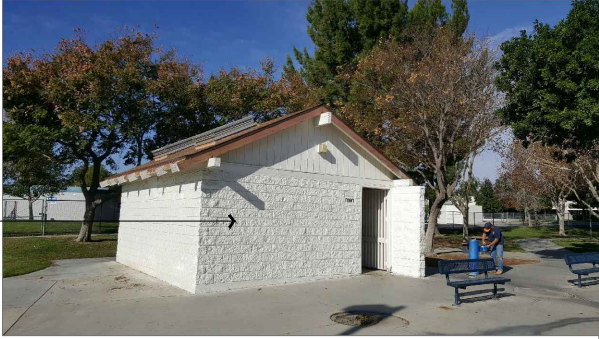
Deficiencies

KEYNOTES	
	BUILDING MAINTENANCE
1	Missing signage thruout the building
2	Water ponding inside restrooms
3	Replace light fixtures thru-out
4	Rusted door, frame, & hardware
5	No door handles at exterior doors
6	Provide door sweep at all exterior doors
7	Cracked rafter tails
8	Cracked blockings
9	Dry rotted fascia
10	Ant hill thru out the exterior of building
11	Refinish floor
12	Repaint entire building
13	Broken concrete slab around restroom

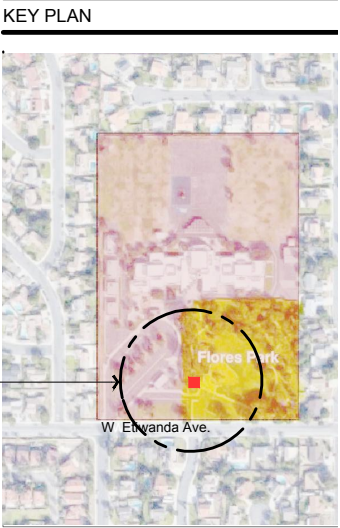
Recommendatio

- KEY NOTES
- 1 New accessible signage
 - 2 Provide sink pipe insulation at lava
 - 3 New soap dispenser
 - 4 New mirror
 - 5 New lavatory
 - 6 Provide new coat hook
 - 7 Provide self-closing door
 - 8 Install new grab bar
 - 9 Provide new toilet paper dispenser
 - 10 Demolish existing wall
 - 11 New partition

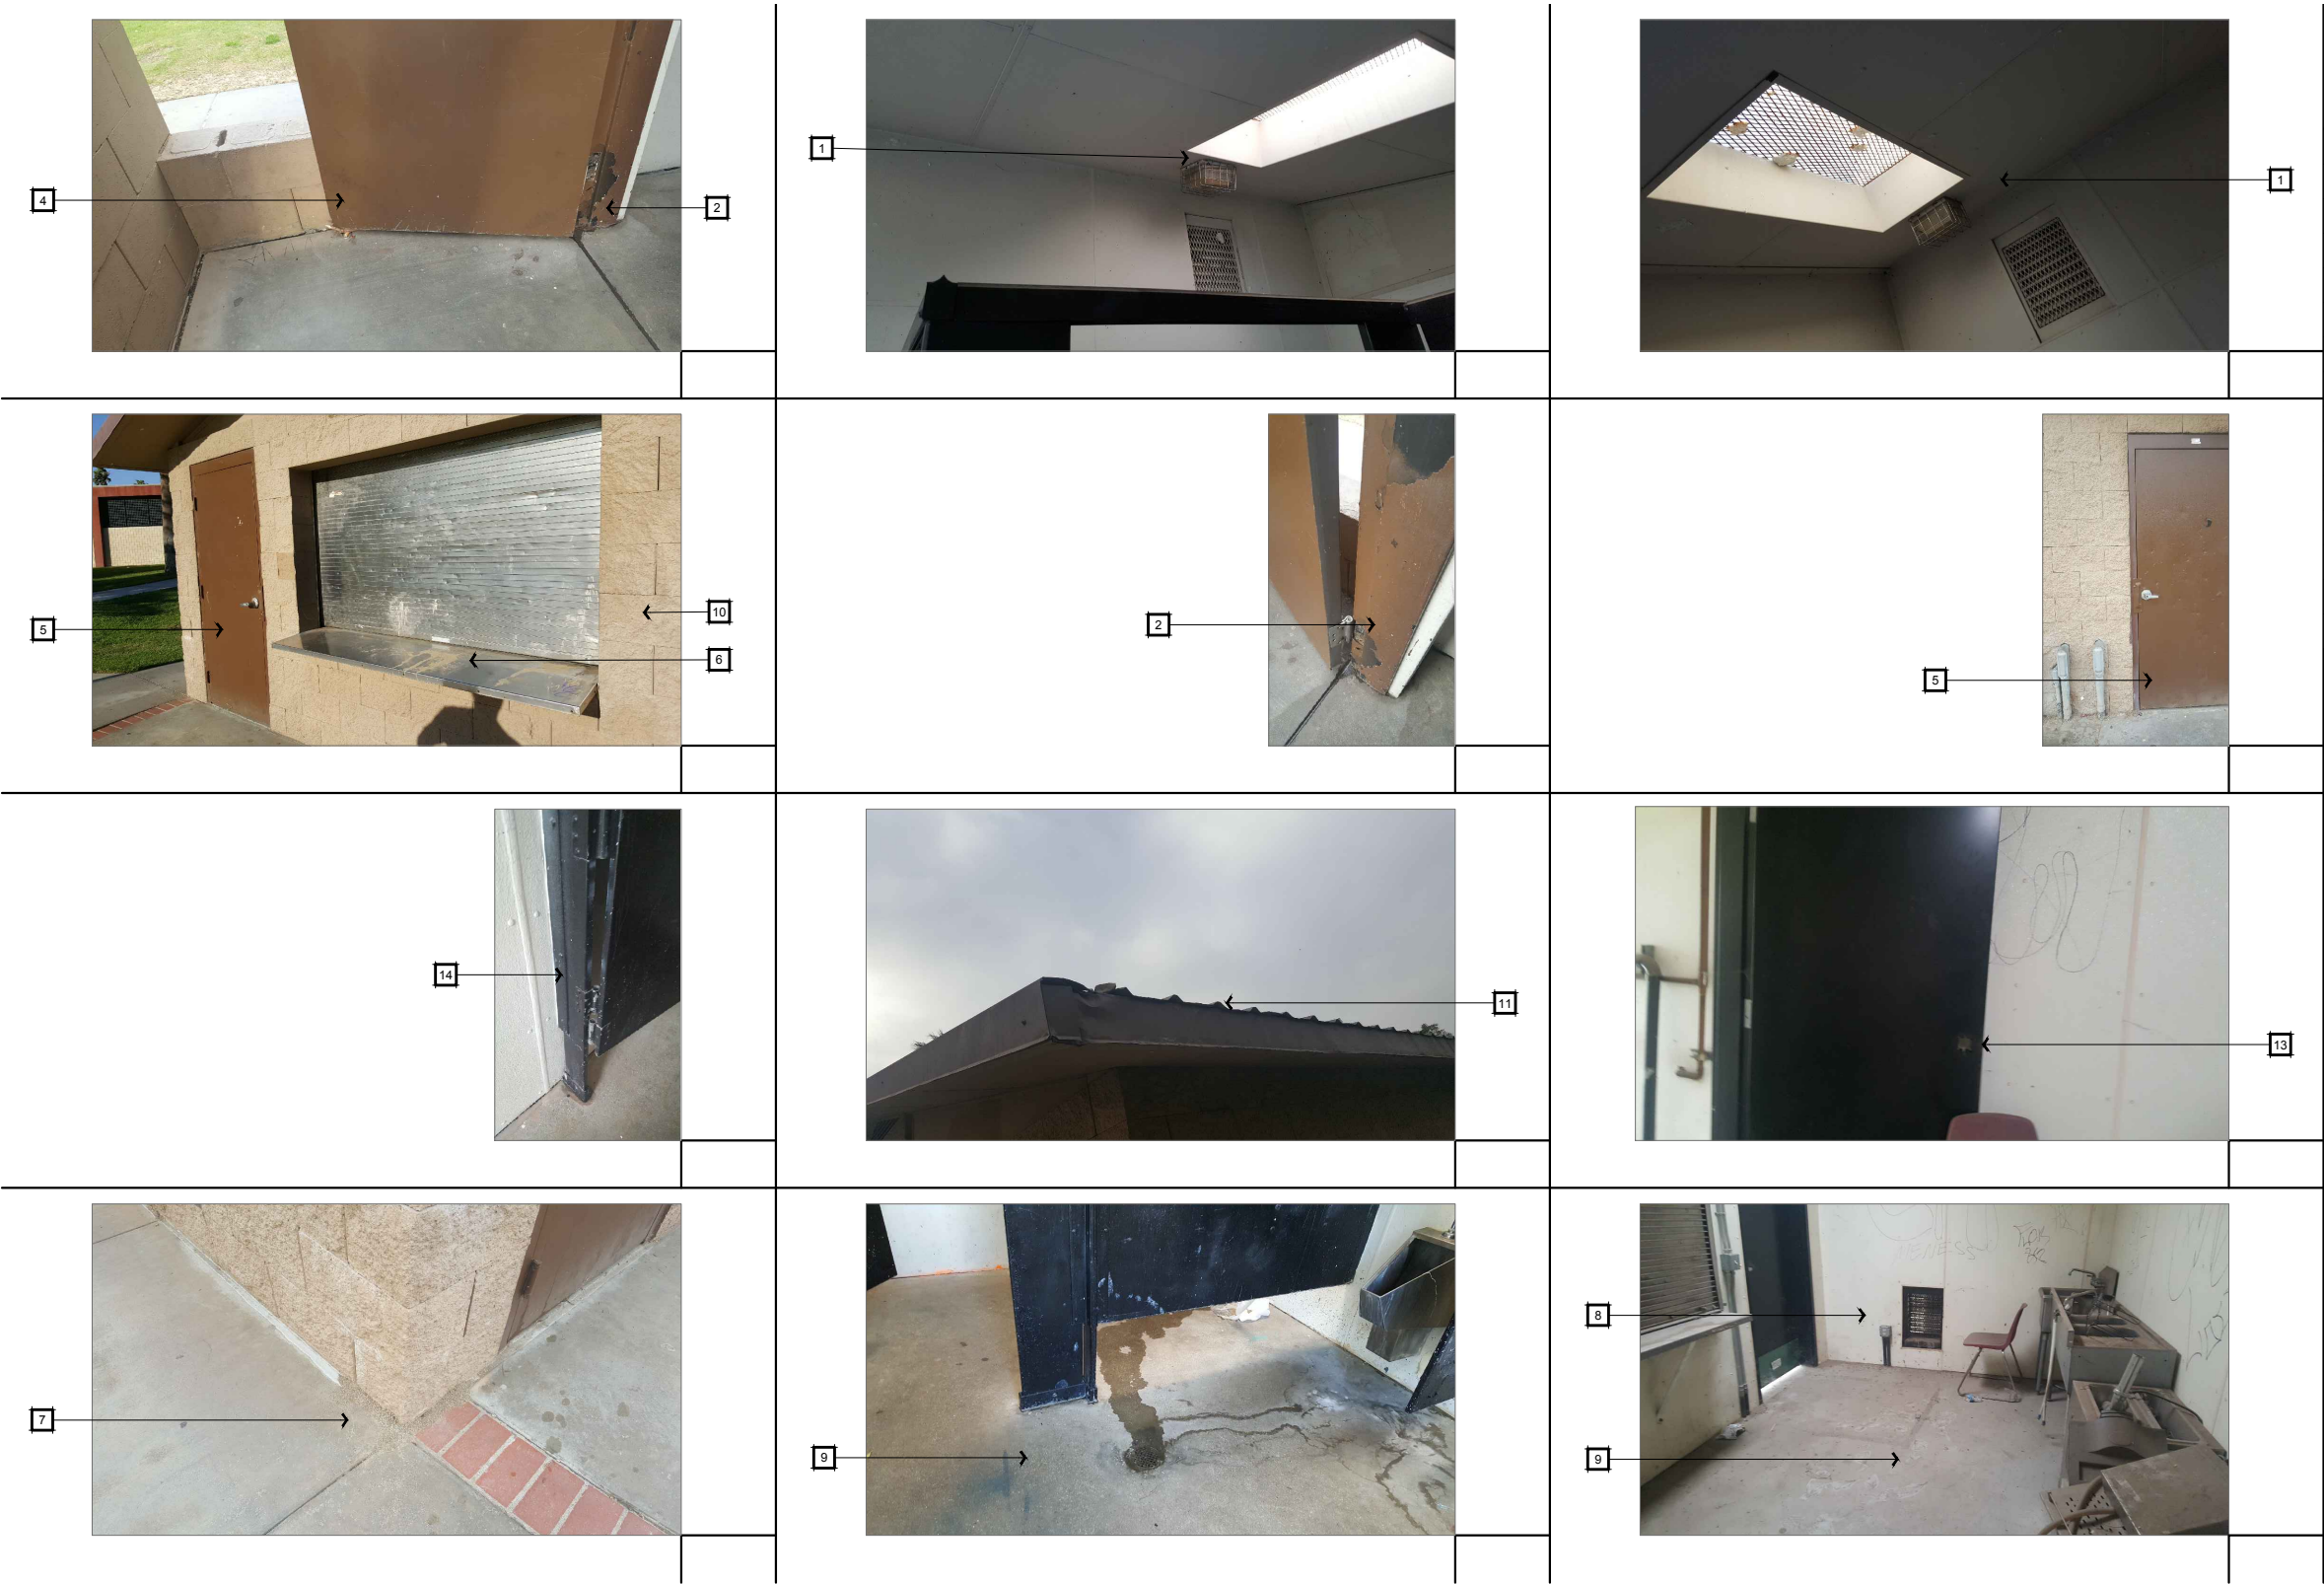
Deficiencies

KEYNOTES	
BUILDING MAINTENANCE DEFICIENCIES	
1	Broken light fixture thru-out
2	Rusted door frame & hinge
3	Broken door stop at both restroom
4	Broken door handles at chase and concession
5	Provide door sweep at all exterior doors
6	Repair accessible counter at snack bar
7	Ant hill thru-out
8	Non-GFCI electric outlets in snack bar
9	Provide new floor finish
10	Repaint entire building
11	Roof oxidation
12	Re-open restroom ventilations
13	Missing door at women's stall
14	Broken hinge at men's restroom
15	Missing door handle at women's accessible stall

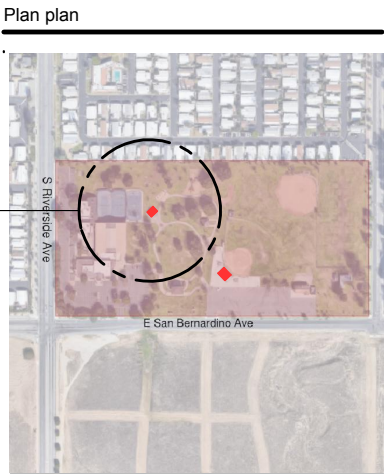
CITY OF RIALTO - Rialto City Park Restroom Building 1

- KEY NOTES
- 1 Demolish existing wall
 - 2 New wall
 - 3 Provide new mirror
 - 4 Demolish existing wall and door
 - 5 Provide coat hook, mount per ADA requirements
 - 6 New ADA compliant door signage
 - 7 Provide sink pipe insulation at lavatory
 - 8 Provide new self -closing door
 - 9 New urinal
 - 10 New soap dispenser
 - 11 New partition, Conforming latch distance at accessible stall

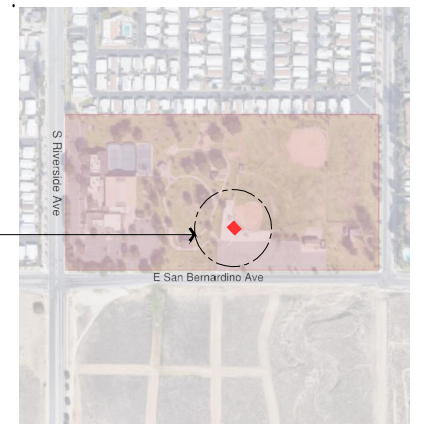
CITY OF RIALTO - Rialto City Park Restroom & Snack Bar Bldg. 2 | Existing Plan

- 1 Accessible signage has no contrast,
- 2 No mirror
- 3 Non-conforming toilet paper dispenser location
- 4 No coat hook
- 5 Non-conforming maneuvering clearance, min. 60" (4'- existing)
- 6 Non-conforming room signage
- 7 Threshold greater than 1"
- 8 Non-conforming latch side clearance, Gas valve obstruction
- 9 insufficient maneuvering clearances
- 10 Non-conforming employee restroom
