Systemic Safety Analysis Report Program

Submitted to:
City of Rialto

December 2019

ALBERT
GROVER &
GA ASSOCIATES

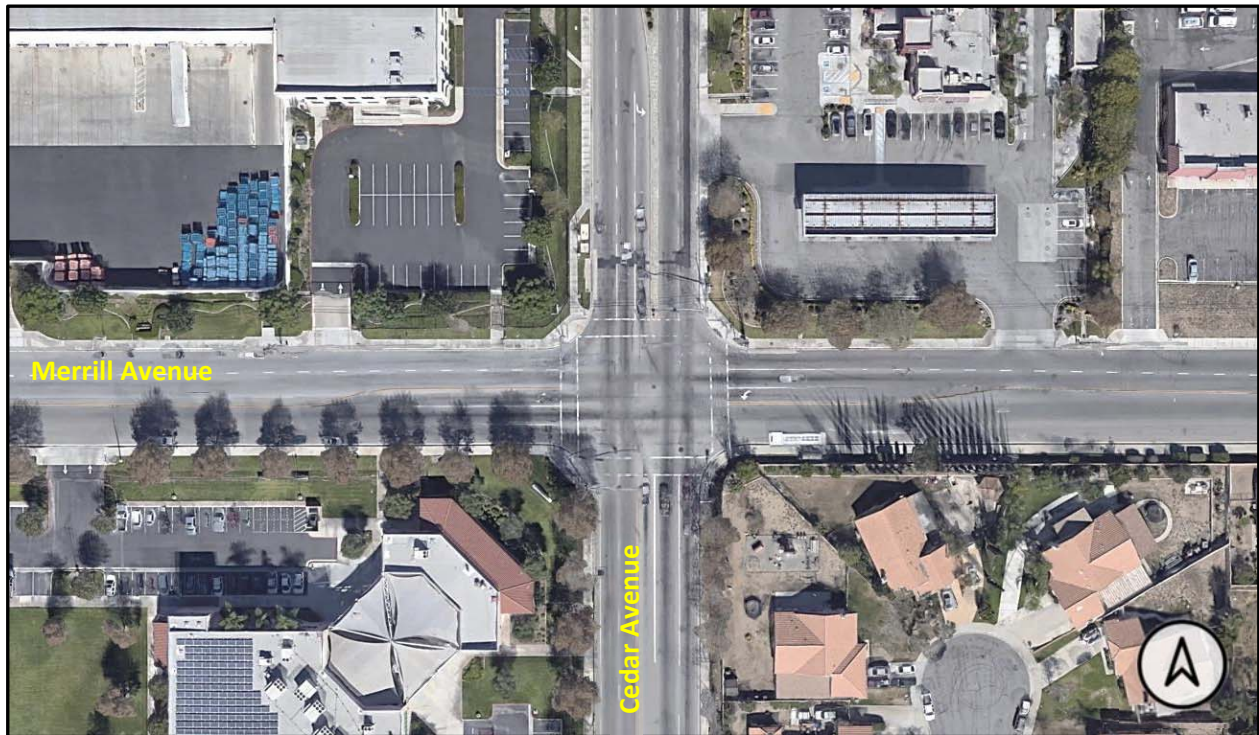
7.1. Cedar Avenue at Merrill Avenue

This intersection is located in the southwest sector of the city, next to several industrial and commercial properties. Per the City of Rialto General Plan, Cedar Avenue is classified as a Major Arterial, while Merrill Avenue is classified as a Secondary Arterial. At this location, both Cedar Avenue and Merrill Avenue are four-lane arterial roadways with posted speed limits of 45 mph and dedicated left-turn pockets at the intersection. A gated commercial building sits on the northwest corner, a Chevron gas station on the northeast corner, a walled-off residential neighborhood on the southeast corner, and a church—Calvary Chapel Rialto—on the southwest corner.

The intersection is controlled by a traffic signal, with left-turn arrows provided for the northbound and southbound approaches on Cedar Avenue. The northbound and southbound left-turn arrows currently operate on protected lead/lag phasing, where one direction receives the left-turn green arrow concurrent with the beginning of the through phase and the other direction receives a left-turn green arrow at the end of the through phase. Pedestrian crossings are provided across all approaches.

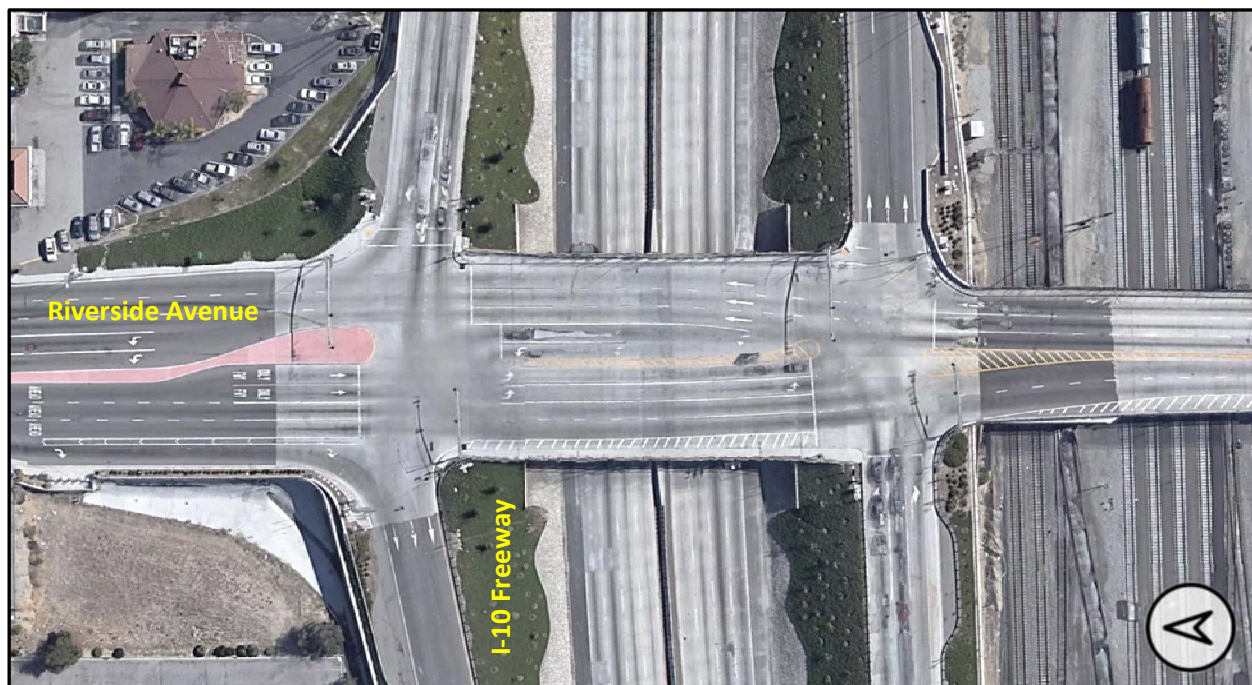
7.4. Riverside Avenue at Interstate 10 Freeway Interchange (State owned and operated)

Due to the geographical tagging of the collision history database used in this study, incidents recorded along Riverside Avenue at the Interstate 1- (I-10) freeway interchange were inconclusive as to be distinguished between the eastbound or westbound ramp signal. Therefore, the two traffic signals were treated as one study location. The similar geometries and traffic signal operations—as well as their close proximity—provide for a comprehensive assessment of the interchange as a whole.

This study location is in the southern part of the city, connecting the City of Rialto to the Interstate 10 (I-10) freeway, a regional thoroughfare. At this location, Riverside Avenue is a six-lane arterial roadway classified as a Modified Major Arterial II under the City's General Plan. Dual dedicated left-turn pockets are provided on Riverside Avenue for traffic entering the freeway.

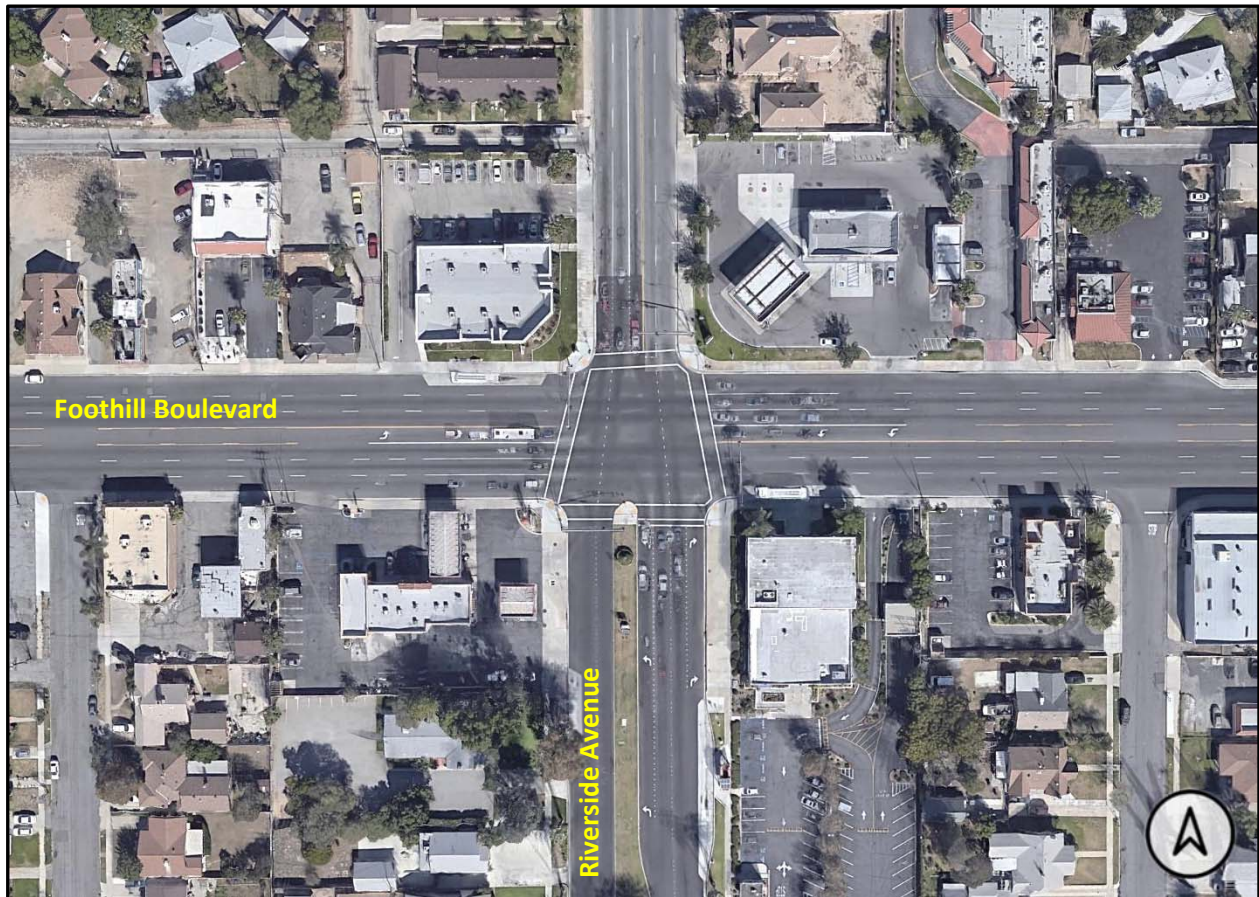
7.8. Riverside Avenue at Foothill Boulevard

This intersection, which serves as the northern “gateway” to the Downtown Rialto area, is located in the heart of the city and surrounded by a mix of commercial properties and residential lots. Per the City of Rialto General Plan, Foothill Boulevard is classified as a Modified Major Arterial I, while at this location Riverside Avenue is classified as a Major Arterial north of the intersection and a Modified Major Arterial II south of it. At this location, Foothill Boulevard is a six-lane arterial roadway with a 40 mph posted speed limit and a two-way left-turn median lane, while Riverside Avenue is a four-lane arterial roadway with a raised, landscaped center median south of the intersection. All four approaches have dedicated left-turn pockets, with a dedicated right-turn pocket also provided for the northbound approach. A commercial building sits on the northwest corner, a Chase bank on the southeast corner, and gas stations on the northeast and southwest corners.

The intersection is controlled by a traffic signal, with left-turn arrows provided for all approaches. Pedestrian crossings are provided across all four approaches.

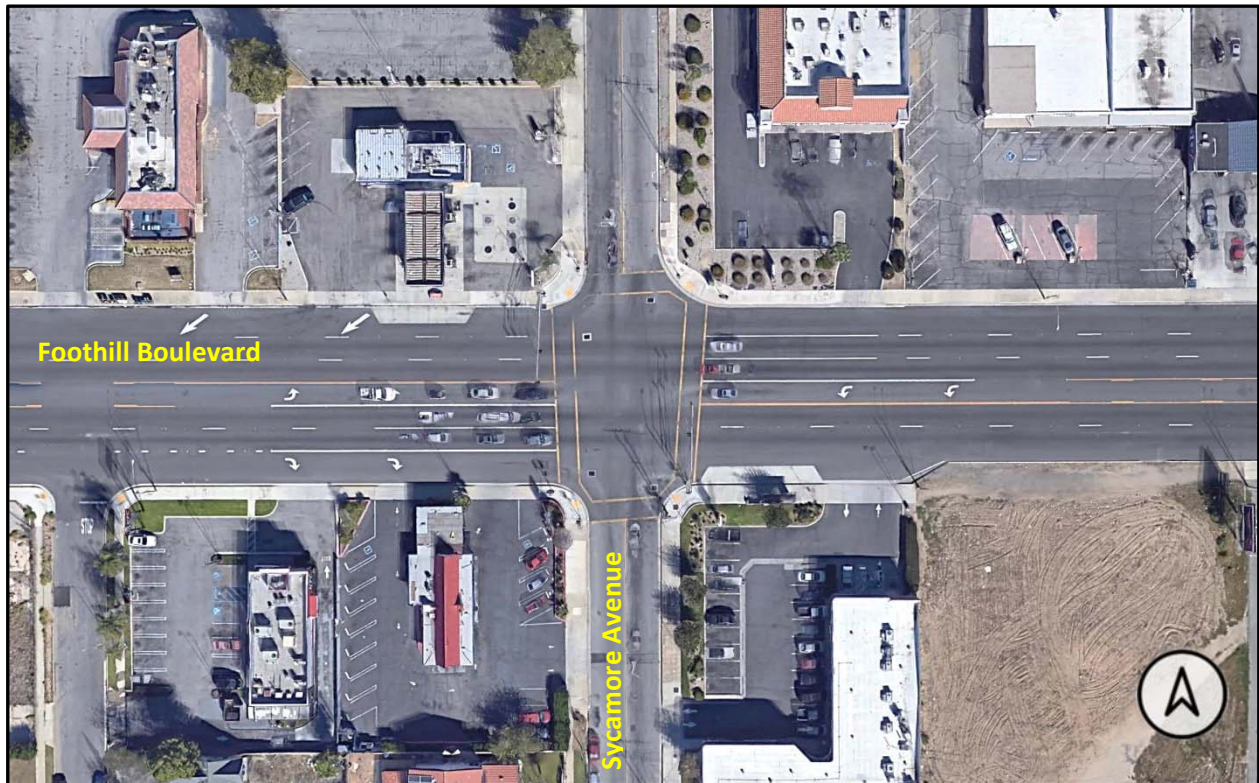
7.9. Foothill Boulevard at Sycamore Avenue

This intersection is located on the eastern edge of the city, surrounded by commercial properties. Per the City of Rialto General Plan, Foothill Boulevard is classified as a Modified Major Arterial I, while Sycamore Avenue is classified as a Collector Street. At this location, Pepper Avenue is a four-lane arterial roadway included in the City's truck route network with a 45 mph posted speed limit. West of Pepper Avenue, Foothill Boulevard is a six-lane arterial roadway with a 40 mph posted speed limit. East of Pepper Avenue, Foothill Boulevard is a four-lane arterial roadway under Caltrans' jurisdiction with a 50 mph posted speed limit. All four approaches have two-way left-turn median lanes which open up to provide dedicated left-turn pockets at the intersection. The County of San Bernardino Department of Health Services sits on the northwest corner, a Church's Chicken with drive-through on the northeast corner, a Southern California Edison facility on the southeast corner, and a commercial center on the southwest corner.

The intersection is controlled by a traffic signal, with left-turn arrows provided for the eastbound and westbound approaches on Foothill Boulevard. Near-side signal indications are provided on all approaches, which provide advance information to improve motorist awareness. Pedestrian crossings are provided across all approaches.

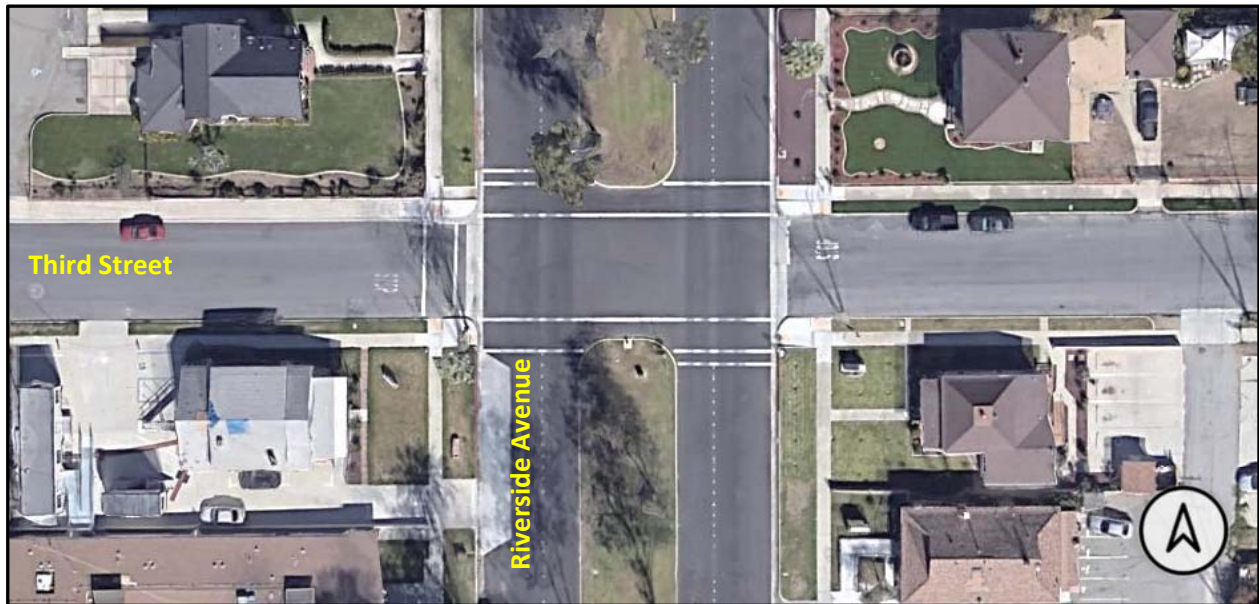
7.11. Riverside Avenue at Third Street (Downtown Rialto)

This intersection is located in the heart of the city, within the historic Downtown Rialto district, surrounded by a mix of commercial and residential properties. At this location, Riverside Avenue is a four-lane arterial roadway classified as a Modified Major Arterial II with a raised, landscaped center median and a mph posted speed limit. In contrast, Third Street is a two-lane local street with a 50 mph posted speed limit.

The intersection is unsignalized, with two-way stop-controls for the eastbound and westbound approaches on Third Street. Pedestrian crossings are provided across all approaches.
