## STRUCTURAL ASSESSMENT FOR 335 W. RIALTO AVE

RE: Structural Report for Public Works Building Fire Damage Restoration Project,  
335 West Rialto Avenue

## **GEOPHYSICAL EVALUATION** **CITY OF RIALTO PUBLIC WORKS REBAR SCANNING (GPR)**

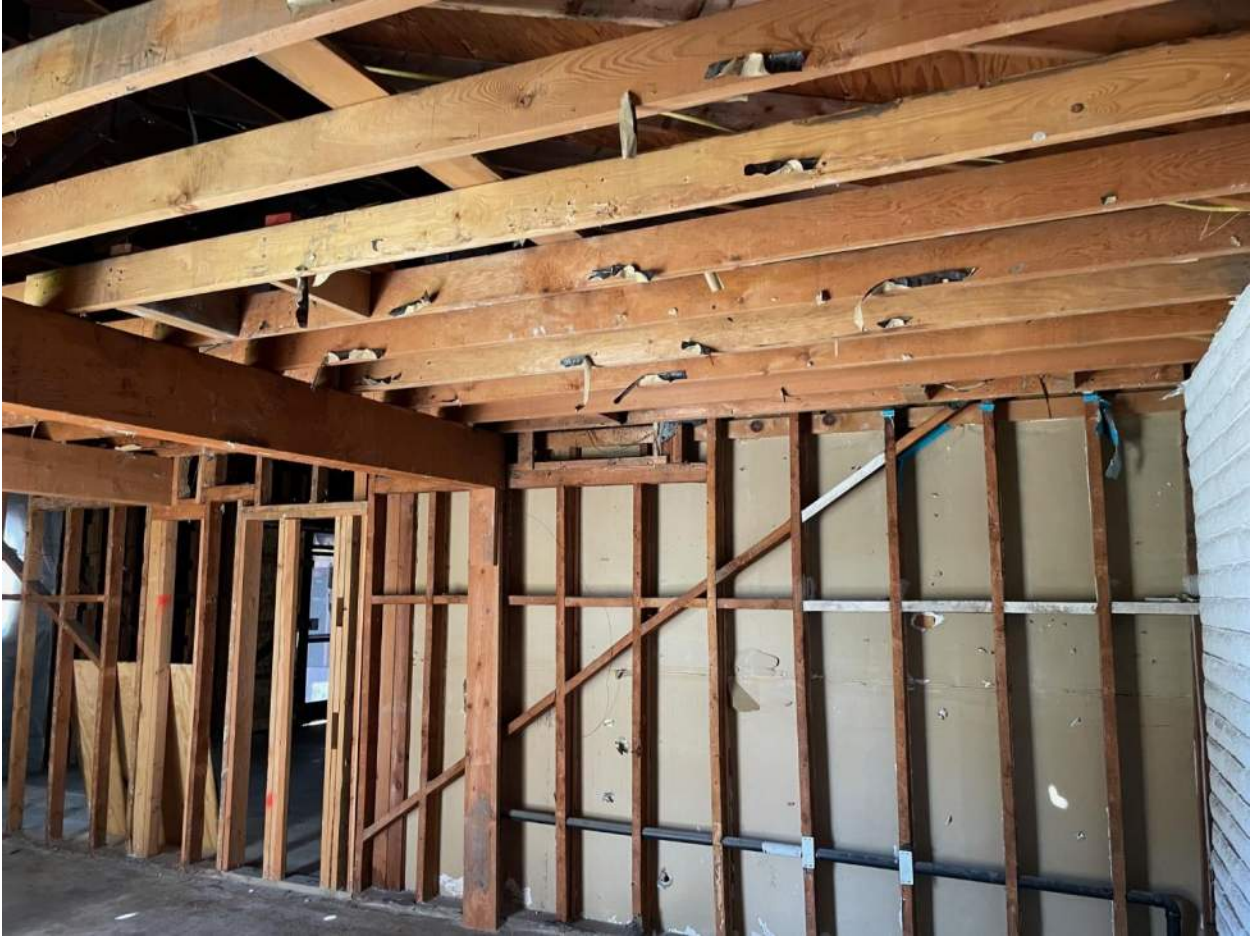
PICTURE 28

Line F-F The southerly part of the demising/shear wall is a hodgepodge of framing with limited consistency of the stud framing. This continues for the wall above the ceiling to the roof. The northerly section of the wall has all been cut for plumbing. The support for the roof support beams is nonexistent. The whole wall will need reframing or at least some type of supplement. Photos 24 to 26 and Photos 29 and 29.

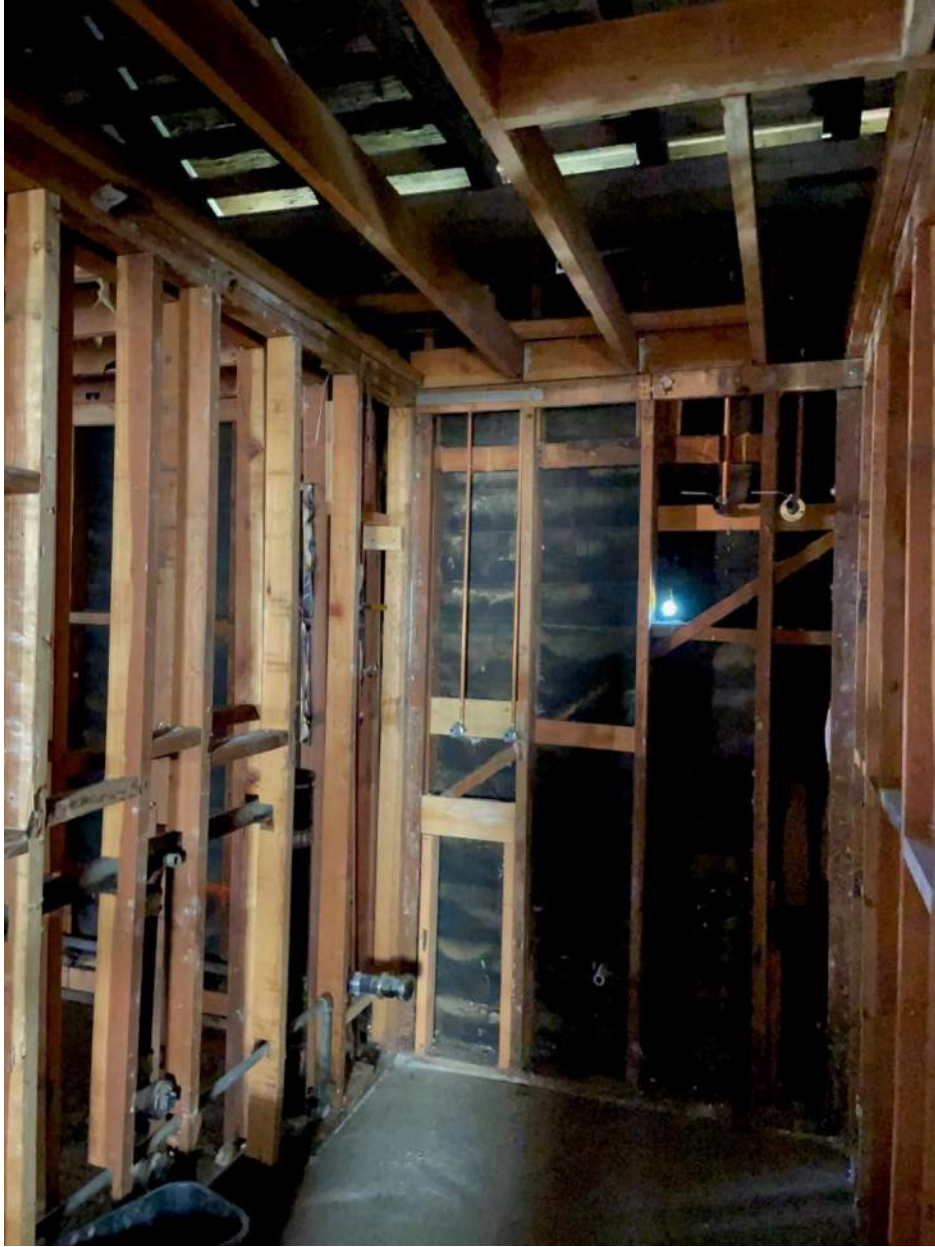
PICTURE 34

- Line 1-1 E to F      The walls sit on the slab and studs continue full height, there are a few locations where there is what may have been headers interrupting the continuity. For almost the entire wall section the bottom of the stud are cut up to about 2 1/2" leaving almost nothing for load support. The wall will need to be at least supplemented or potentially fully replaced. Photos 34 to 40.

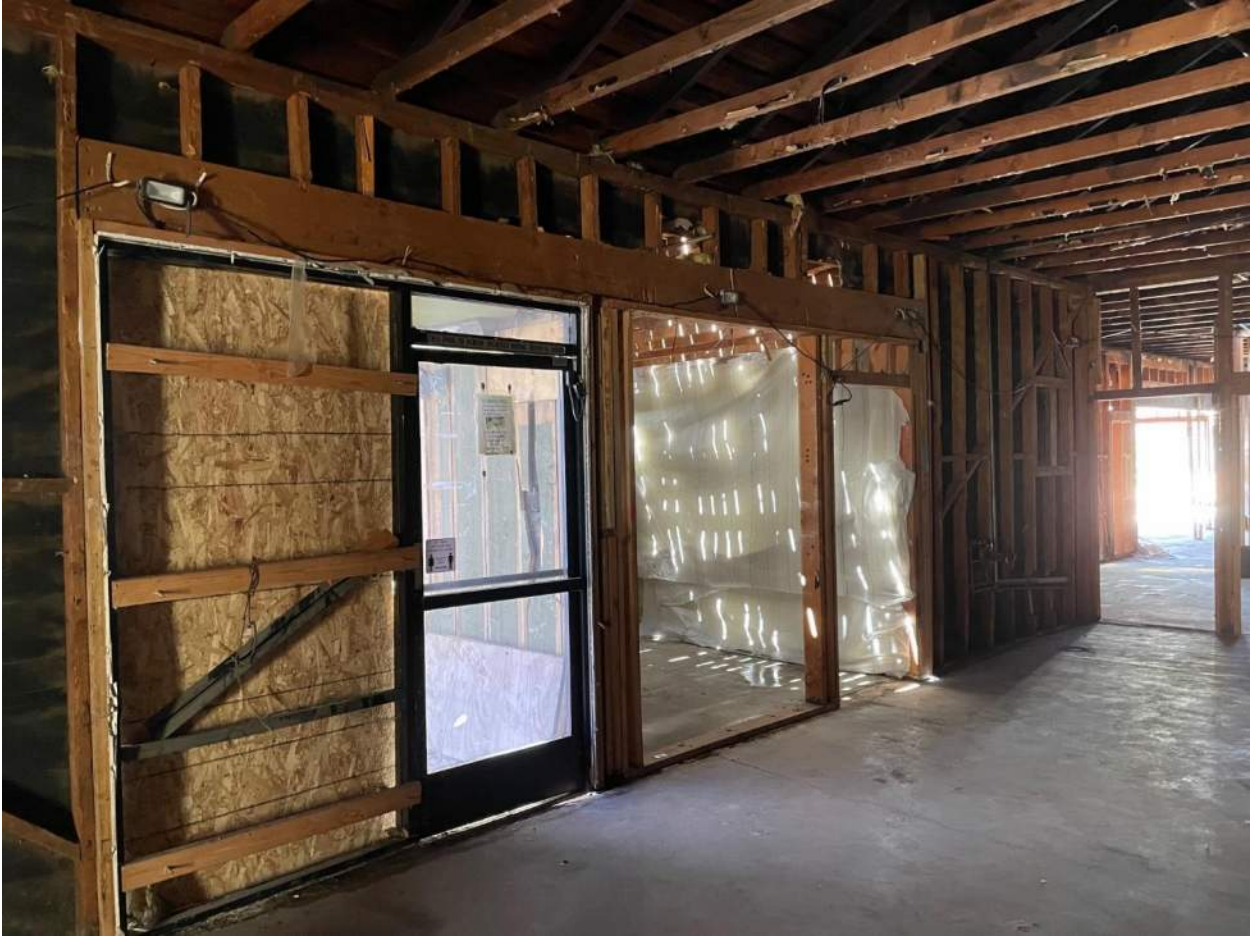
PICTURE 48

- Line 2-2 E to F      The wall is at truss height in good condition with a long header over openings in about the middle. The westerly end is all compromised by the plumbing installation. It would need to be supplemented or replaced. Photos 47 to 49.

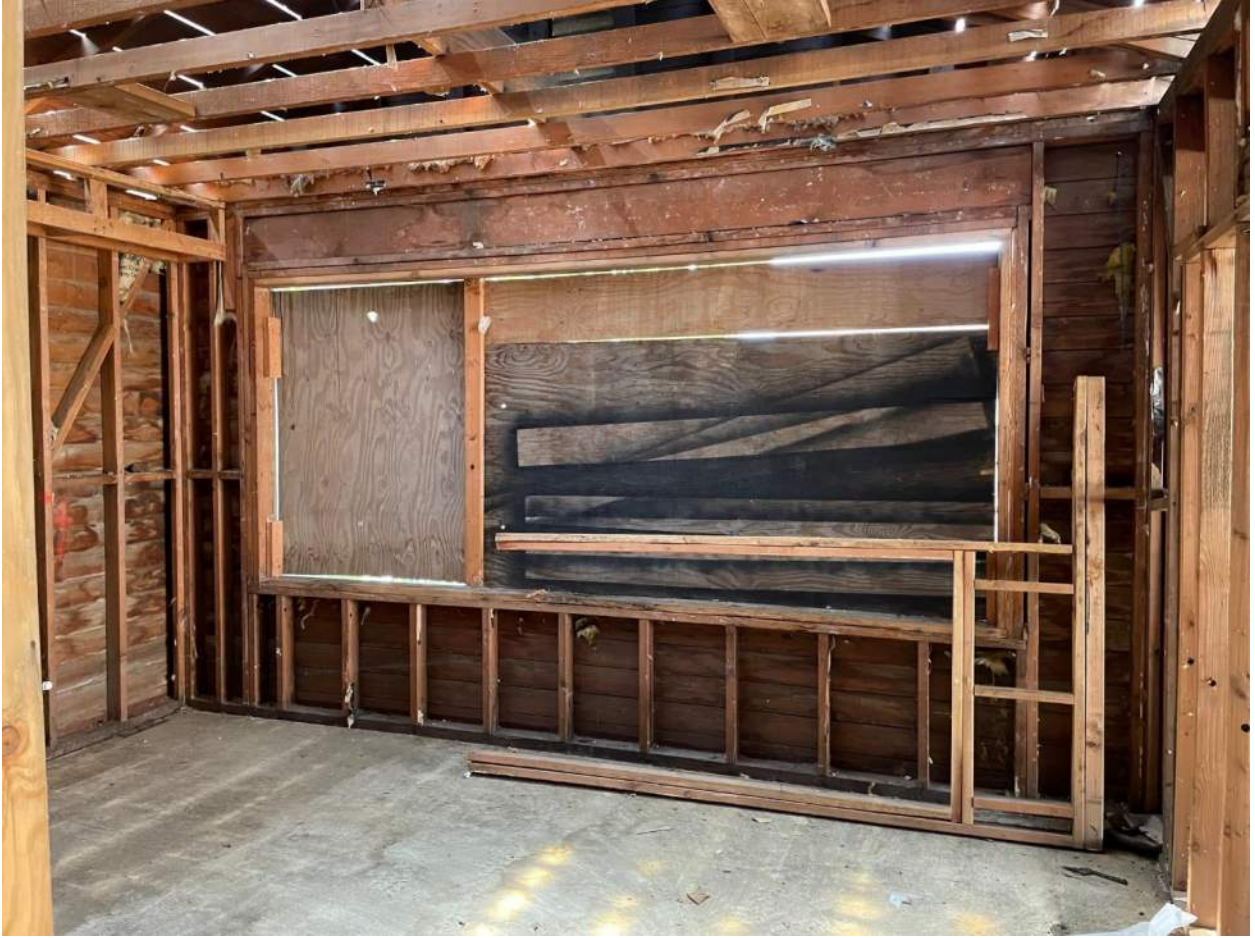
PICTURE 54

- Line 4-4 C to D      This wall is already removed since the building is being widened for consistent truss installation.
- Line 4-4 D to E      Wall plate height is 8' and the walls all have large openings which will be reframed for the new openings. These walls will have to be brought up to meet truss height. Photos 54 to 56.
- Line 4-4 B to C      The wall is infilled in the post and beam framing. The studs do not go to full height because they are broken by a double plate about 18" from the top. These will have to be checked to see if the double plates are sufficient for the lateral loads on the wall. Photos 66 to 68.

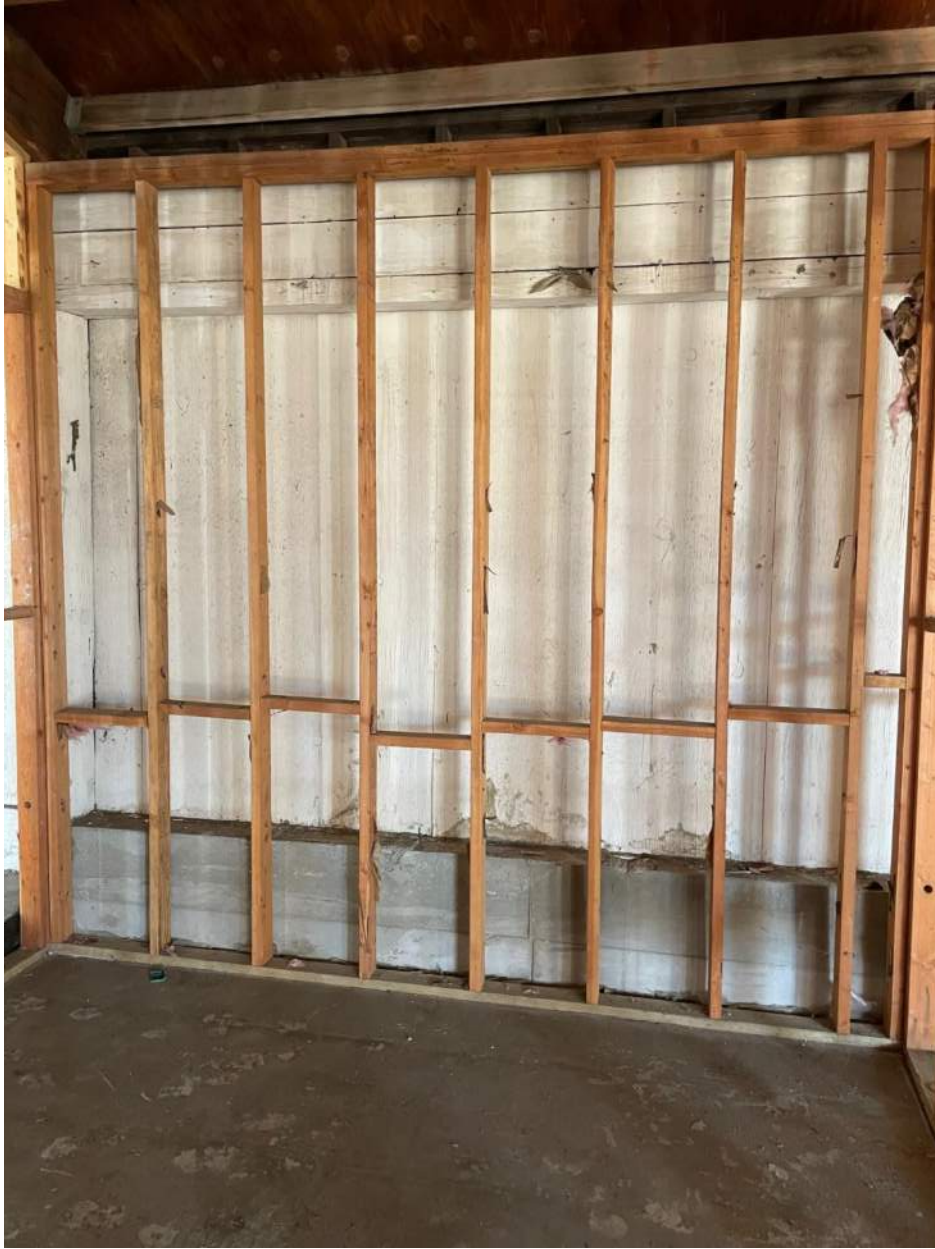
PICTURE 58

the proper attachment needs to be determined. Photos 57 to 63.

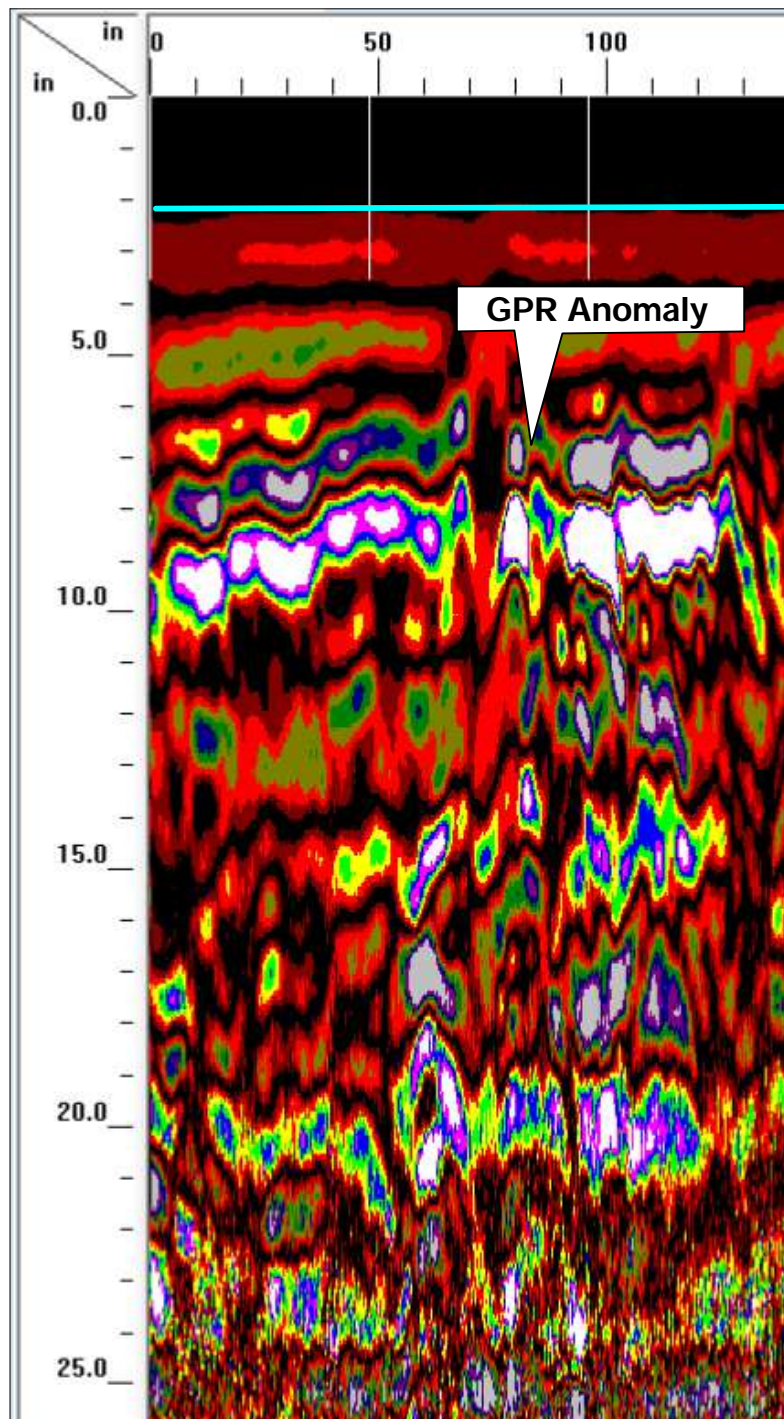
**Box 3**  
Profile 6 (N to S)

An additional unknown structure is visible in boxes 3 and 4 (Figure 3d), appearing as a linear, east-west trending continuous pipe approximately 10 inches in diameter, oriented parallel to the building footprint. This structure is located below the bottom of the concrete slab, with a layer of soil in between, and may correspond to an unidentified pipe or utility line. From field evaluations, there is no evidence that this is part of the slab or foundation.

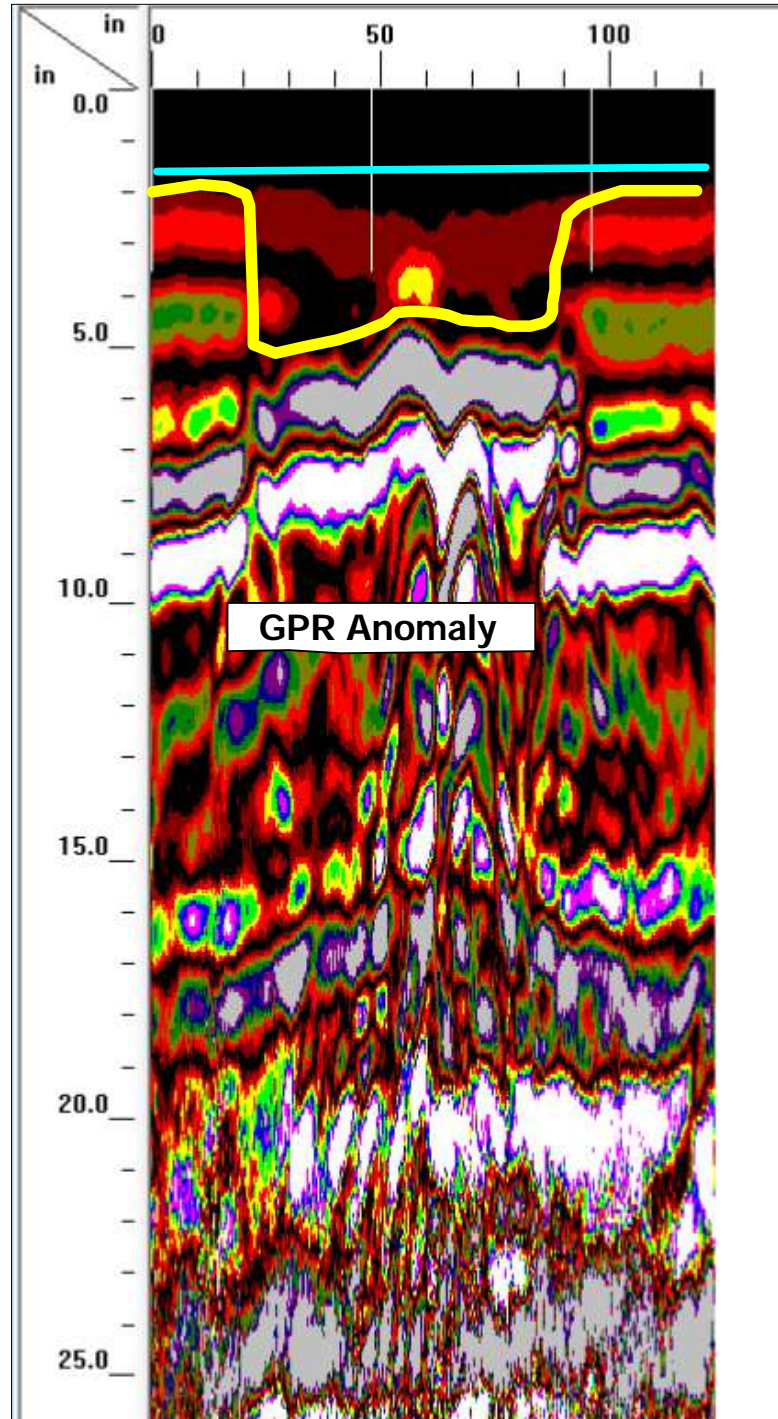
**Box 4**  
Profile 7 (W to E)

Parabolic anomalies, observed in profile 4 (box 1) and profile 6 (box 4), may correspond to buried cobbles or pebbles, consistent with materials visually identified in excavated soil piles adjacent to the scan areas. One notable layered structure is observed in profiles 15 and 16 from box 4 (Figure 4g), dipping towards the footprint of the building and increases with depth from the west to the east. This structure is not observed in Box 3 and may be an isolated structure, likely associated with remnant concrete or a clay-rich layer within the soil. Unlike the interior profiles, no well-defined, layered anomalous structures were identified in the exterior scan areas that would typically be indicative of concrete footings or subsurface structural elements.
