2018 SL-RAT Acoustic Inspection Case Study

Rialto Wastewater Collection System

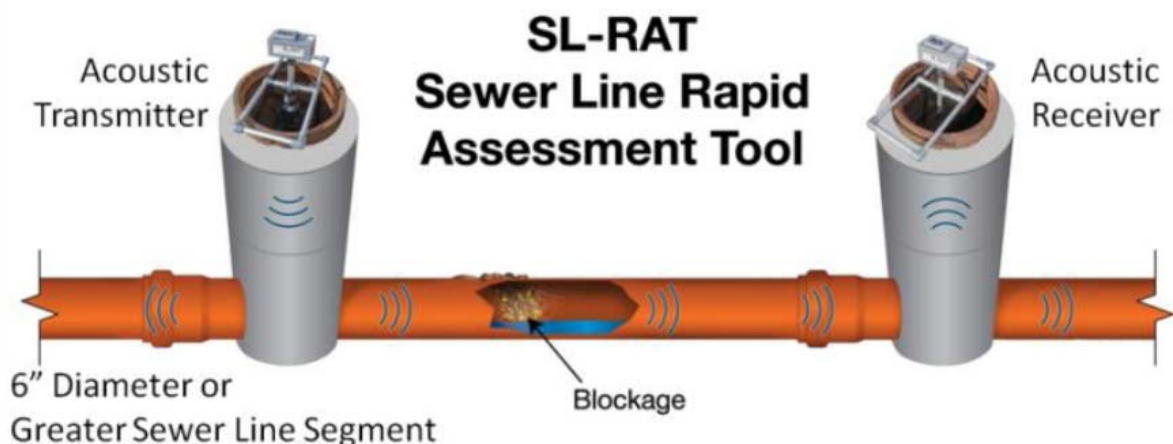
Figure 2. SL-RAT Operating Methodology

The SL-RAT combines two components – a transmitter and a receiver. An operator places the transmitter in an open manhole and sends a loud sequence of tones through the airspace above the flow within the pipe. The receiver is placed in an adjacent manhole and listens for degradation in tones it hears. The resulting data is analyzed in real-time on the device using a sophisticated pattern matching algorithm. The technology exploits the fact that sound and water flow similarly through the free space within a pipe. Hence, if a known sound signal transmitted through a pipe segment is degraded, the SL-RAT analyzes the result in less than three minutes and provides a simple assessment of blockage within the pipe on a scale of 0 to 10. A score of 0 indicates a significant pipe anomaly that should be prioritized and investigated quickly. A score of 10 indicates the pipe sounds as clean as a known clear reference pipe. The scores are grouped into categories of "Red Light" for 0 to 4, "Yellow Light" for 5 to 6, or "Green Light" for 7 to 10. The inspection requires no prior preparation of the pipe other than opening the cover sufficiently to insert the speaker and microphone elements just below the plane of the manhole. The tool works in almost all gravity-fed pipe and manhole geometries, as well as with all types of pipe material.
