PROPERTY CONDITION ASSESSMENT

CITRUS GROVE OF RIALTO
1432 Willow Avenue,
Rialto, California 92376

September 01, 2023

Project No. COR-120

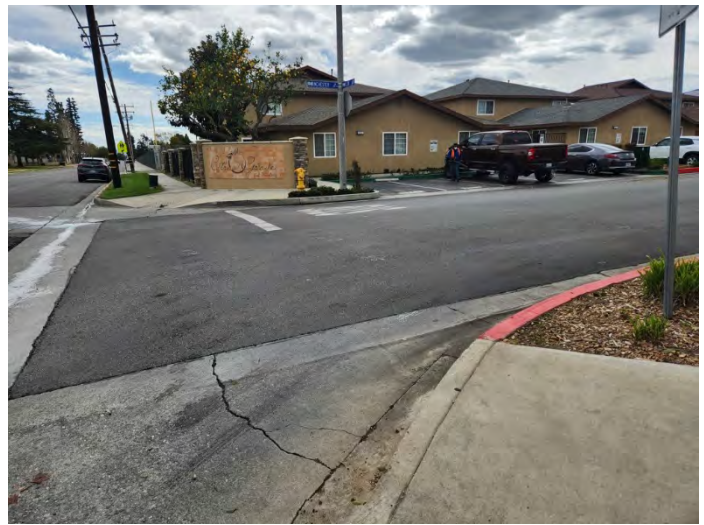
1. The property monument sign at the corner of Willow Street and Winchester Drive.

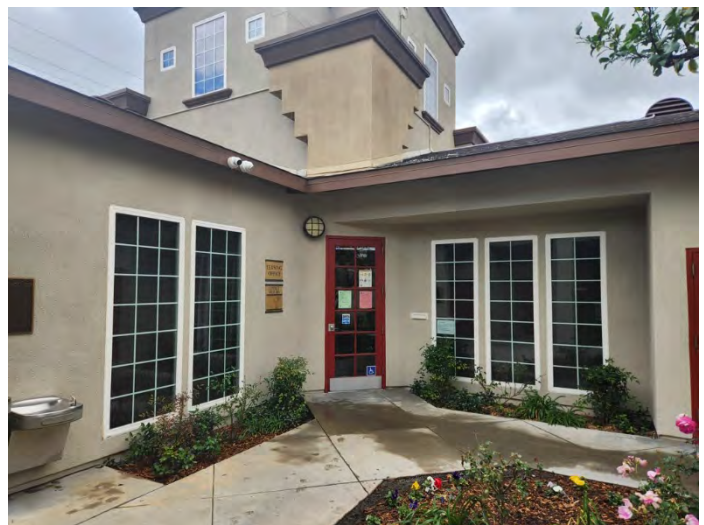
2. The entrance court that leads to the leasing office.

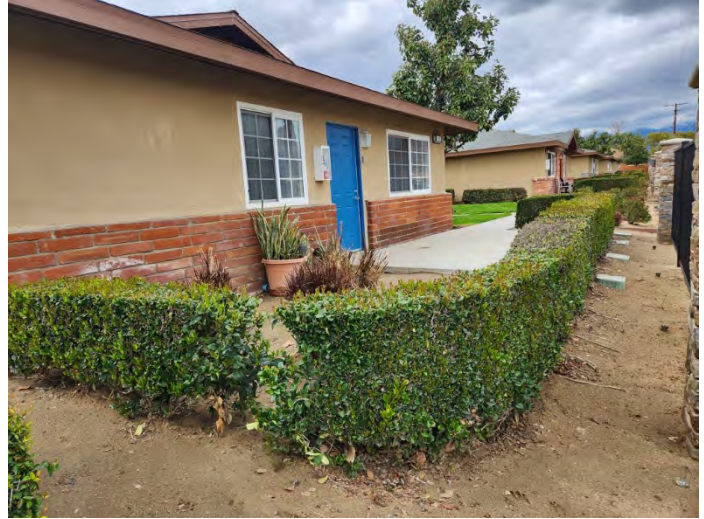
3. The Willow Street frontage of Building 1452W.

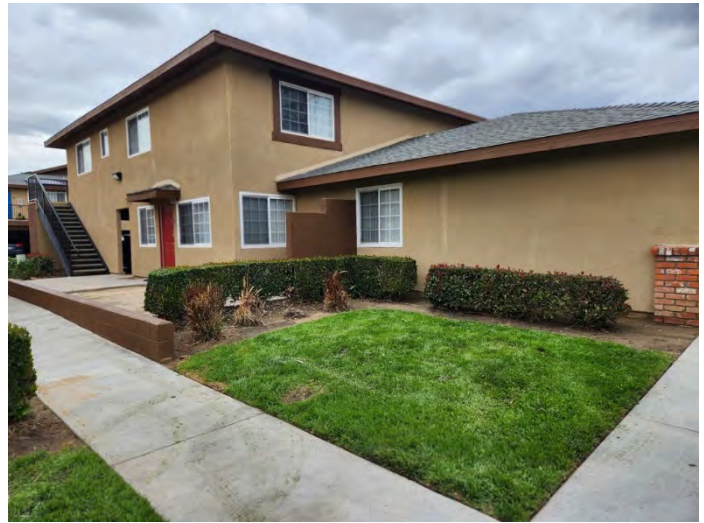
4. Building 1462W and the landscaping in front.

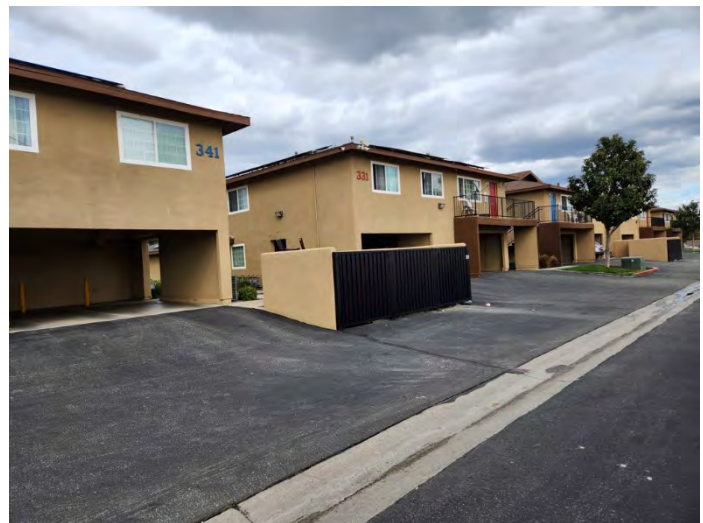
11. Buildings 1341W and 1331W and the trash enclosures in front.

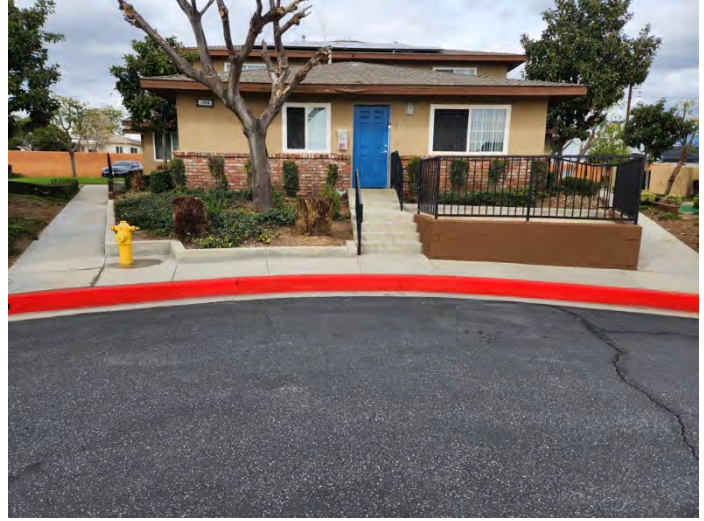
12. The steps on front of Apartment 1-1486M.

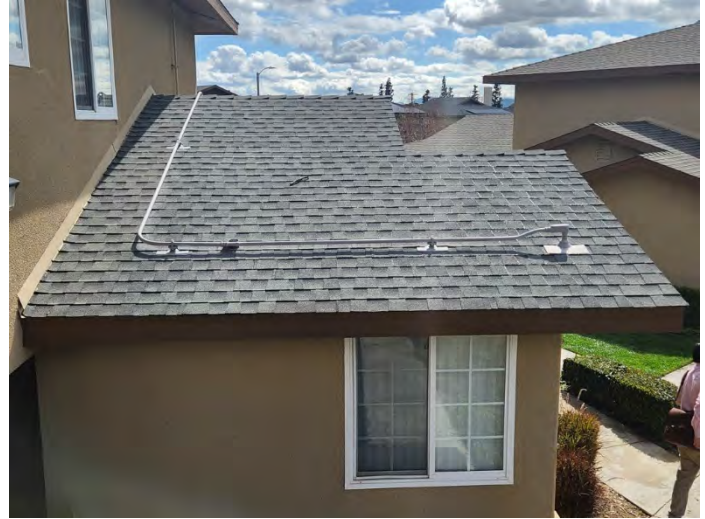
15. The lower roof over Building 1482C.

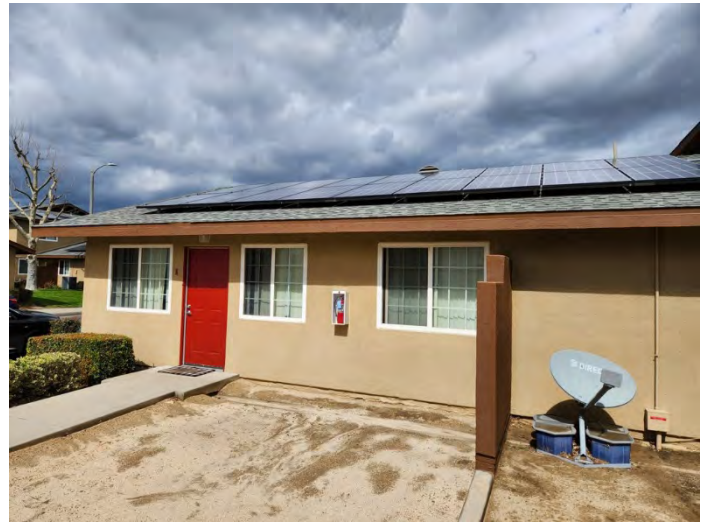
16. The solar panels and a dome attic vent on the roof over Building 1441M.

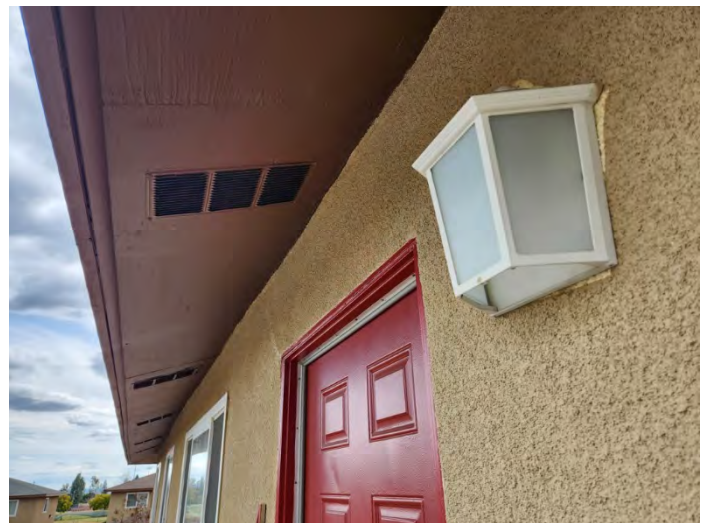
17. A typical wall-mounted light fixture and the eaves soffit in Building 1431C. Eaves soffit vents are provided.

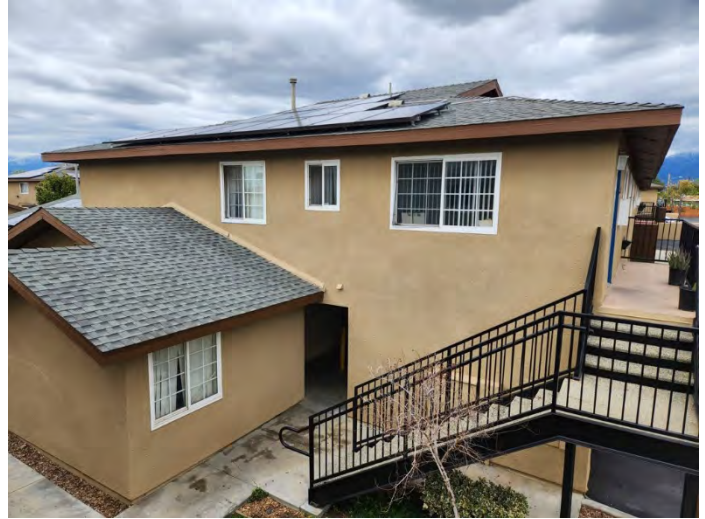
18. The roof and solar panels on Building 1441C.

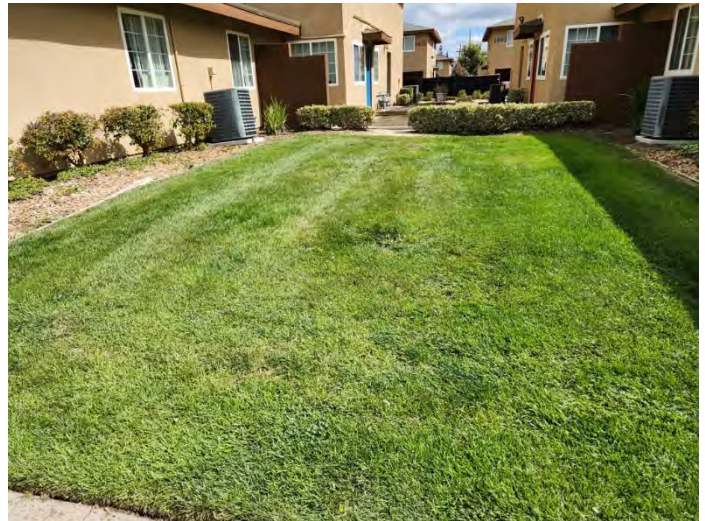
19. A typical landscaped area between Buildings 1451M and 1441M.

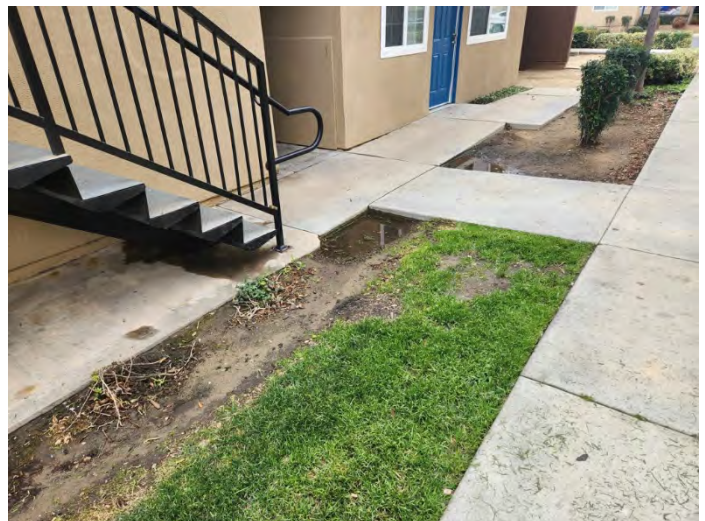
20. Ponding in the landscaped area in front of Building 1431M.

Stormwater Drainage: The open areas should be re-graded, and catch basins and storm lines should be replaced with adequately sized components to improve storm drainage. See Item 3.7.

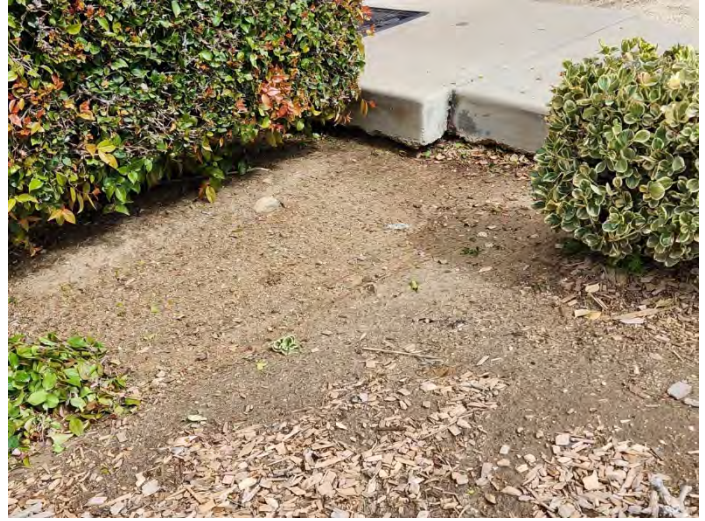
21. Erosion below the entrance patio slab at Apartment 1-1461M.

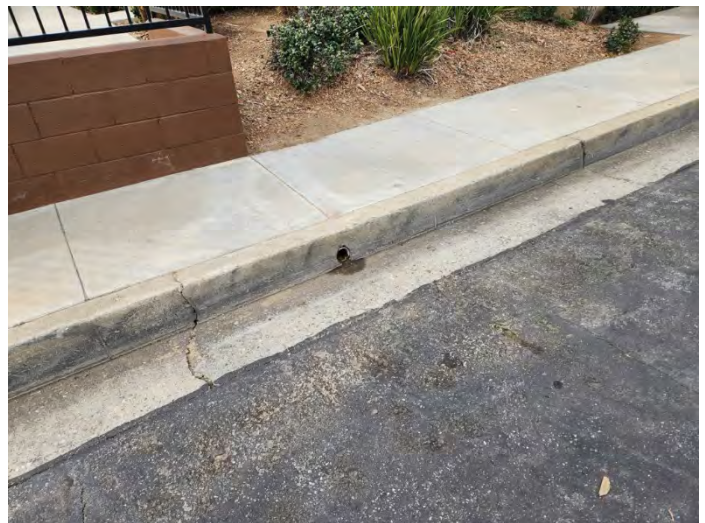
23. A typical curb outlet for the stormwater from the landscaped area between Buildings 1452M and 1462M.

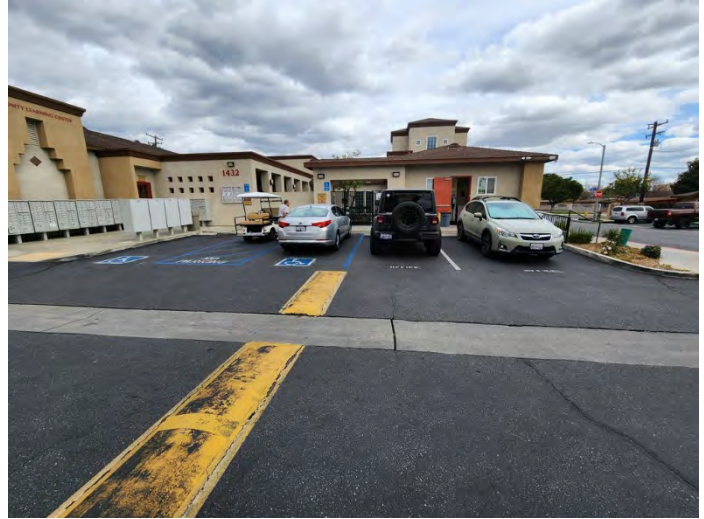
24. The parking spaces in front of the leasing office. There is 1 van-accessible and 1 regular accessible parking spaces.

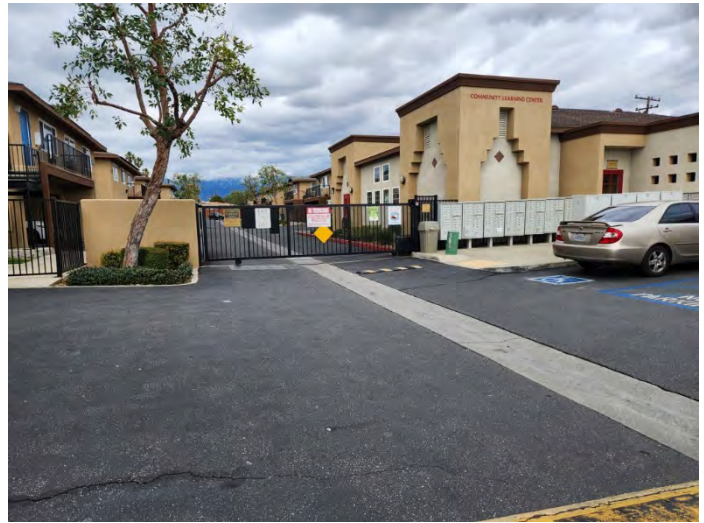
25. The entrance to the property at the alley That extends north from Winchester Drive (adjacent to the leasing center on the right).

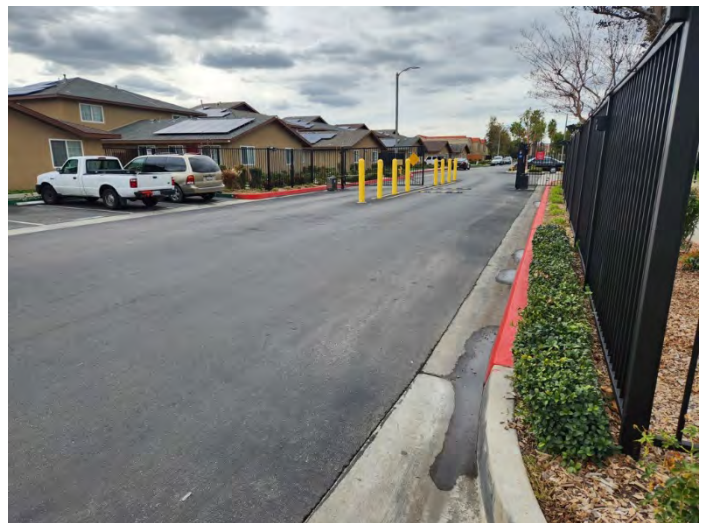
26. The entrance to the property at the corner of Willow Avenue and Winchester Drive.

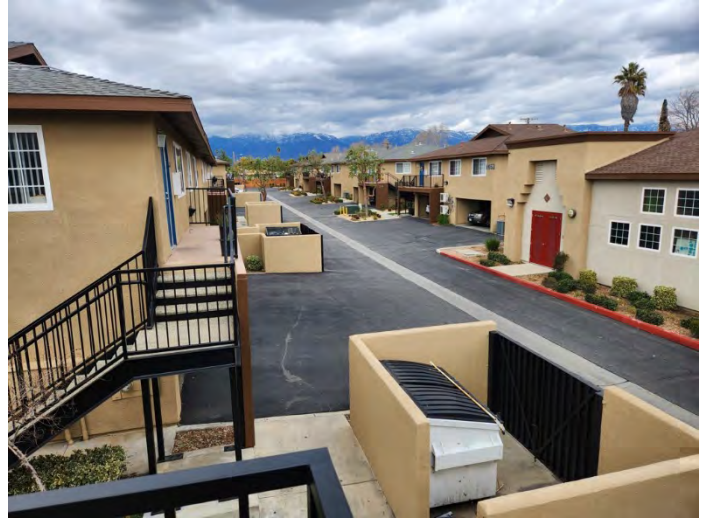
27. Looking north in the alley that extends from the leasing office area north. In the foreground is a typical trash enclosure.

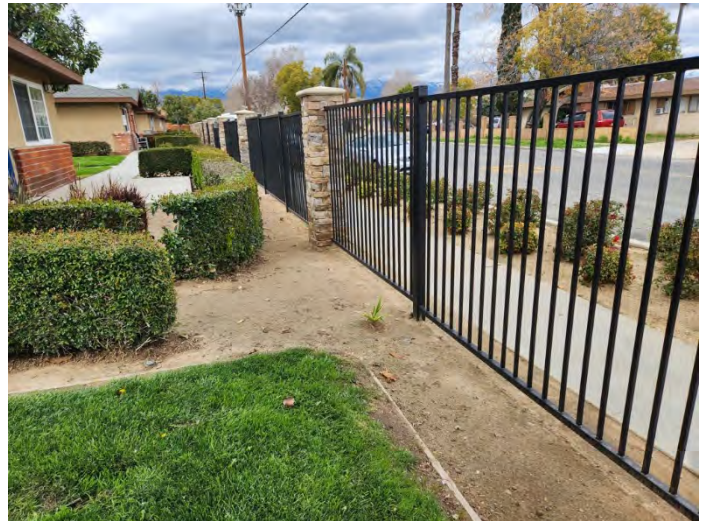
28. The metal picket and stone pier fence that extends along the Willow Street property line.

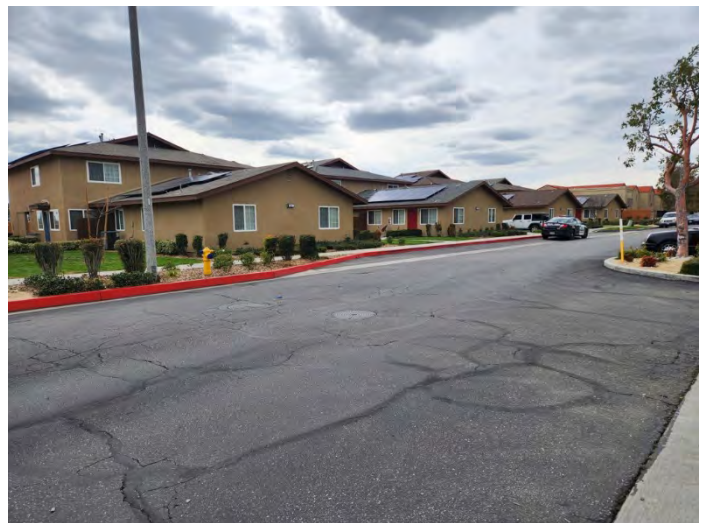
32. A general view of the properties along the fire lane taken from the corner of Winchester Drive and Clifford Street.

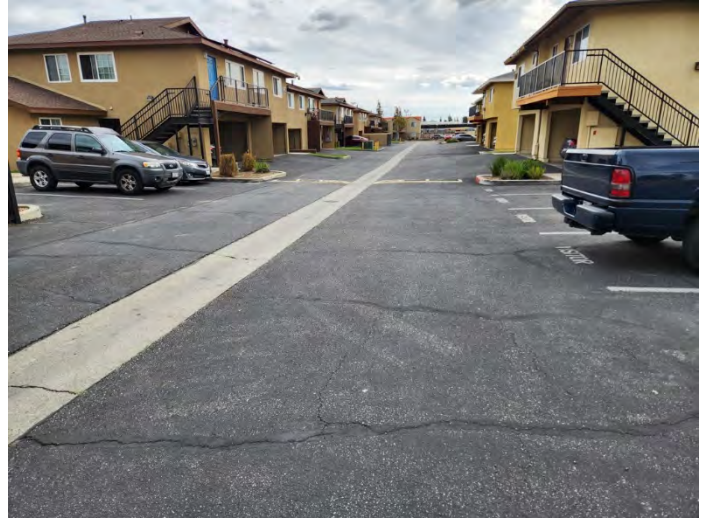
36. Looking south at the alley between the Citrus Grove of Rialto property on the left and the Vista Cascade property on the right.

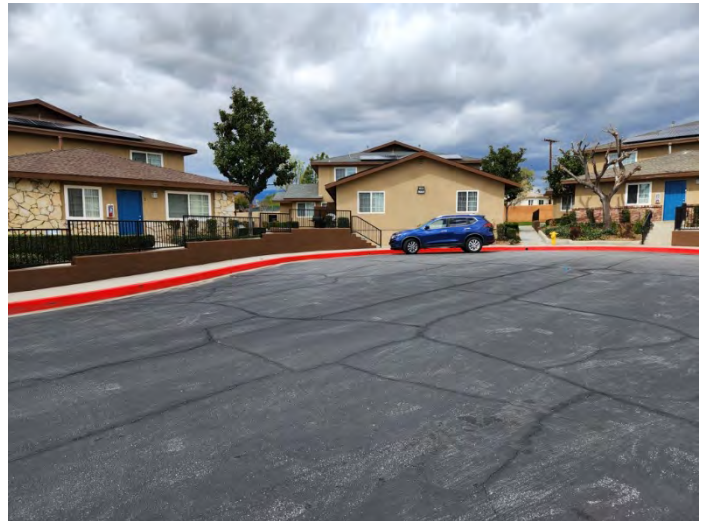
37. The cul de sac at the north end of Millard Street. To the left is Building 1472M which has a decorative stone veneer accent wall. To the right is Building 1486M which has brick veneer accent wall below sill level.

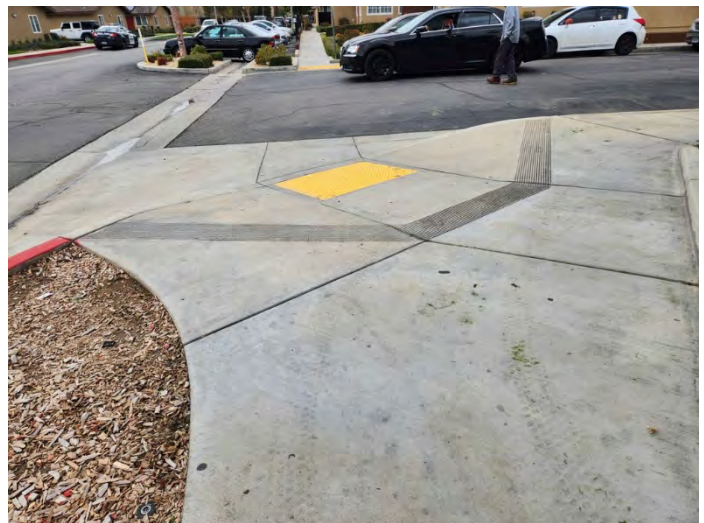
38. The curb ramp and detectable warning surface at the corner of Clifford Street and Winchester Drive.

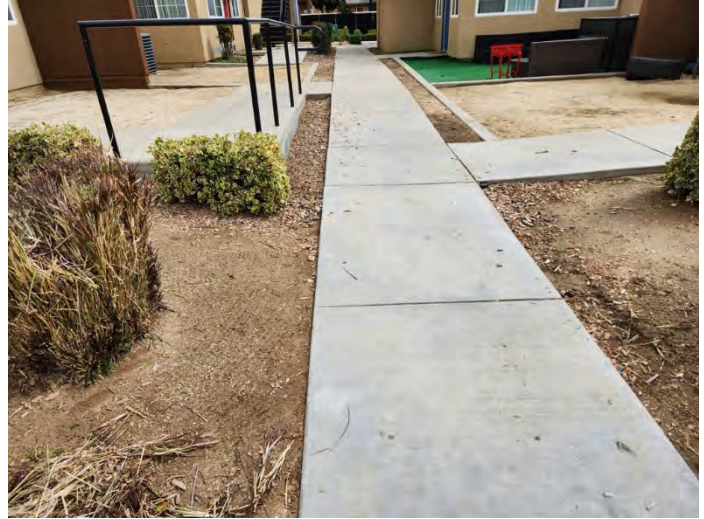
39. The concrete walkway and an accessible ramp between Buildings 1461M and 1451M.

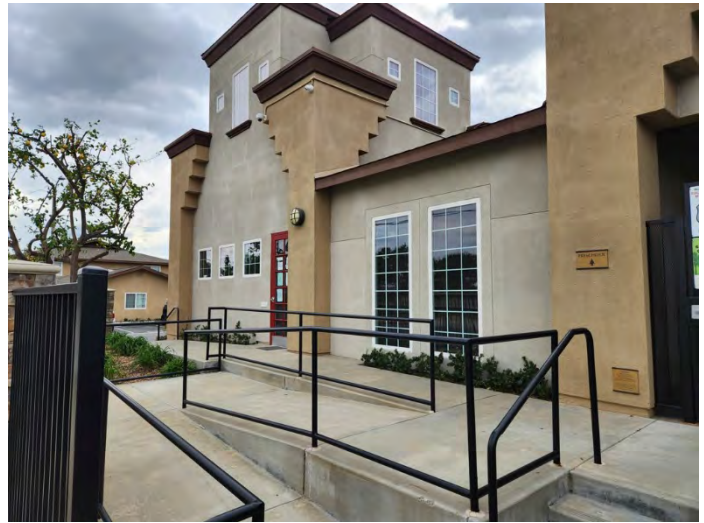
40. The concrete steps and accessible ramp that extends to the leasing office entrance on Willow Street.

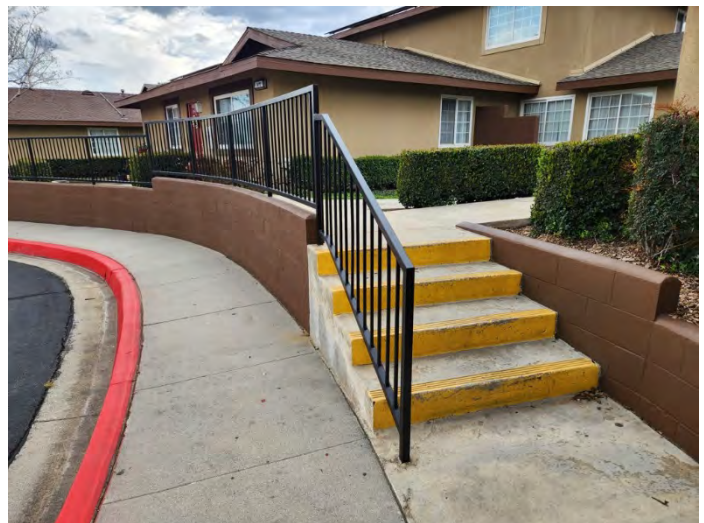
41. The concrete steps at the end of the accessible ramp in front of Building 1472C.

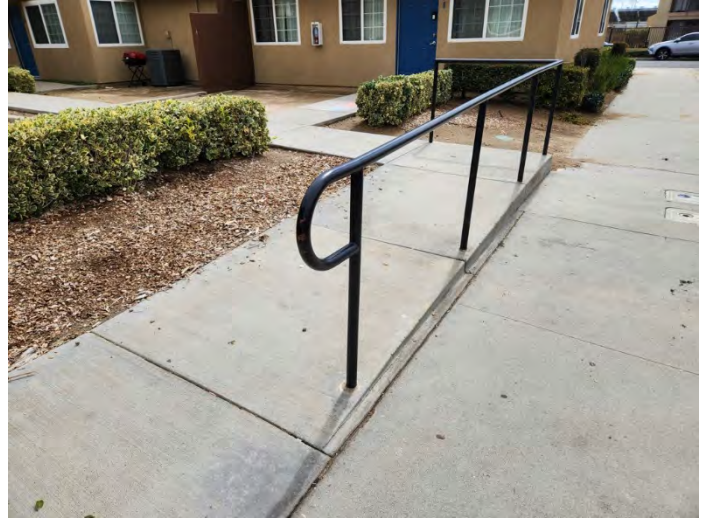
42. The accessible ramp between Buildings 1441M and 1431M on Millard Street.

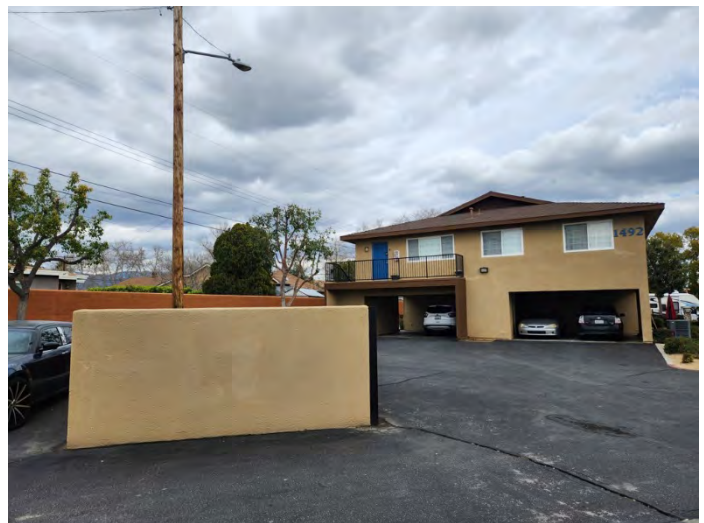
44. Building 1492W and, on the left, a typical pole-mounted light fixture in the parking area.

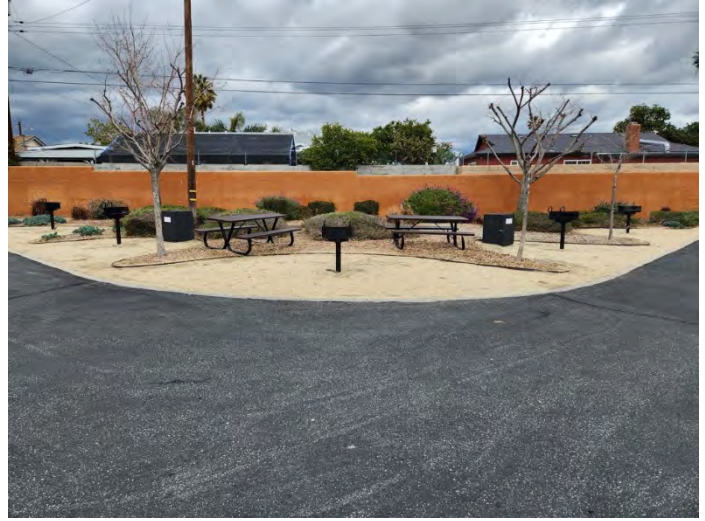
45. The barbeque area on the north portion of the site.

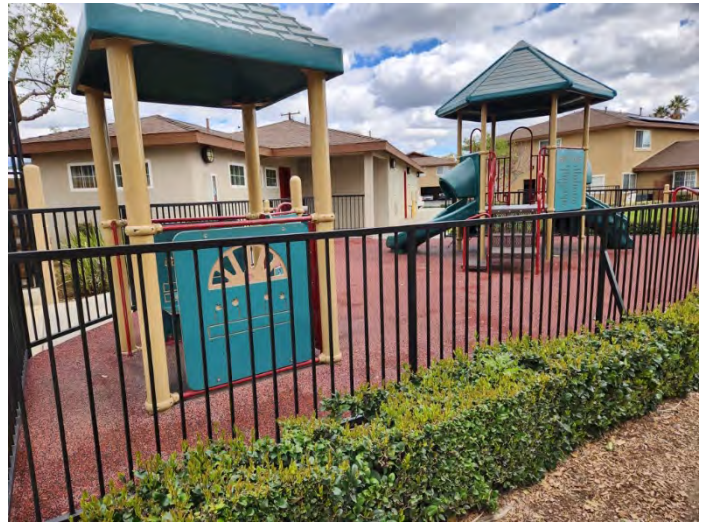
46. The play area on the north portion of the site near Building 1482C.

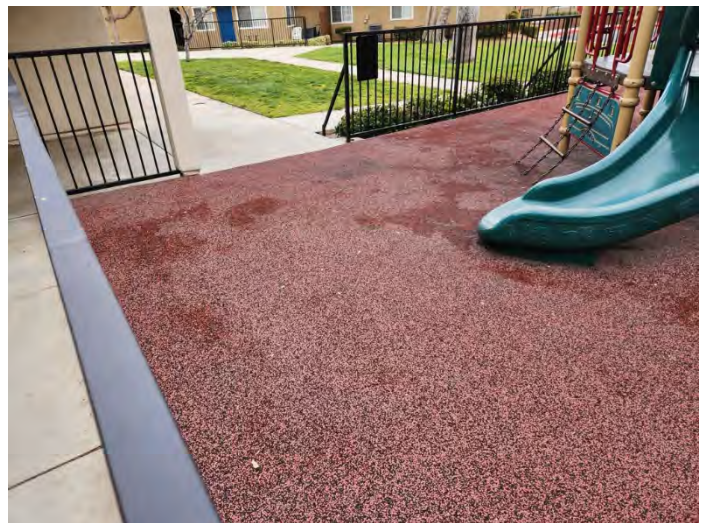
47. The entrance to the play area.

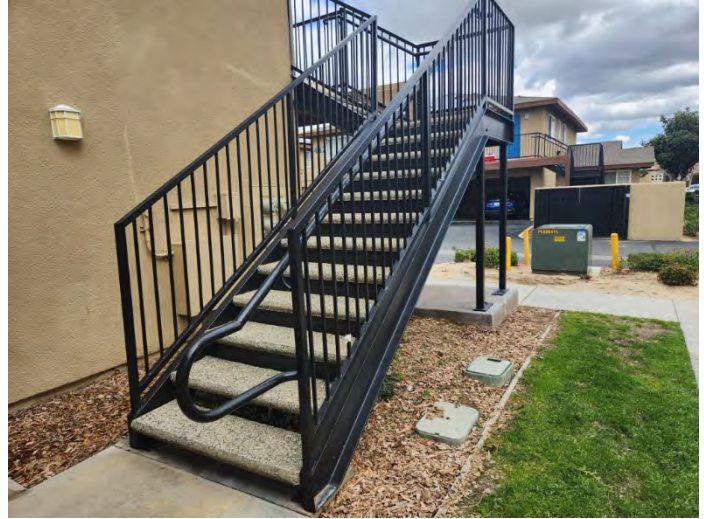
48. The steel stair that serves Building 1441M. This stair has precast concrete treads.

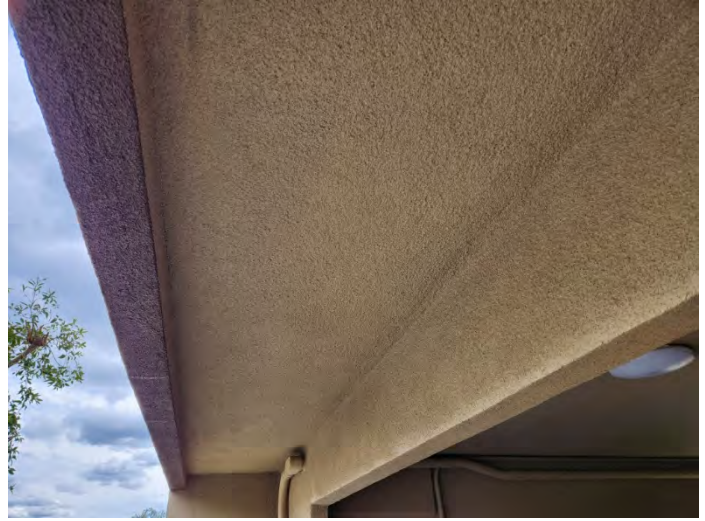
51. The soffit below the second floor landing/porch at Building 1461C. Generally, the soffits are not vented.

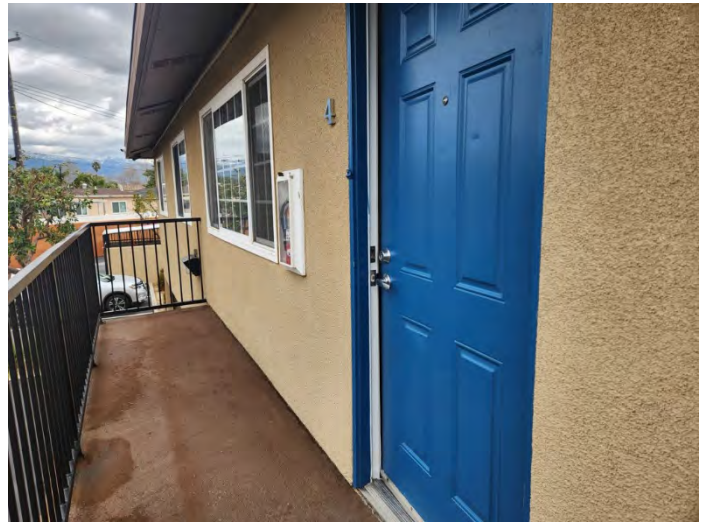
52. The entrance balcony that serves Apartment 4-1482C.

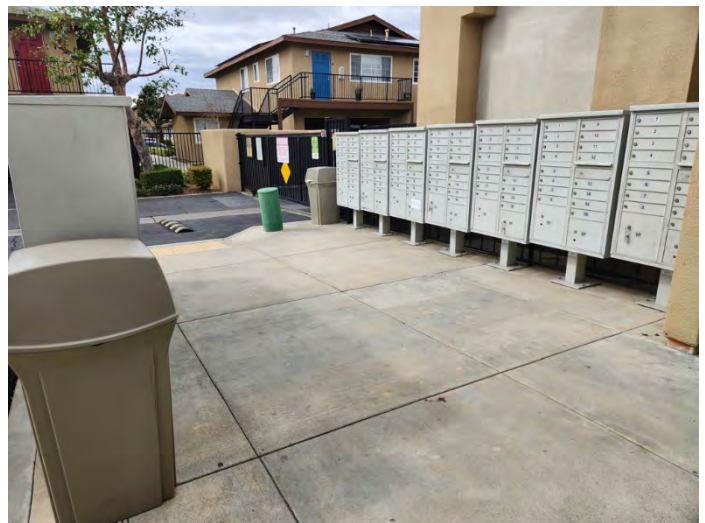
53. The mailboxes near the leasing office entrance.

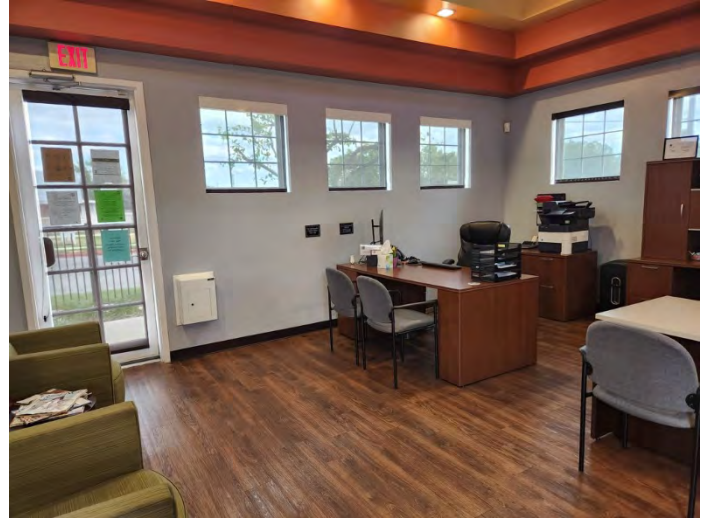
54. The main leasing office area.

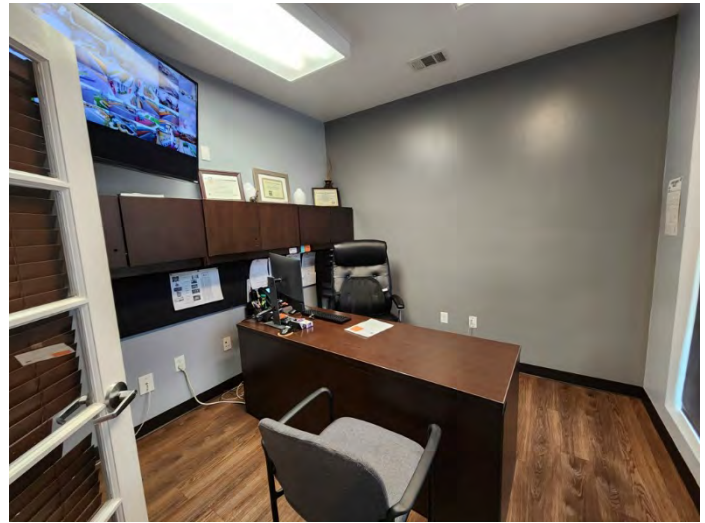
55. The community manager's office.

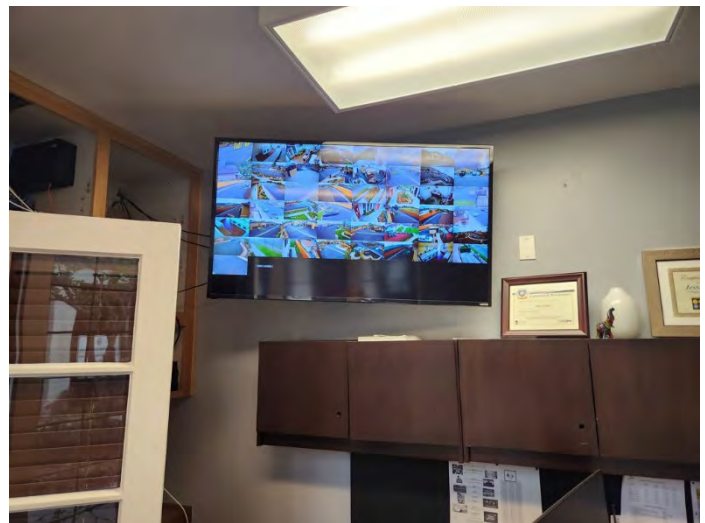
56. The monitor that serves the closed circuit tv security system.

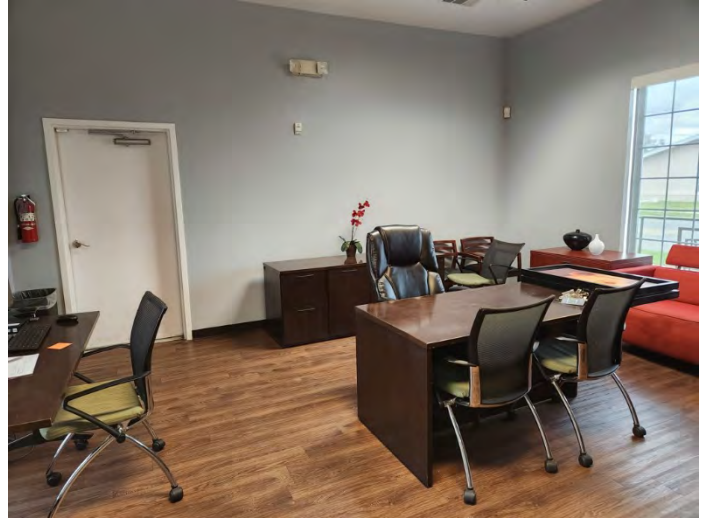
57. The conference room in the leasing office building. On the wall is a typical emergency exit light.

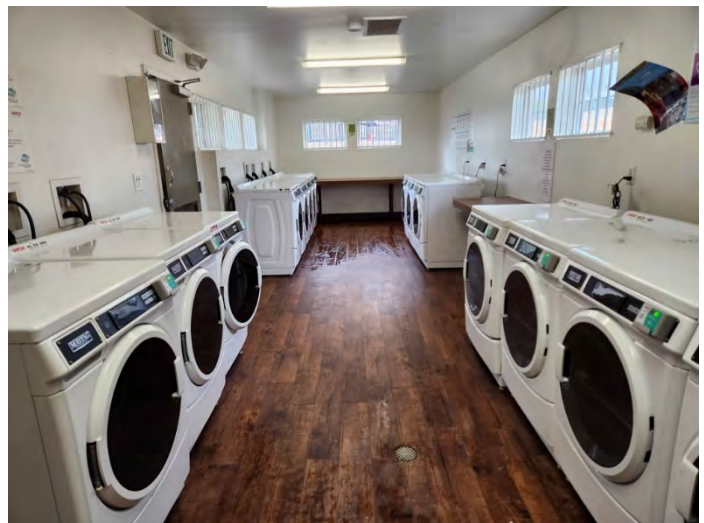
60. The laundry room in the leasing office building.
